ITEM DESCRIPTION: 2018 Fire Department Capital Budget Station Repairs

May 29, 2015
ZS Project No. 7402

Subject: **Fire Station 1 Condition Assessment FINAL Report
833 New York Avenue, Sheboygan, Wisconsin**

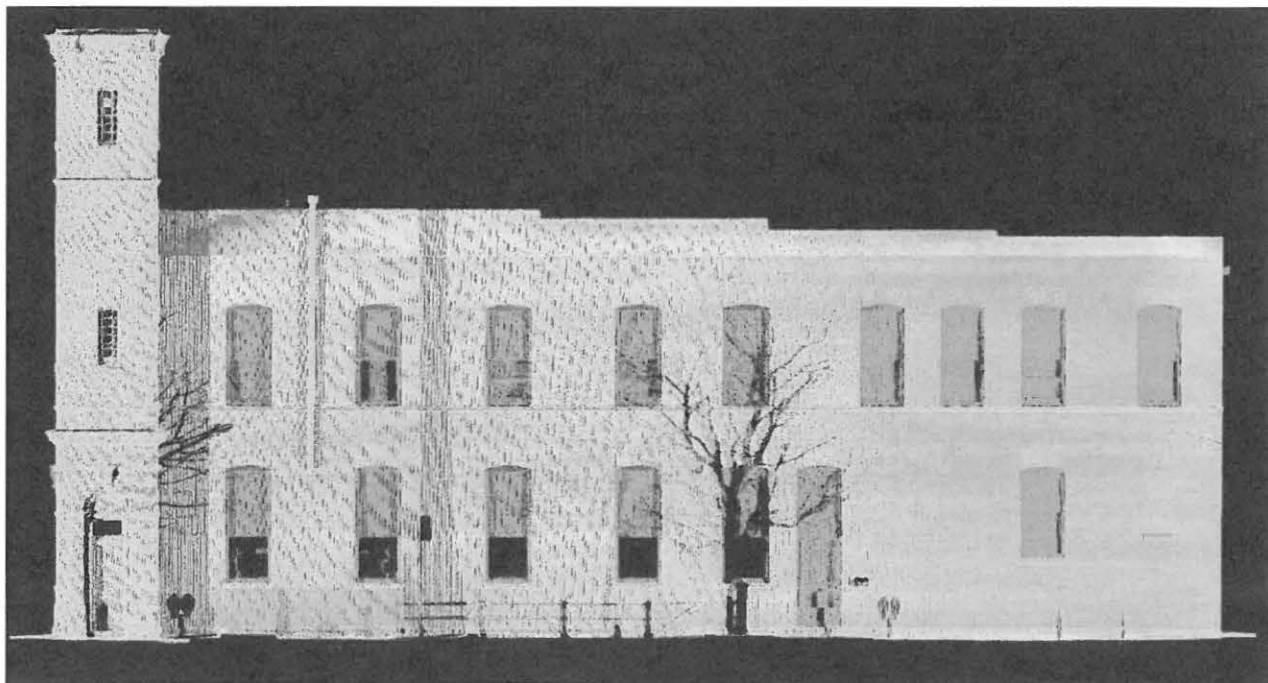
Images: Using the laser scanning data, out-of-plane movement of the walls were identified and accurately measured and depicted. Figures 4 - 6 show the extent of movement of the walls at different elevations. The figures show a colorized point cloud scale depicting the extent of the out-of-plane movement. Red colored areas of the scan indicates out-of-plane wall movement of two inches. For this type of wall, areas of the wall that are bulging two inches or greater are considered excessive and should be repaired.

Findings/Observations: The following specific conditional issues were noted during the laser scan of the facades: bulging brick at parapet level and tower on north and west facades (Figures 4 - 6).

Figure 4: West elevation, plane deviation analysis.

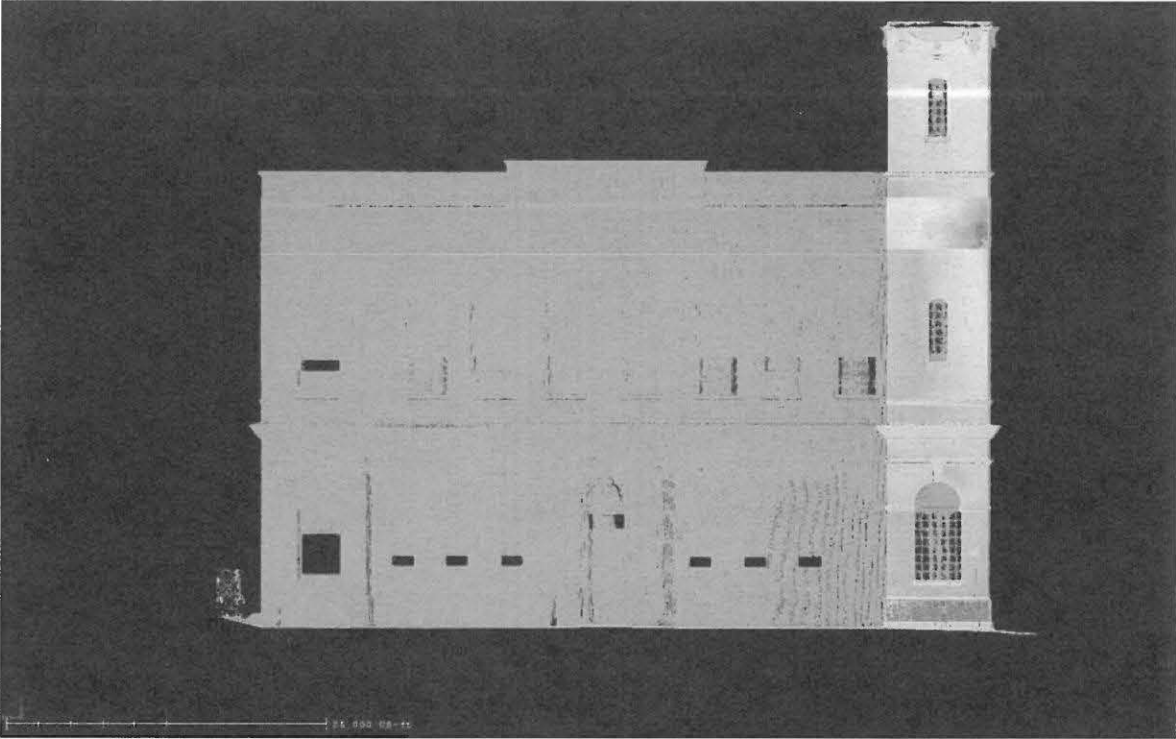
Figure 5: North tower facade, plane deviation analysis.

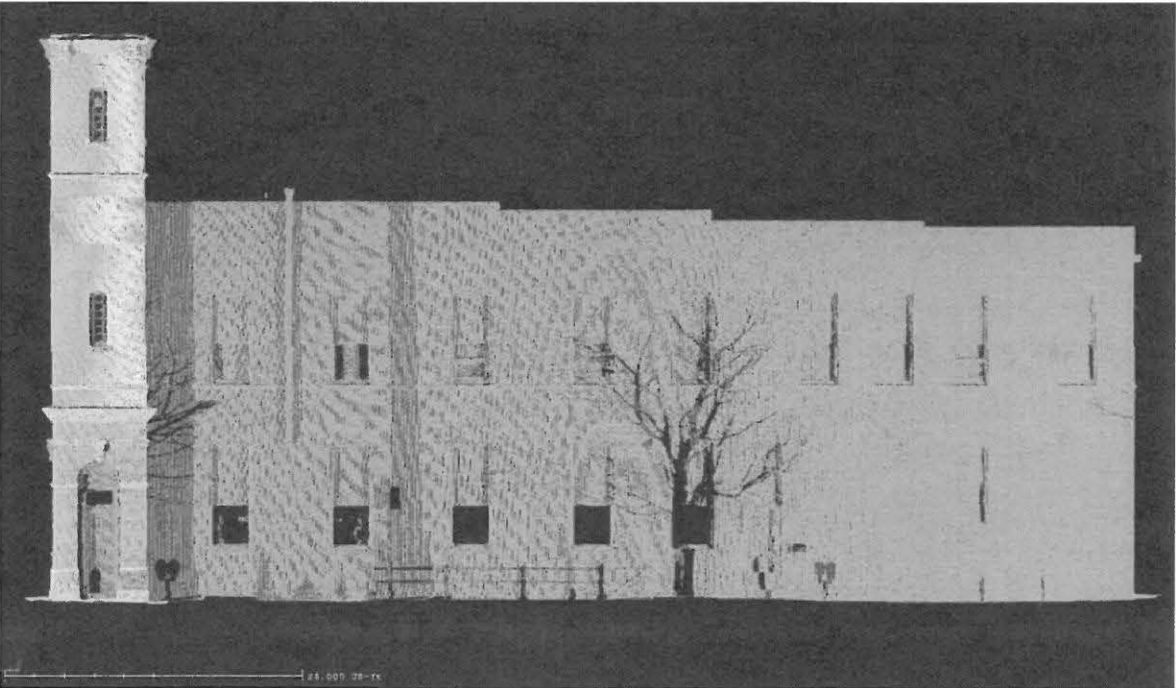
Figure 6: Tower west facade, plane deviation analysis.

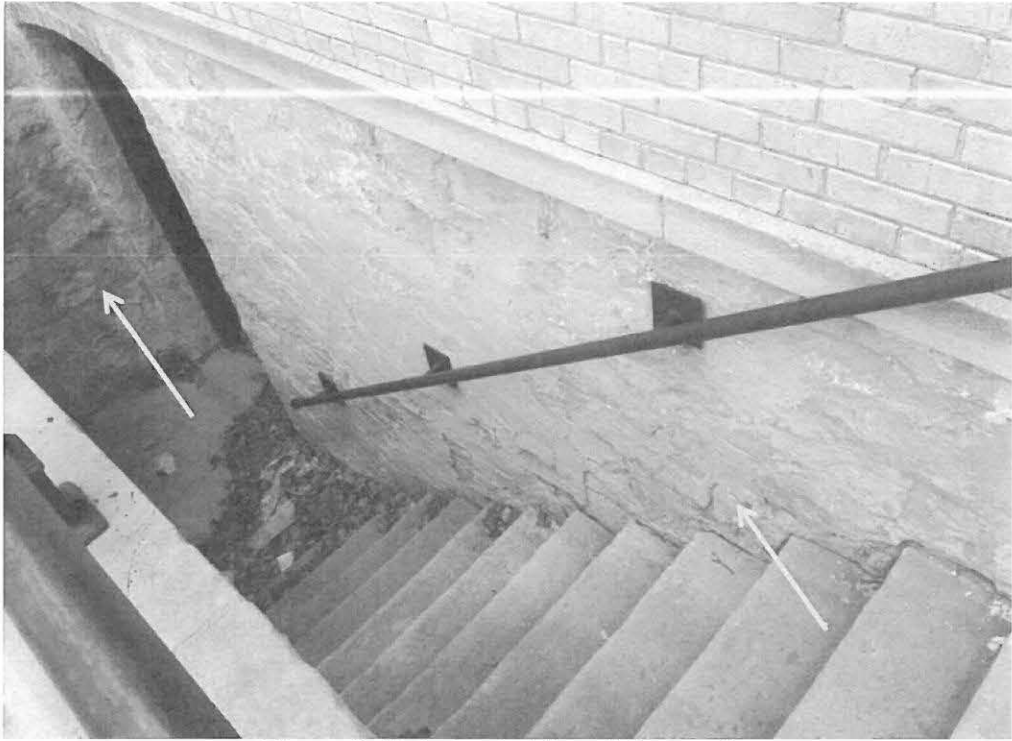
a. Deterioration at exposed foundation walls within below-grade stairwell (Figure 7).

Figure 7: Deteriorated foundation walls.

Repair/Timeframe: Tuckpoint exposed stone surfaces and patch spalled/deteriorated stone units (1-3 years).

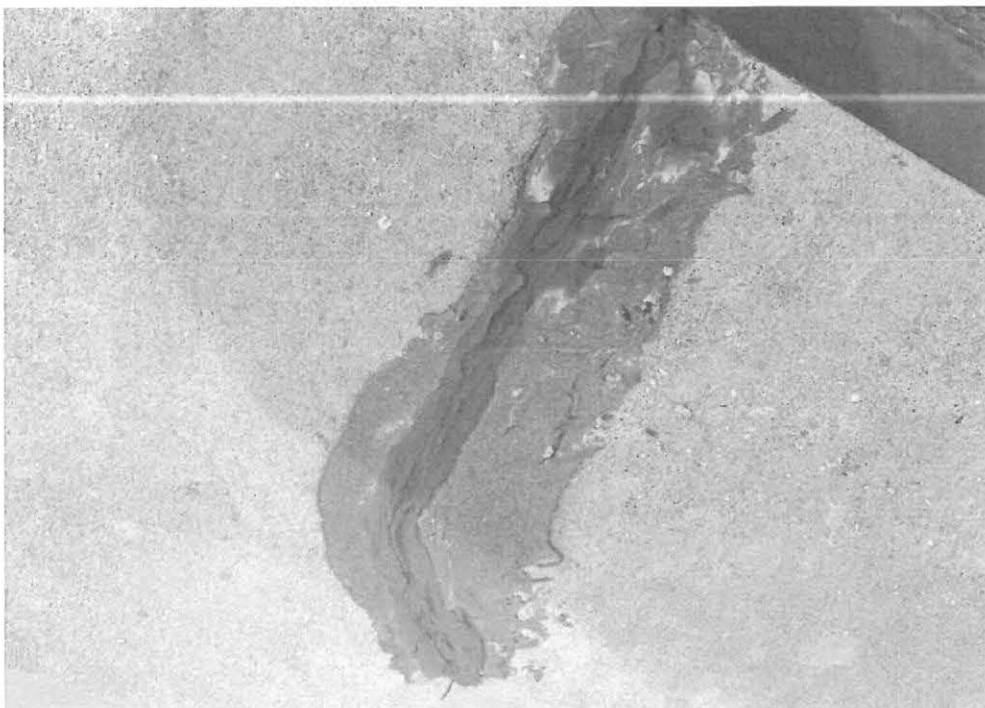
- a. Deteriorated stone coping sealant at all locations (Figure 9).
Repair/Timeframe: Remove all existing stone coping sealant and replace with new sealant (1-3 years).

Figure 9: Deteriorated stone coping sealant.

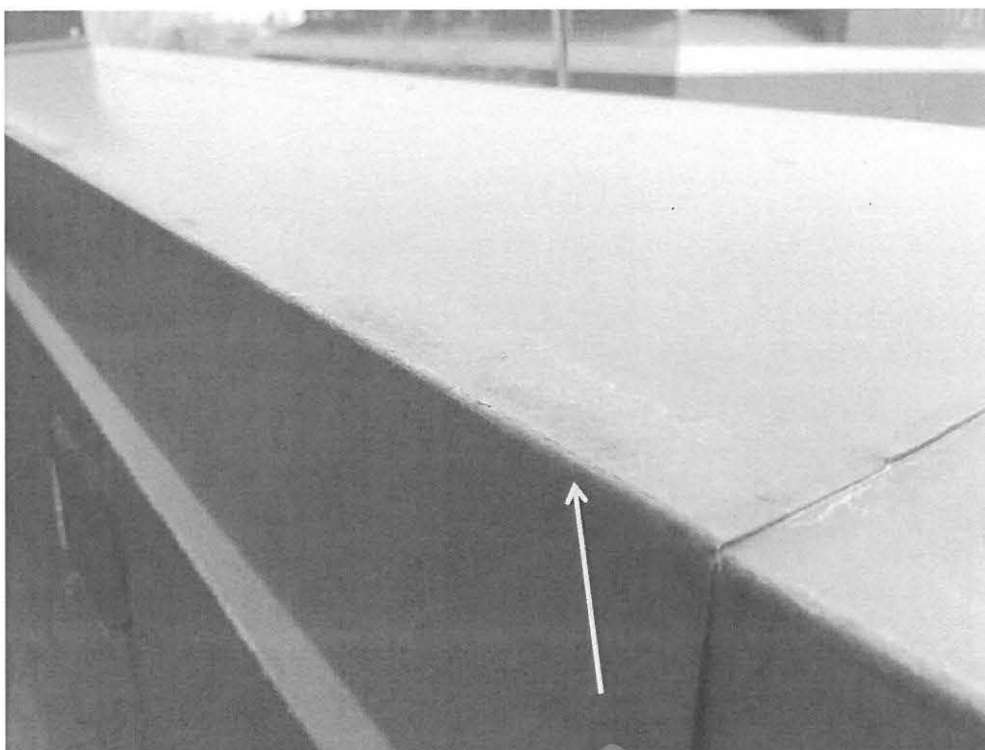
- b. Paint deterioration on metal coping at isolated locations (Figure 10).
Repair/Timeframe: Replace copings in conjunction with roof replacement (1-3 years).

Figure 10: Coping paint deterioration.

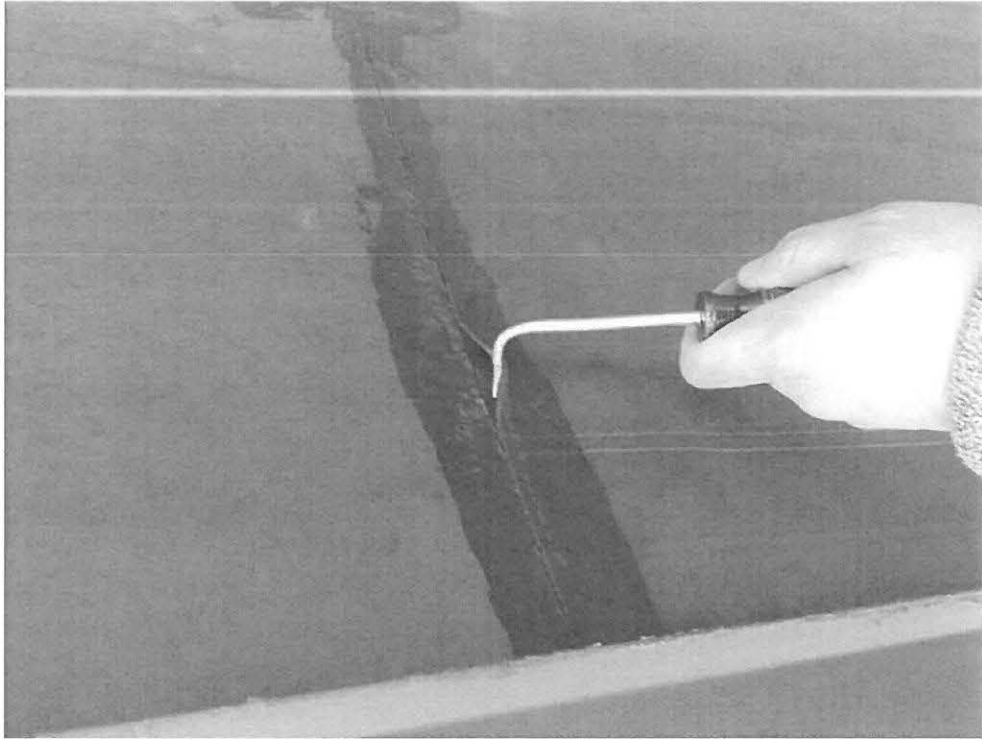
- c. Roof seams are open in approximately 25% of the locations (Figure 11).
Repair/Timeframe: Replace roof system (1-3 years).
- d. Sheet metal vents are corroded at all units (Figure 12).
Repair/Timeframe: Replace units in conjunction with roof replacement (1-3 years).

Figure 11: Open roof seam.

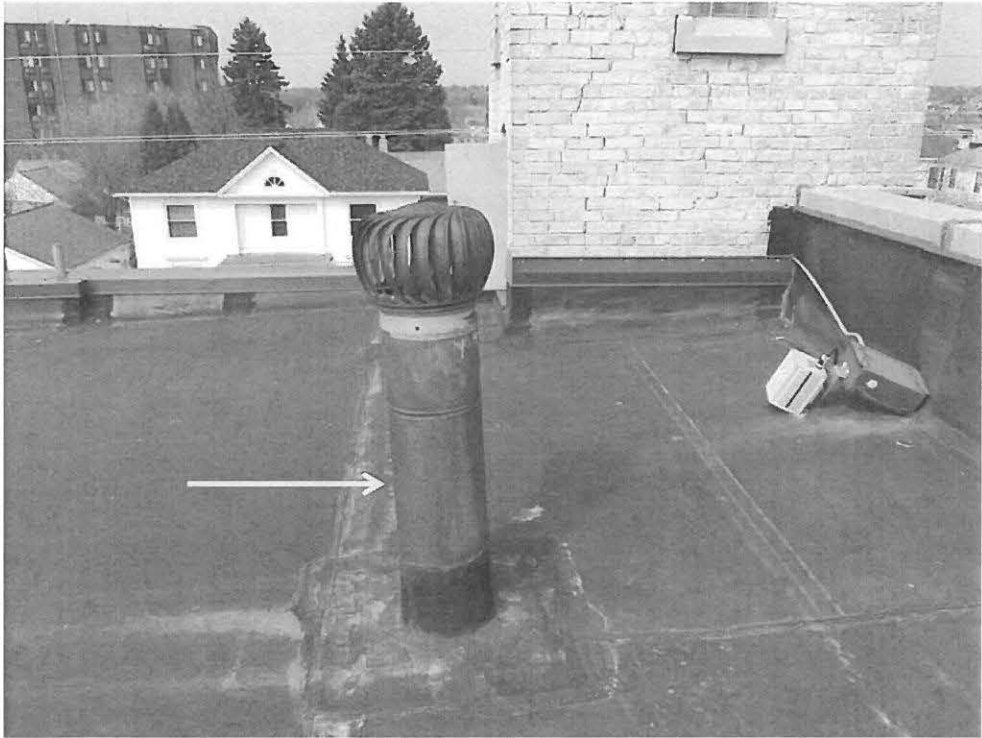
Figure 12: Corroded metal vent.

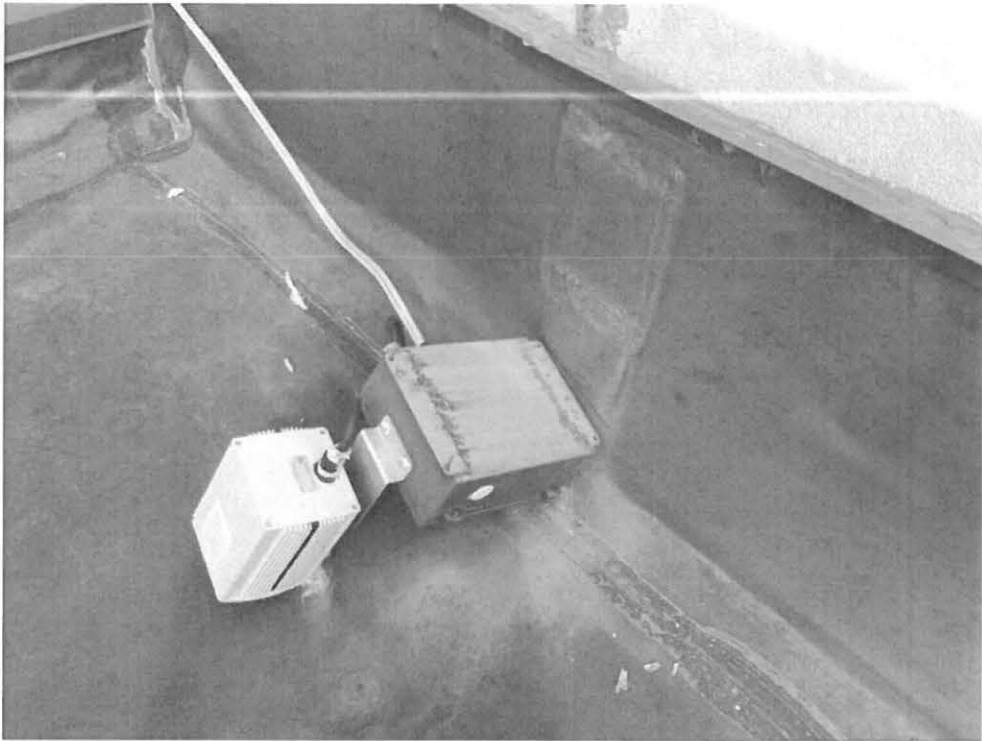
- e. Disconnected light fixture near the northeast corner (Figure 13).
Repair/Timeframe: Reattached light fixture (1-3 years).
- f. Deteriorated sealant on top of sheet metal counter flashing at all locations (Figure 14).
Repair/Timeframe: Replace roof system (1-3 years).

Figure 13: Disconnected light.

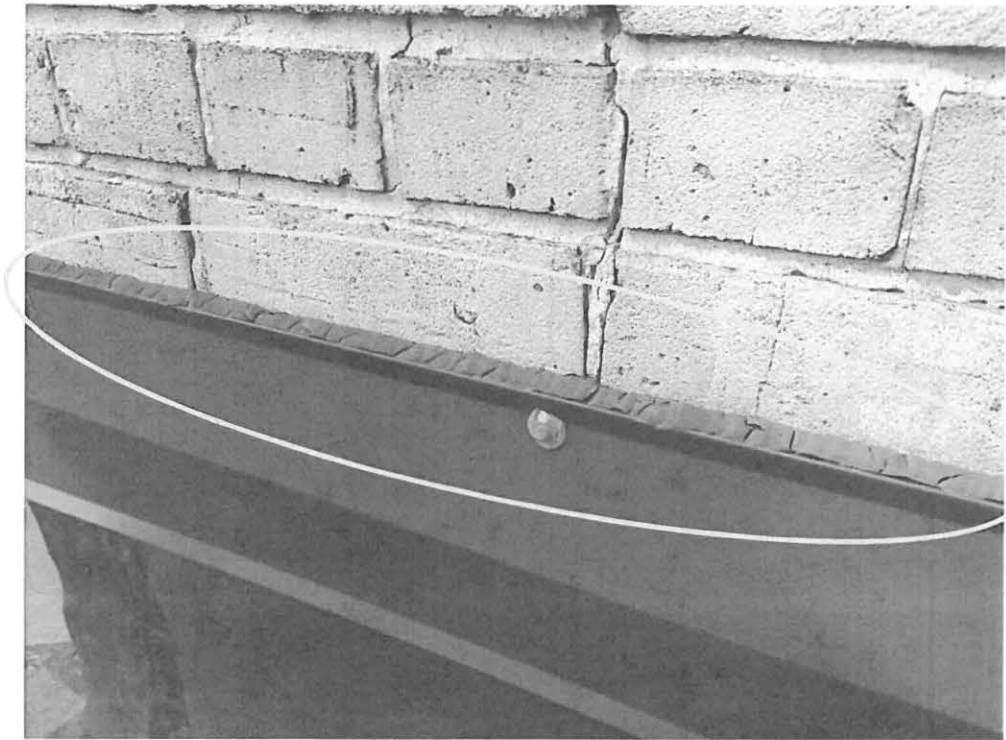
Figure 14: Deteriorated sealant at top of counterflashing.

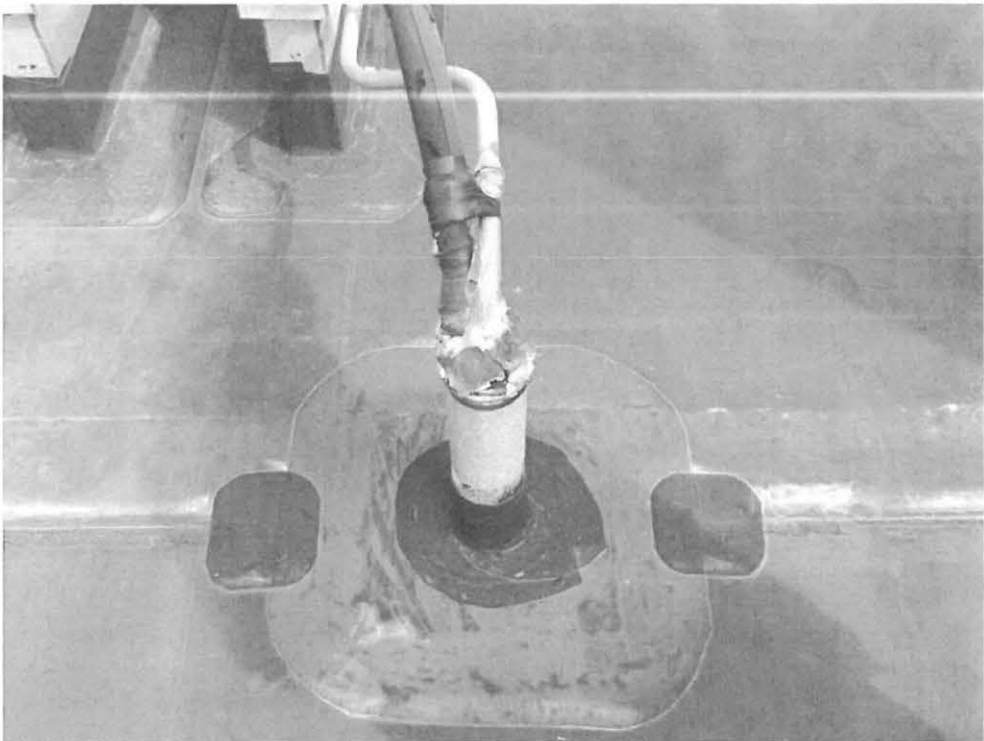
- g. Improperly sealed and failed seals at A/C line penetrations throughout (Figure 15 & 16).
Repair/Timeframe: Replace roof system (1-3 years).
- h. Open seams along wall flashings at multiple locations (Figure 17).
Repair/Timeframe: Replace roof system (1-3 years).

Figure 15: Deteriorated seal at A/C line penetration.

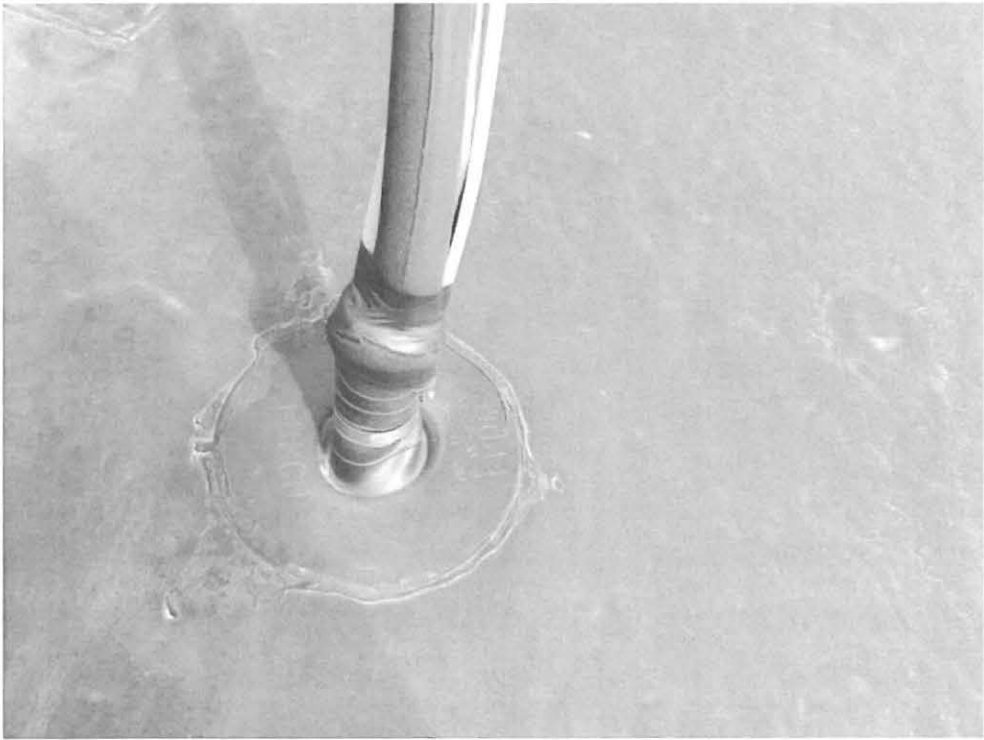
Figure 16: Improperly sealed A/C line penetration.

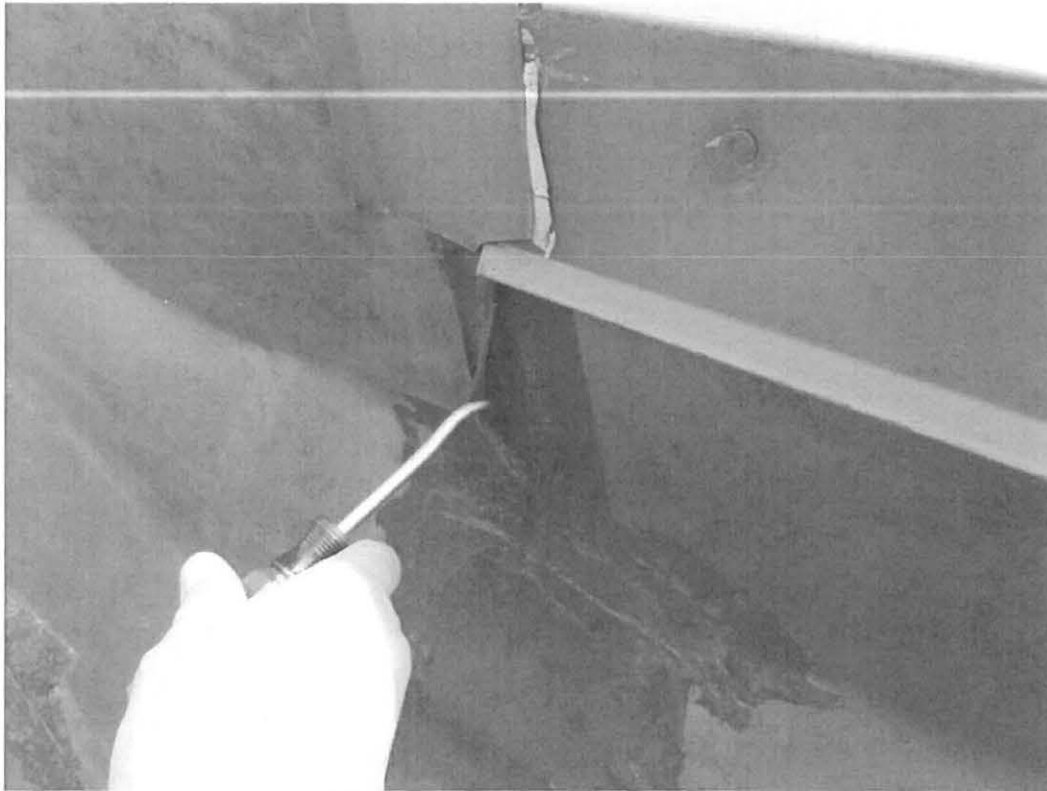
Figure 17: Open flashing seam.

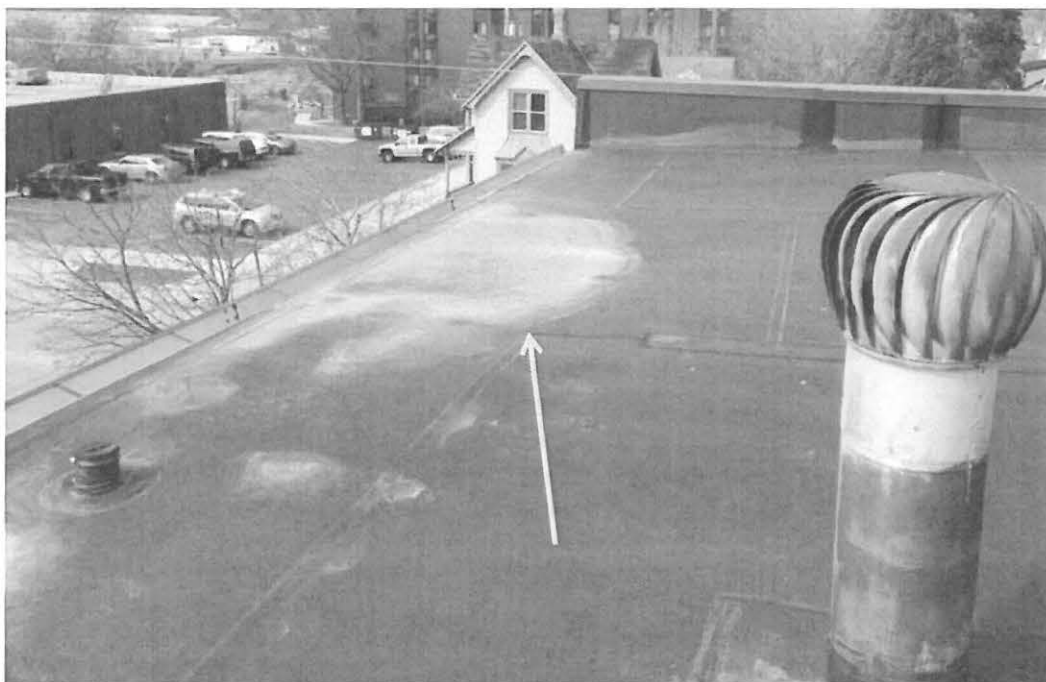
- i. Dirt buildup observed indicating water ponding at south roof edge (Figure 18).
Repair/Timeframe: Adjust roof slope to achieve positive slope to drain during roof replacement (1-3 years).

Figure 18: Ponding at south roof edge.

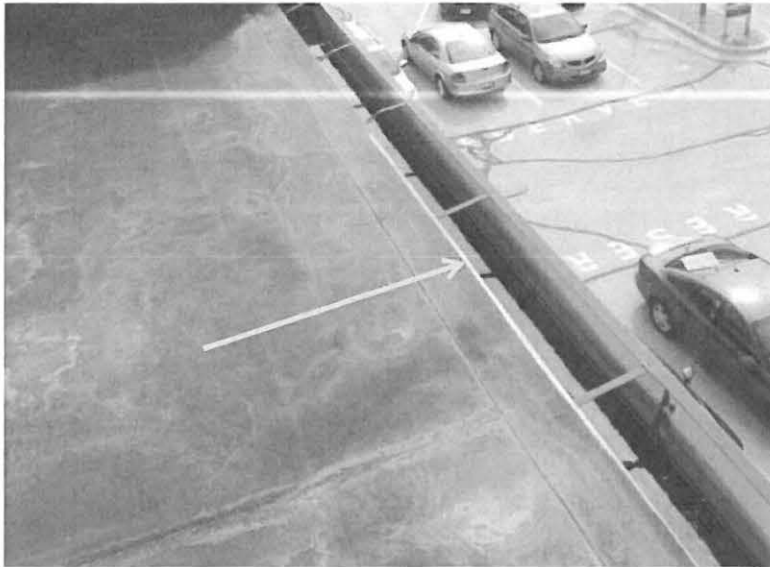
- j. Standing water in south roof gutter (Figure 19).
Repair/Timeframe: Adjust gutters to positively drain towards downspouts (1-3 years).

Figure 19: Standing water in south roof gutter.

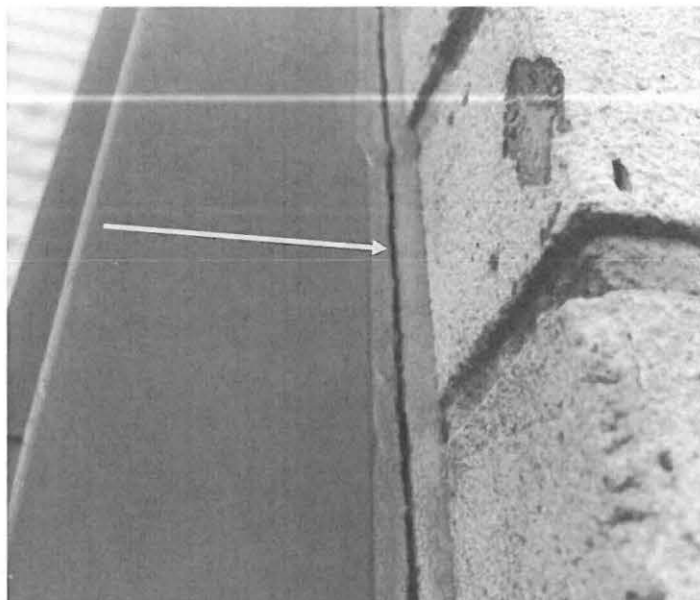
- a. Window perimeter sealant is deteriorated at all locations (Figure 21).

Figure 21: Failed window perimeter sealant.

Repair/Timeframe: Remove existing sealant from all window units and reseal all perimeters with new sealant (1-3 years).

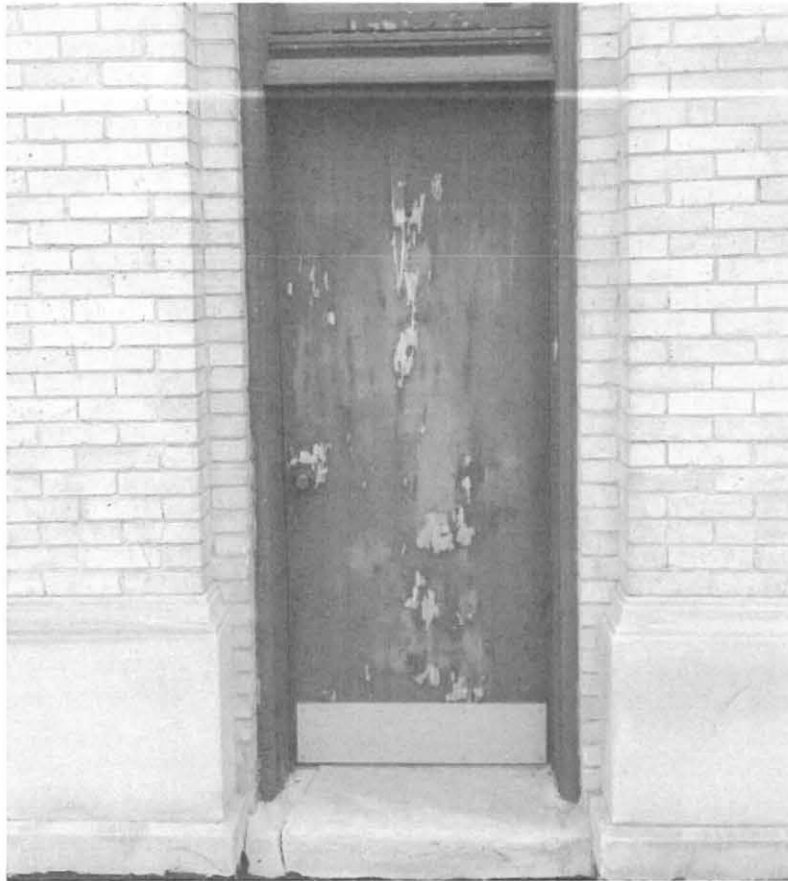
- a. West facade wood doors in extremely poor condition (Figure 23).

Figure 23: Deteriorating wood door.

Repair/Timeframe: Replace doors on west facade (0-1 years).

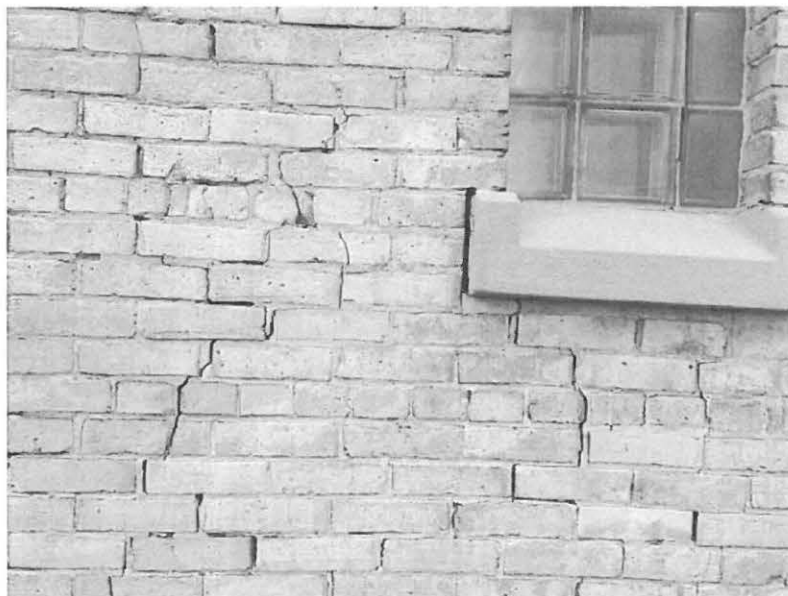
- a. Brick cracking at random locations (Figure 24).

Figure 24: Brick/mortar cracking.

Repair/Timeframe: Remove crack brick masonry units and replace with new brick provide horizontal stitching reinforcement as necessary (3-5 years).

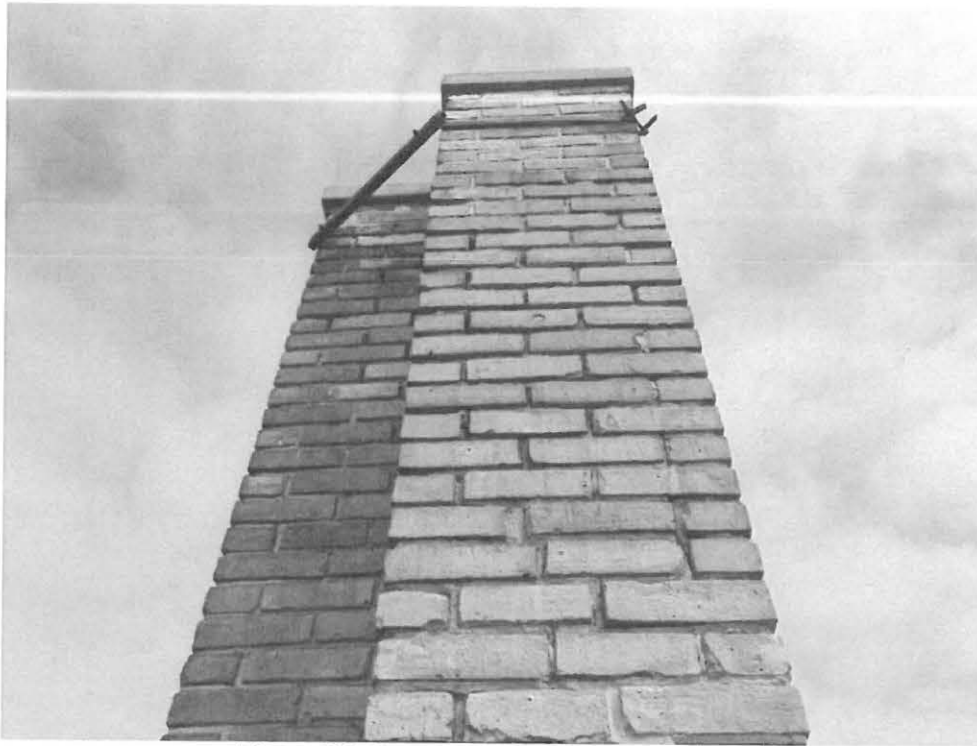
- b. Deteriorated brick units at the chimney (Figure 25).

Figure 25: Deteriorated brick at chimney.

Repair/Timeframe: Replace deteriorated bricks (1-3 years).

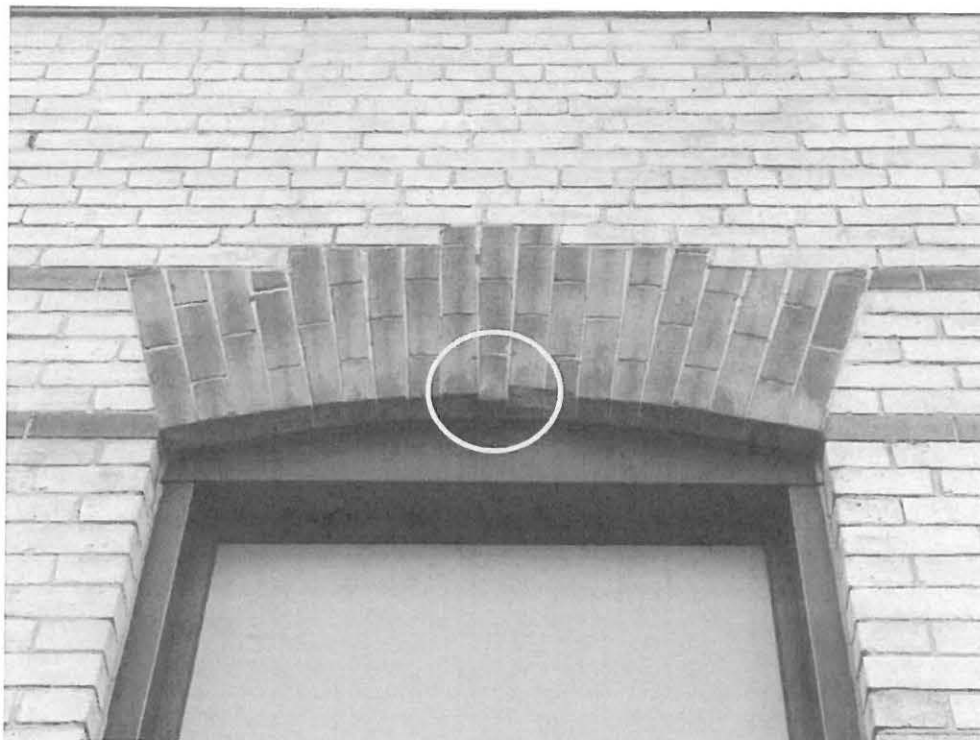
c. Loose brick units at isolated locations (Figure 26).

Figure 26: Loose brick unit.

Repair/Timeframe: Remove and reset loose brick units (0-1 years).

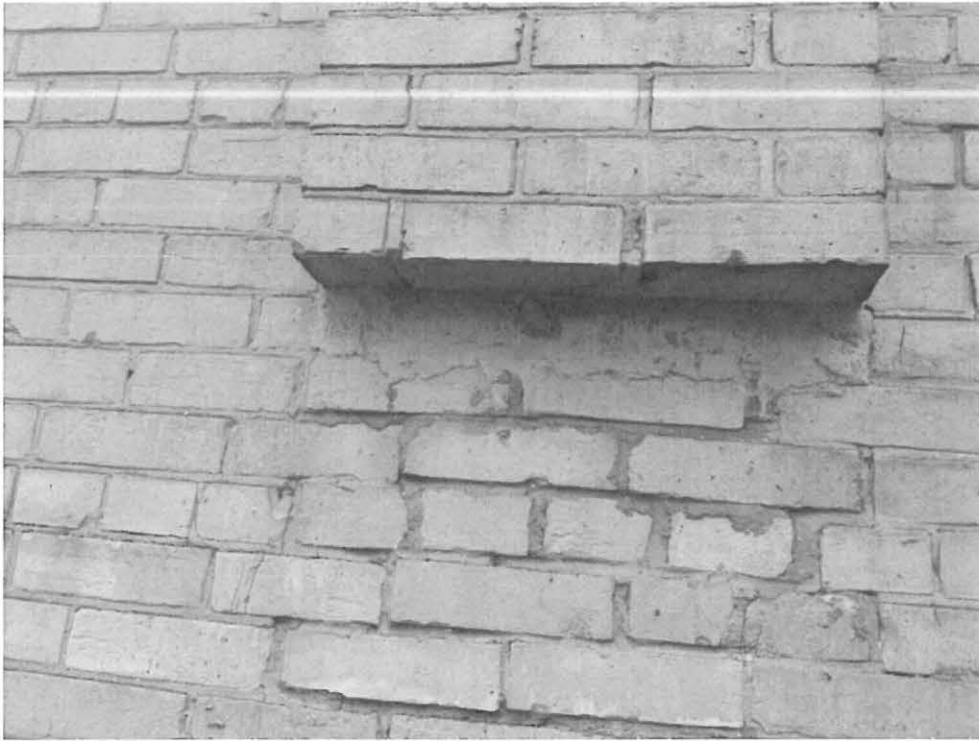
d. Mortar deterioration throughout (Figure 27 & 28).

Figure 27: Deteriorated mortar joints.

Repair/Timeframe: Cut out existing mortar to a depth of a minimum of ¾" and install new pointing mortar (1-3 years).

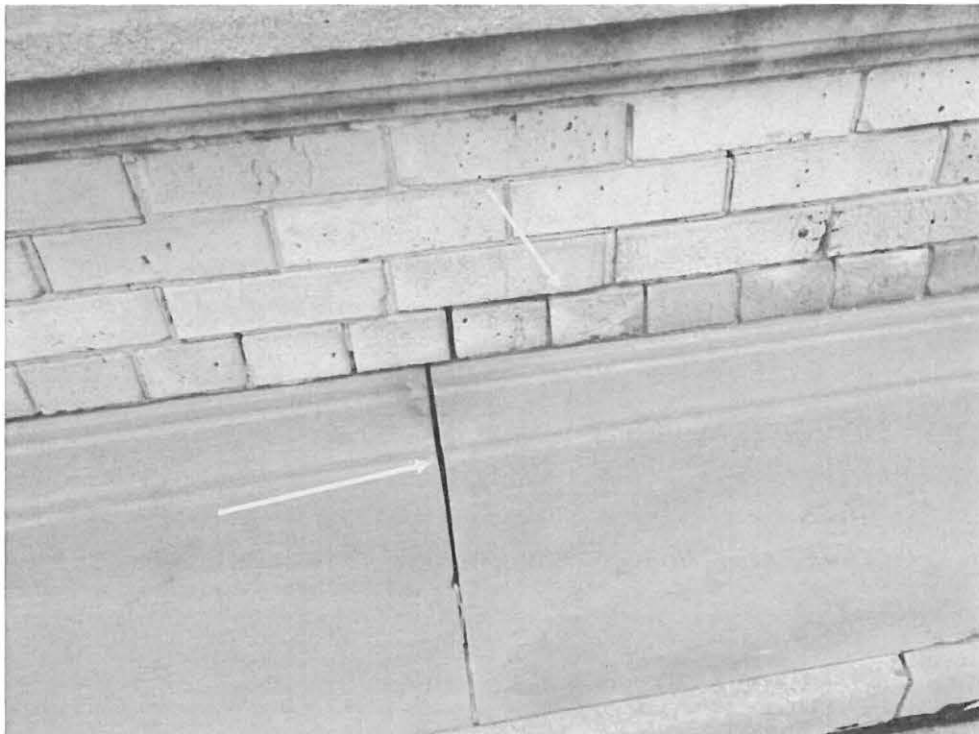
Figure 28: Deteriorated and open mortar joints.

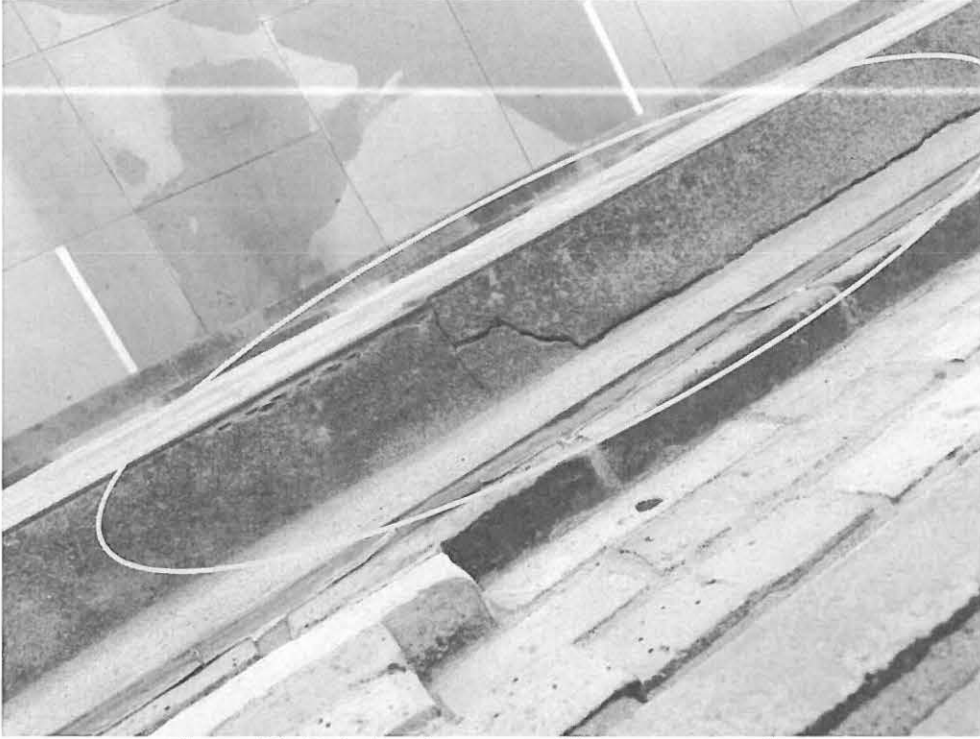
e. Deteriorated cementitious parge coating (at removed cornice area) on upper portion/parapets at north and west facades (Figure 29).

Figure 29: Deteriorating cementitious parge coating.

Repair/Timeframe: Removed deteriorated parge coat and replace with alternate coating material (1-3 years).

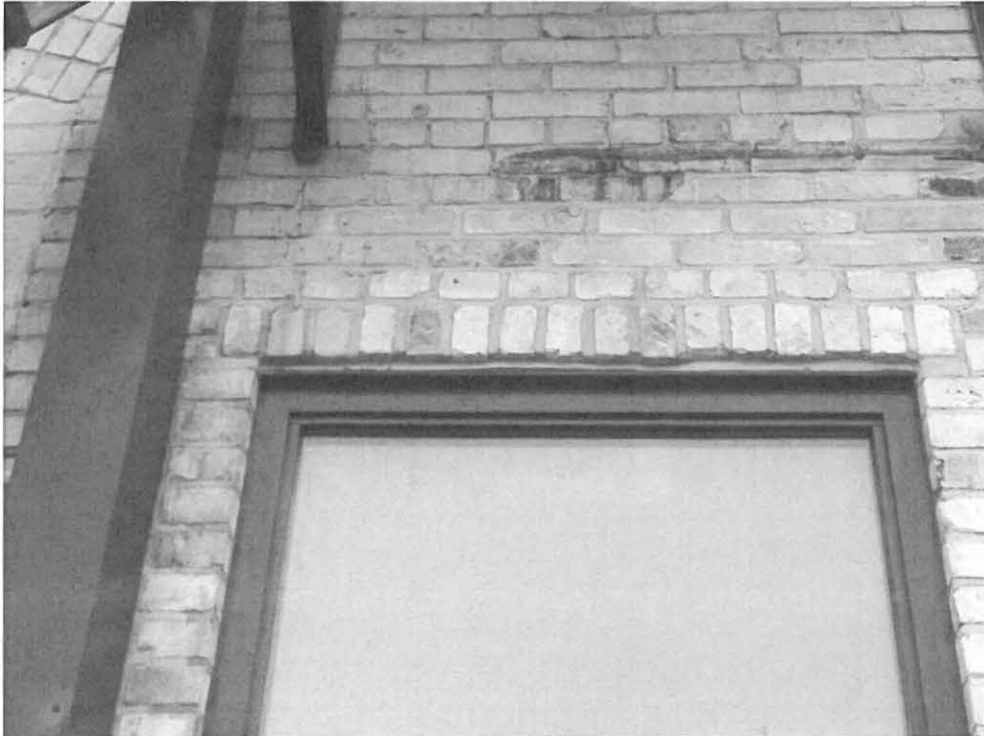
f. Corroded steel lintels at most locations with rust jacking causing brick masonry out of plane movement and interior cracking ((Figure 30 & 31).

Figure 30: Corroded steel lintel.

Repair/Timeframe: Remove brick to expose lintels at identified locations, repair or replace lintels, install new through wall flashing and replace removed brick masonry (1-3 years).

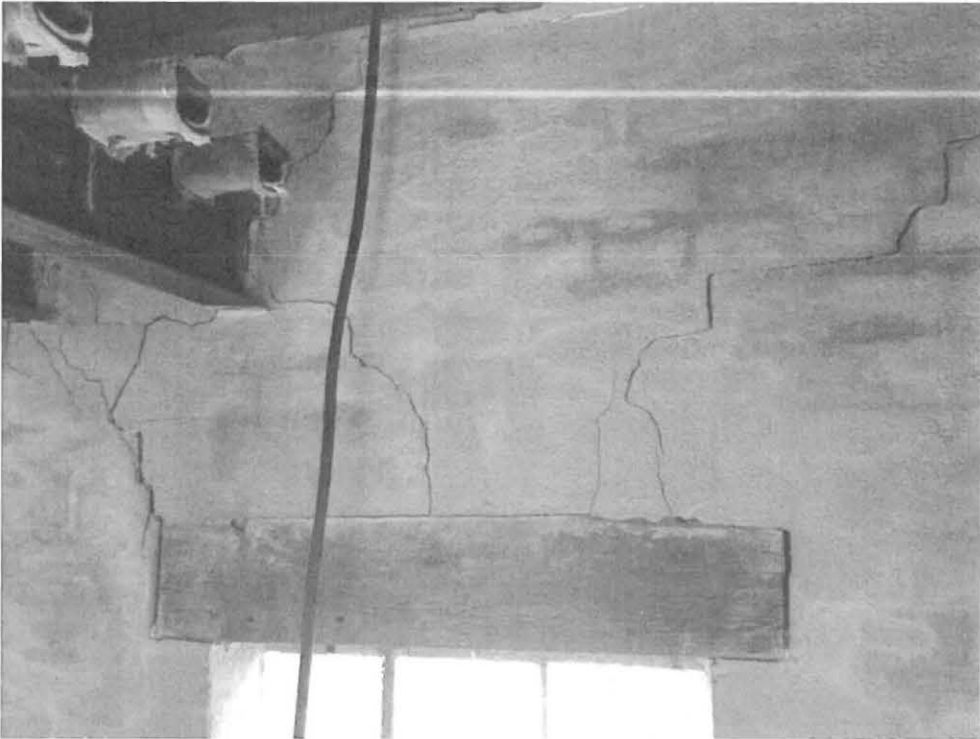
Figure 31: Interior cracking at lintel.

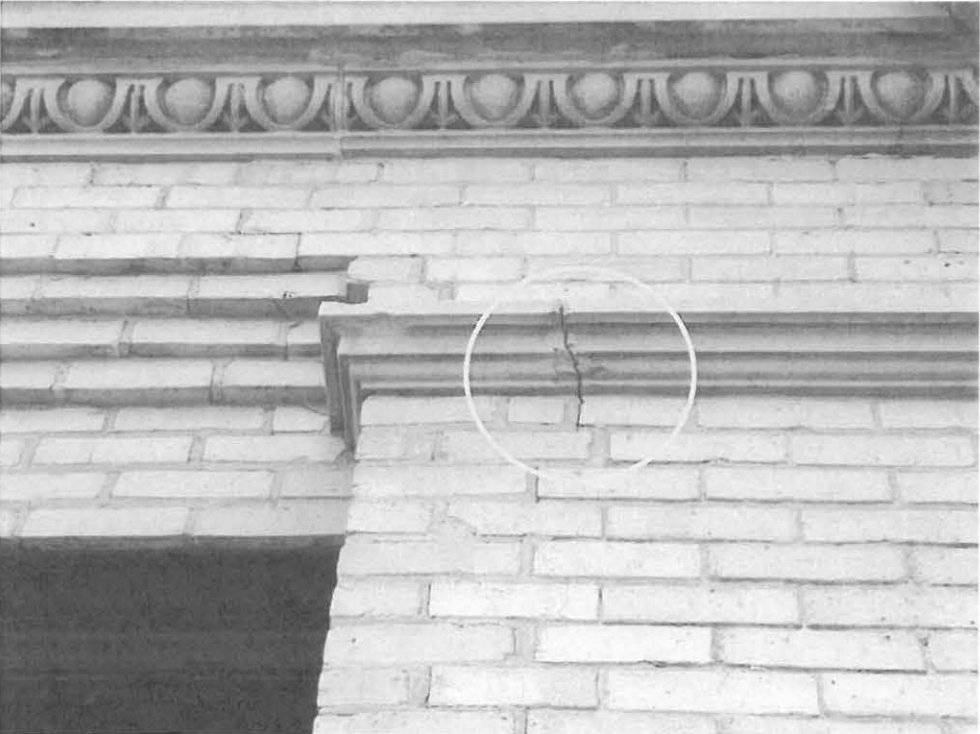
a. Cracked stone units at several locations (Figure 32).

Figure 32: Cracked stone unit.

Repair/Timeframe: Perform stone crack repair (1-3 years).

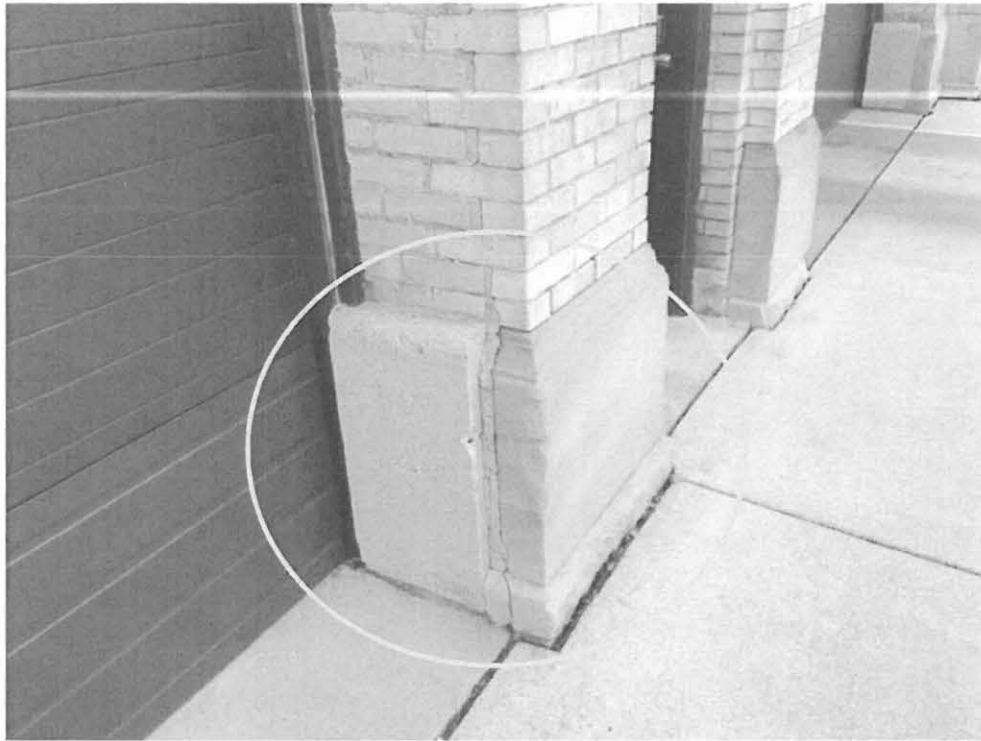
Figure 33: Stone deterioration.

Repair/Timeframe: Remove loose stone material and tool/reprofile stone units (1-3 years).

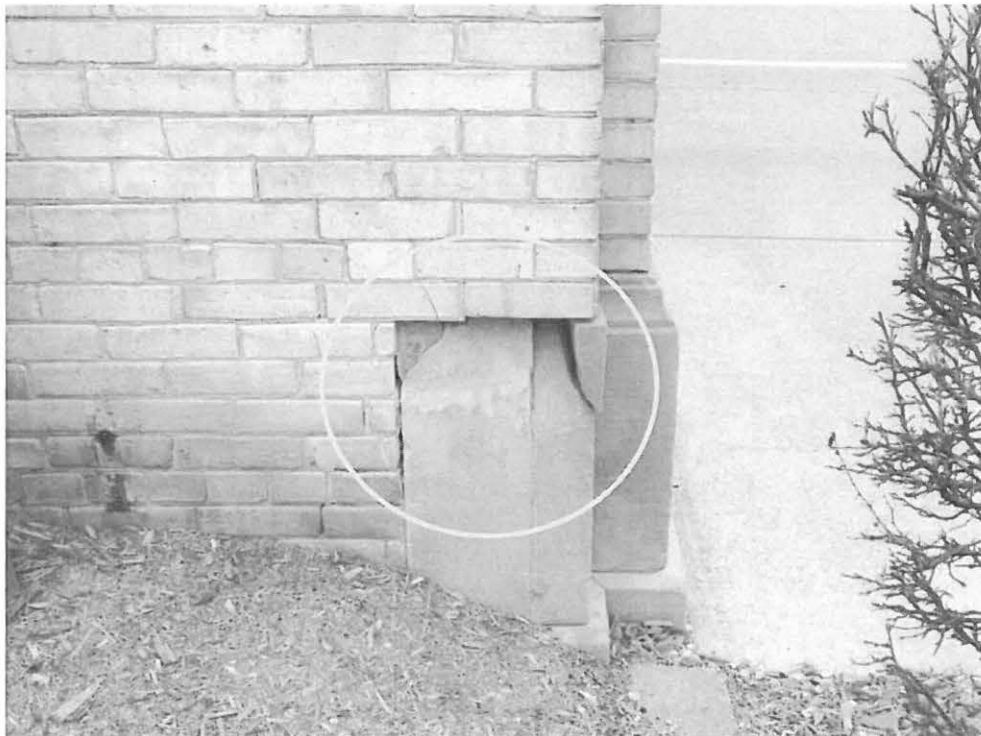
c. Spalled stone units at several locations (Figure 34).

Figure 34: Stone spalling.

Repair/Timeframe: Perform Dutchmen repair of spalls (1-3 years).

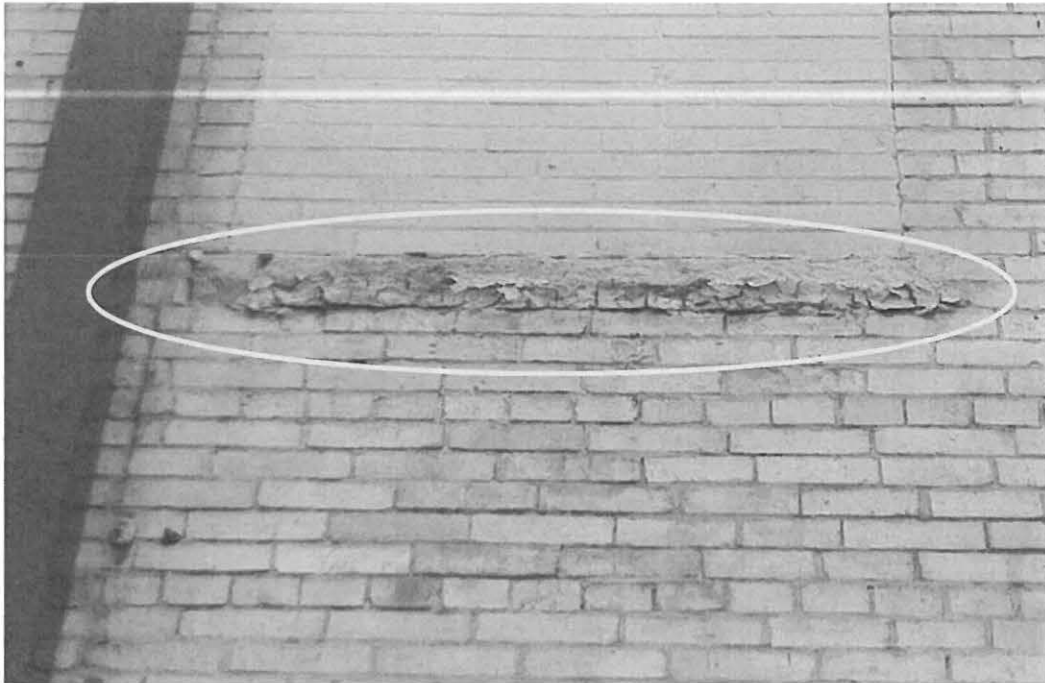
d. Deteriorated and cracked stone sills (Figures 35 & 36).

Figure 35: Deteriorated sill.

Repair/Timeframe: Remove deteriorated stone sills and replace with new limestone sills (1-3 years).

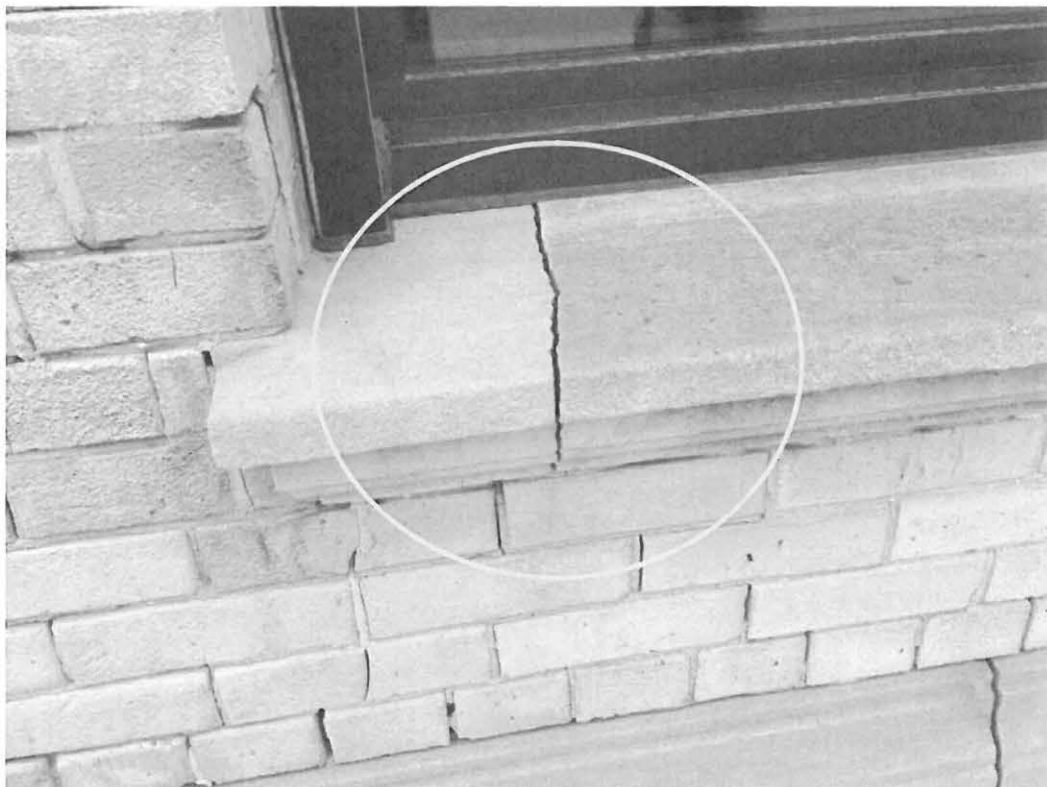
Figure 36: Cracked sill.
