ITEM DESCRIPTION: 2018 Fire Department Capital Budget Station Repairs

May 29, 2015
ZS Project No. 7402

Subject: **Fire Station 1 Condition Assessment FINAL Report
833 New York Avenue, Sheboygan, Wisconsin**

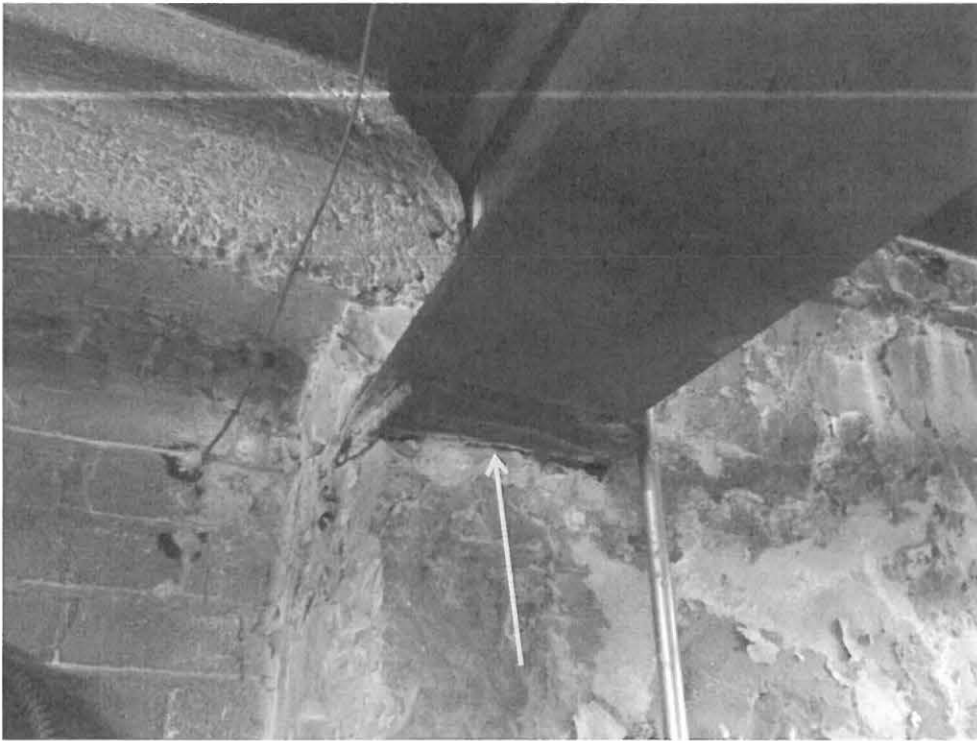
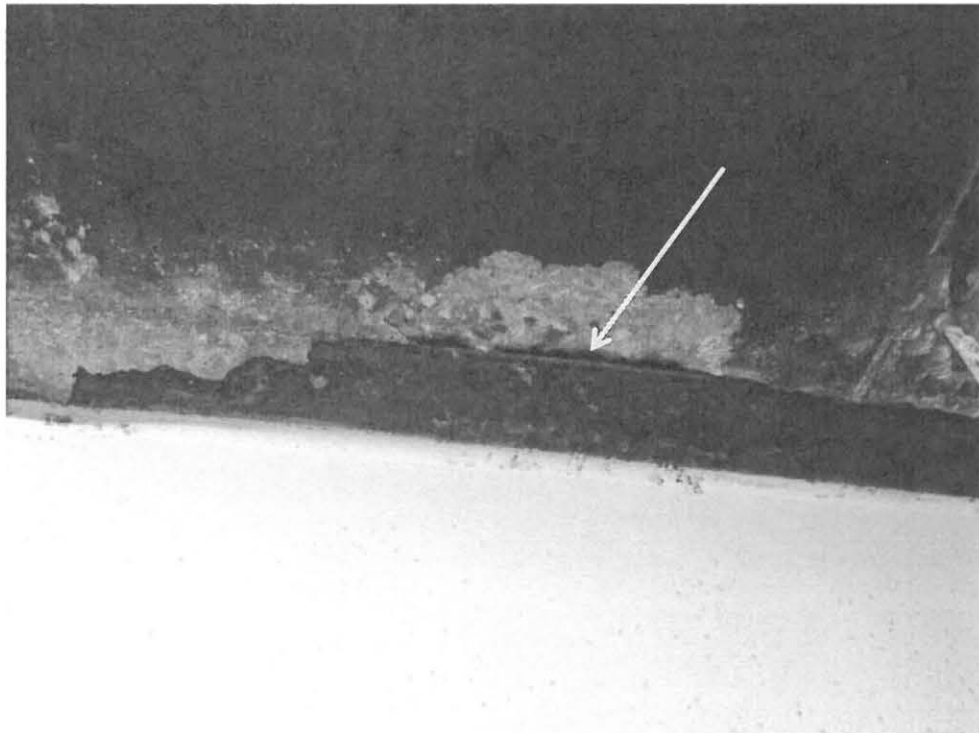
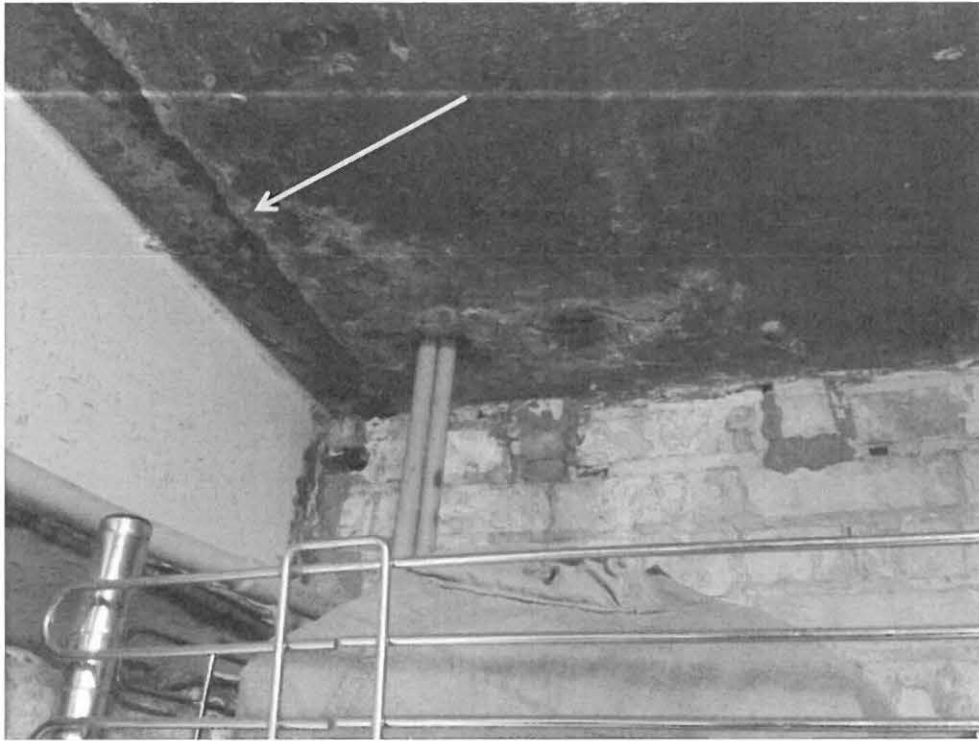
a. Corrosion of structural elements causing concrete/foundation wall spalling (Figures 37 - 39).

Figure 37: Corrosion of steel beam.

Figure 38: Steel corrosion.

Figure 39: Steel Corrosion.

Repair/Timeframe: Remove all corrosion where possible. Replace structural members with section loss (0-1 years).

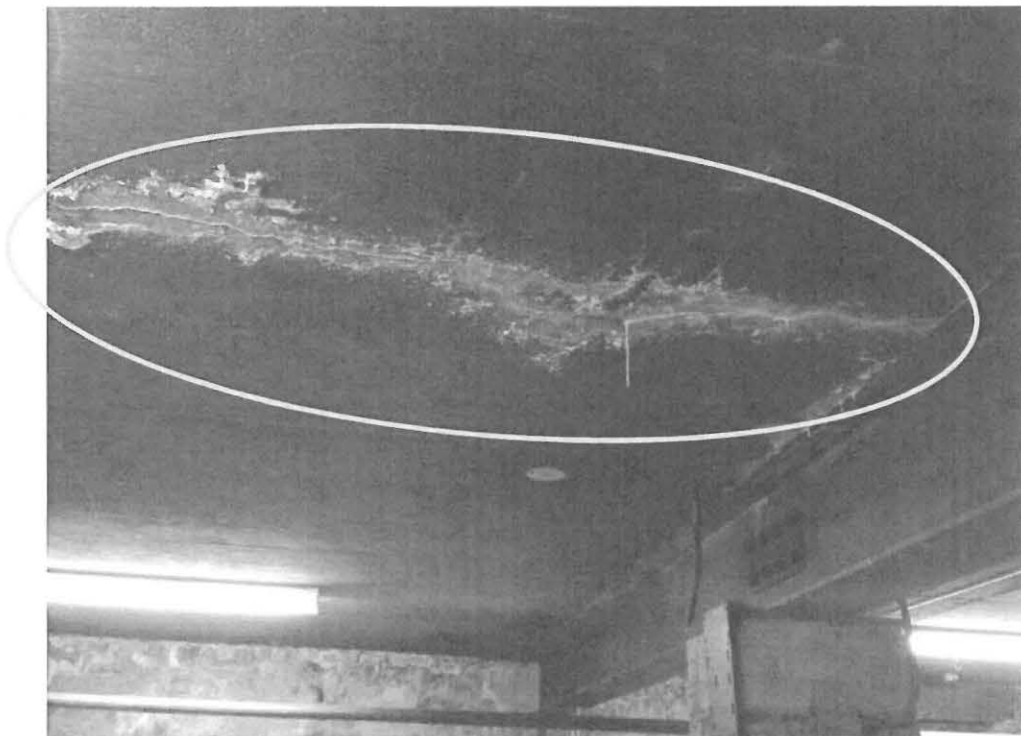
b. Efflorescence on ceiling and water staining on floor under east apparatus bay (Figures 40 & 41). ZS observed active leaking into the basement while the apparatus bay floor was being washed down with water.

Figure 40: Efflorescence on ceiling.

Repair/Timeframe: Limit heavy water spraying of the floors or install waterproofing membrane over floor to prevent leakage into the basement.

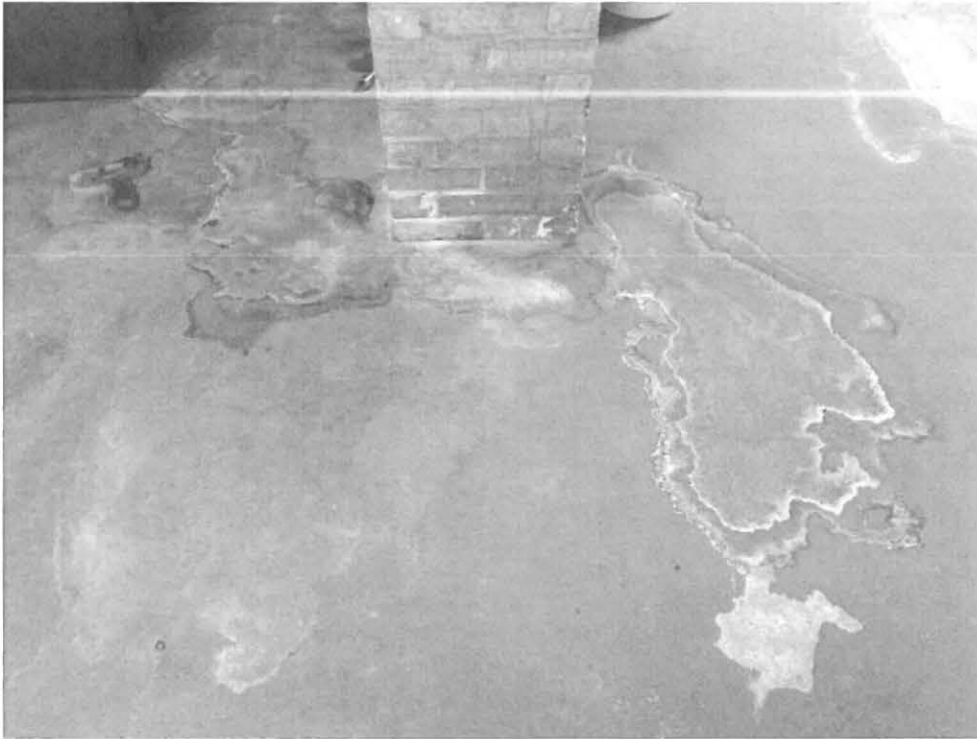
Figure 41: Water staining on floor.

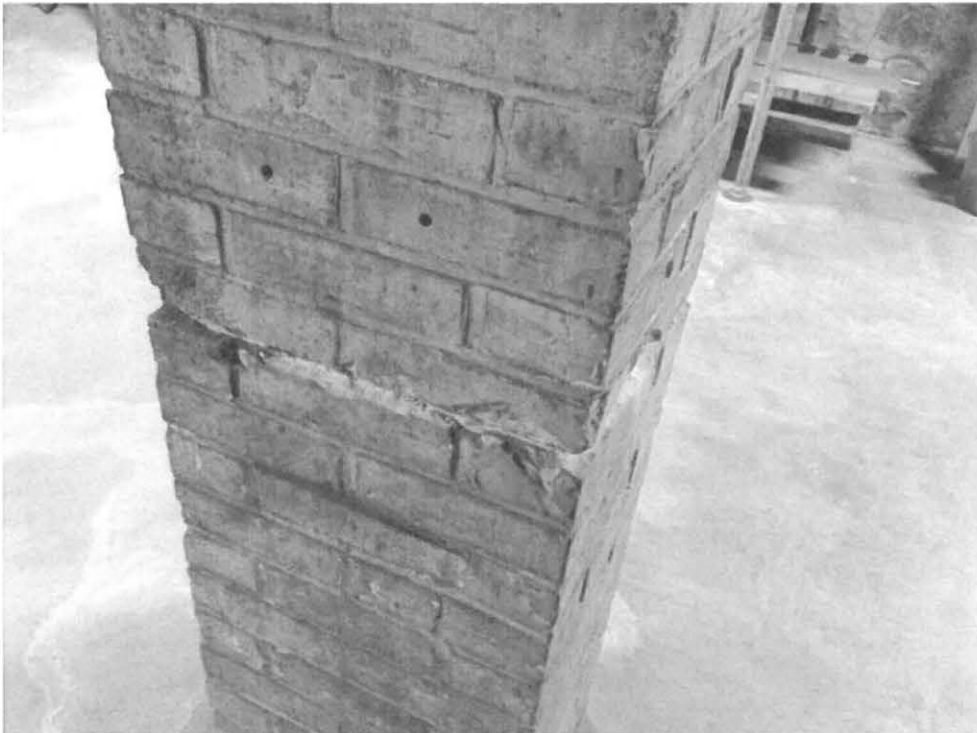
c. Brick deterioration on brick masonry columns (Figure 42).

d. Deteriorated mortar joints on brick masonry columns and along foundation walls (Figure 42).

Figure 42: Brick deterioration; Deteriorated mortar joints.

Repair/Timeframe: Replace deteriorated bricks units (1-3 years).

Repair/Timeframe: Removed existing mortar joints to a depth of a minimum of $\frac{3}{4}$ " and install new mortar (1-3 years).

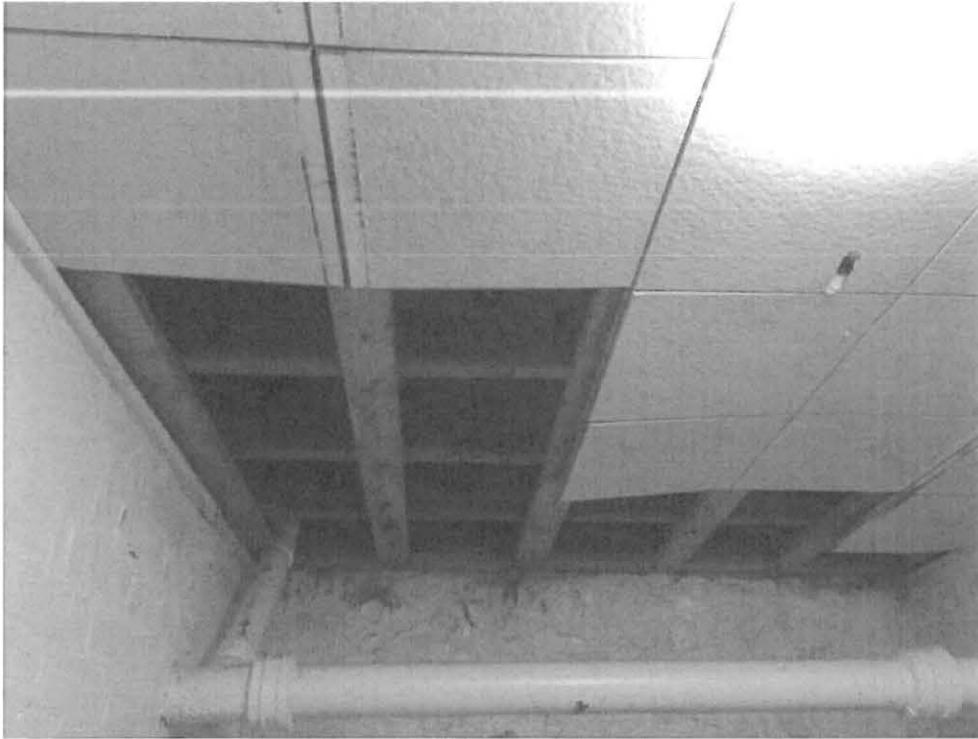
e. Missing hallway ceiling tiles (Figure 43).

Figure 43: Missing ceiling tiles.

Repair/Timeframe: Replace ceiling tiles (0-1 years).

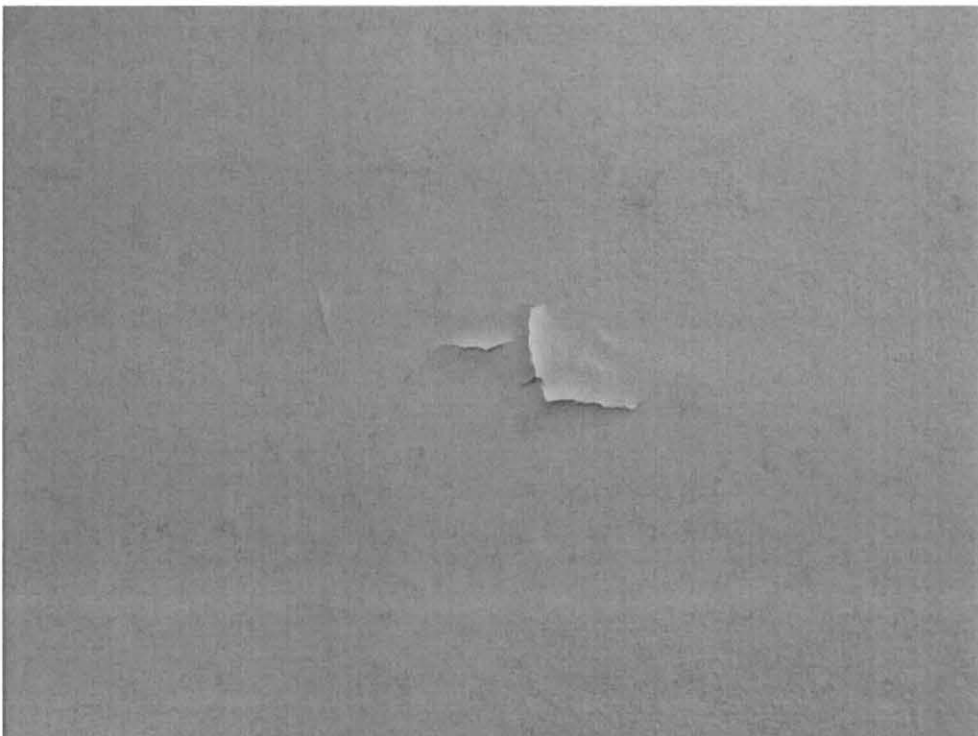
f. Minor paint cracking/peeling in isolated locations (Figure 44).

Figure 44: Paint failure.

Repair/Timeframe: Clean, prime and paint areas where failed (1-3 years).

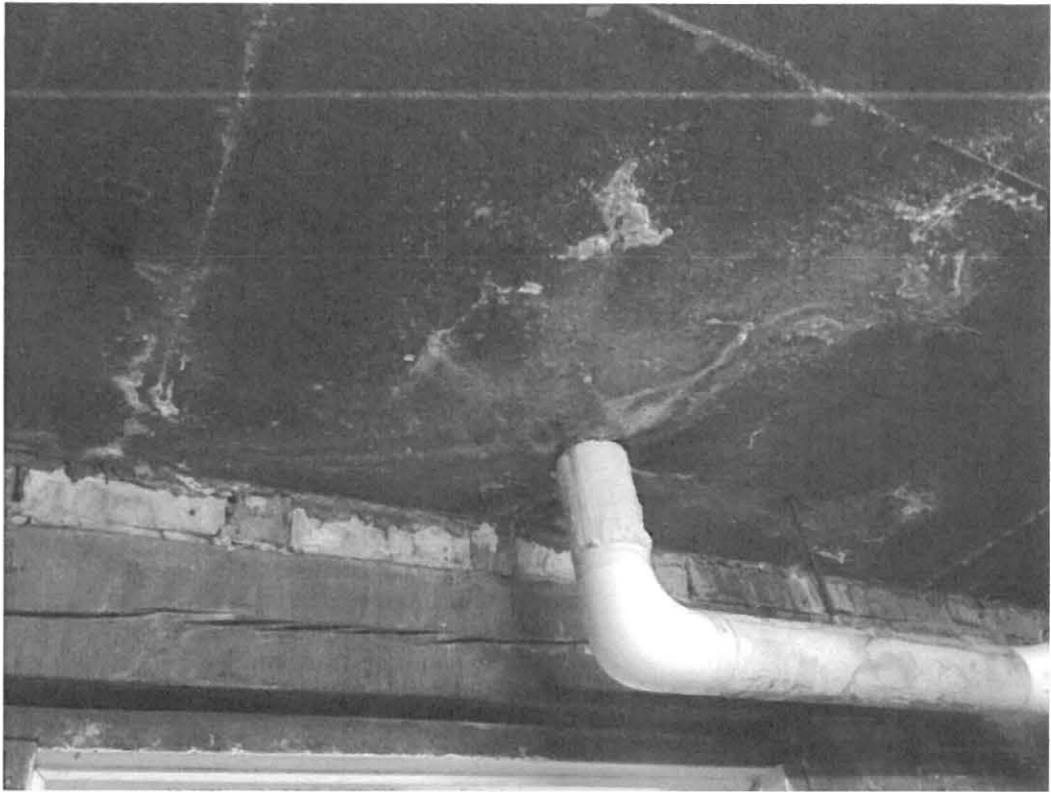
g. Water leaking from first floor garage area floor drain to basement. Water leakage from the drain is causing efflorescence in the basement as well as steel corrosion and concrete spalls on the north wall (Figure 45).

Figure 45: Corrosion, spalls and efflorescence due to leaking at floor drain.

Repair/Timeframe: Replace failed floor drain (0-1 years).

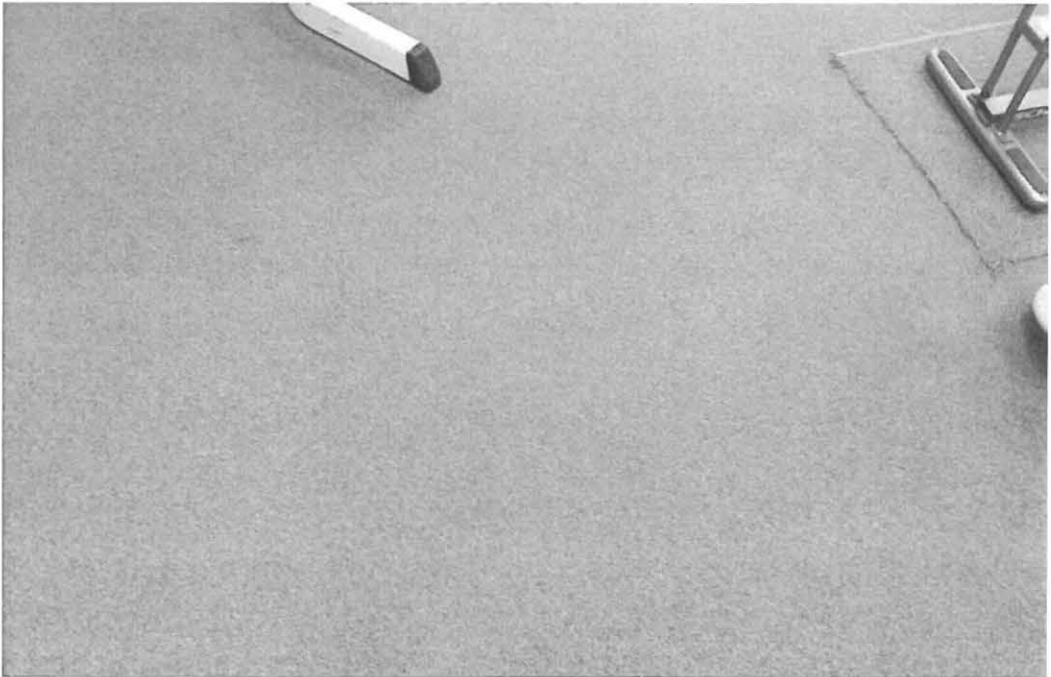
- a. Carpeting throughout in fair condition (Figure 46).

Figure 46: Second floor carpet.

Repair/Timeframe: Replace carpet (3-5 years).

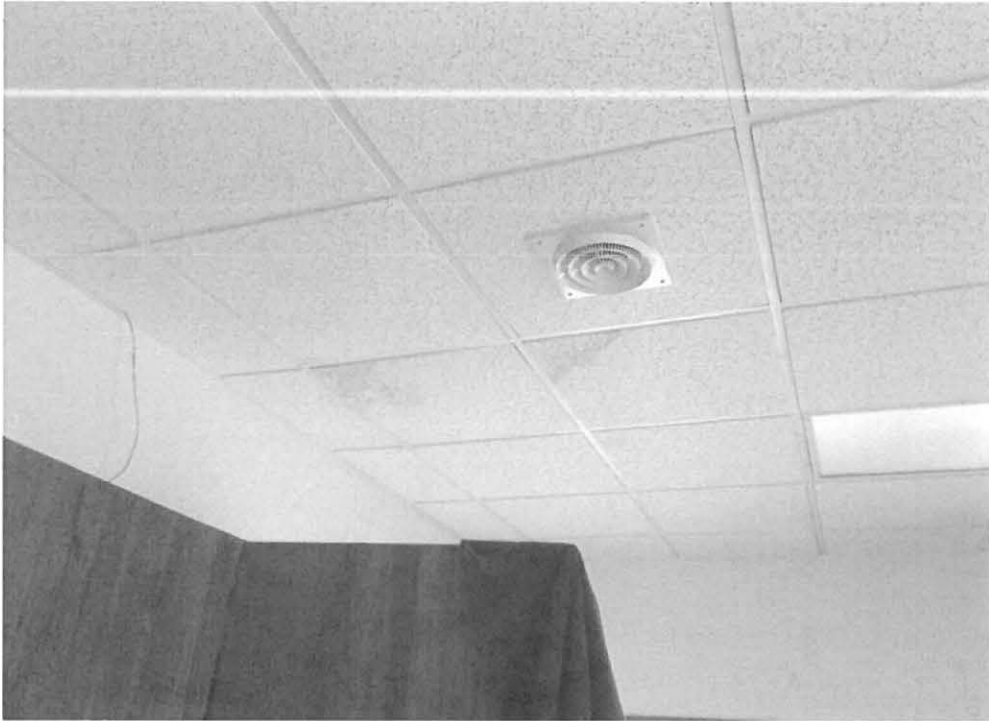
- b. Ceiling tiles throughout in fair condition; some ceiling tiles on the second floor showing signs of leakage/staining (Figure 47).

Figure 47: Stained ceiling tiles.

Repair/Timeframe: Replace ceiling tiles (3-5 years).

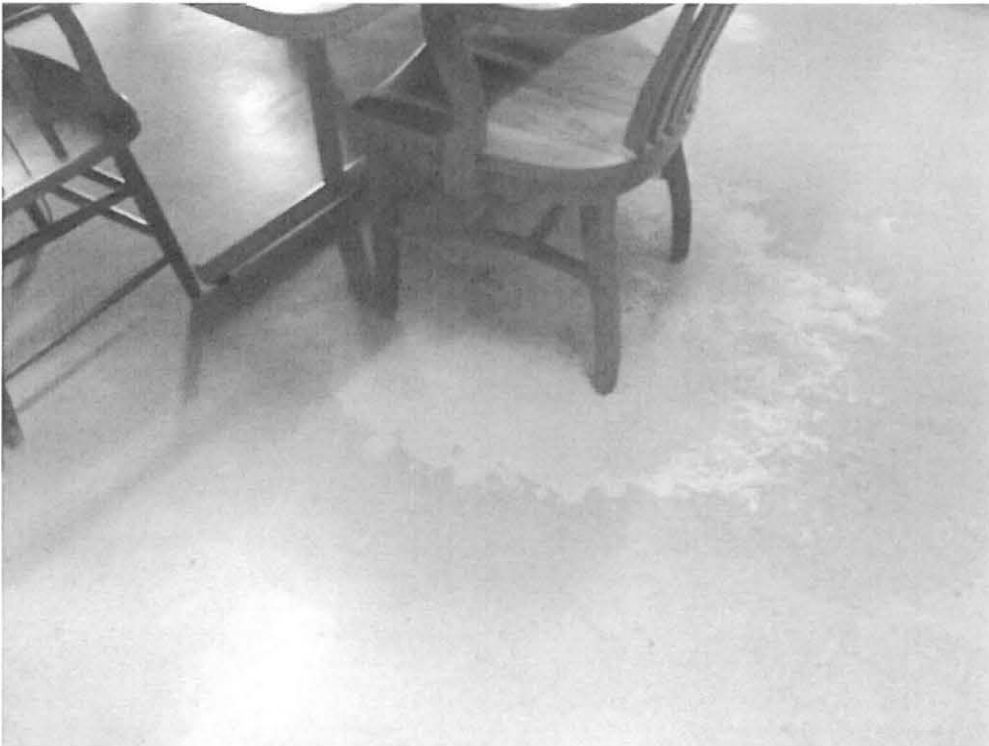
- c. First floor concrete flooring in fair condition (Figure 48).

Figure 48: First floor concrete flooring.

Repair/Timeframe: Reseal concrete floor (1-3 years).

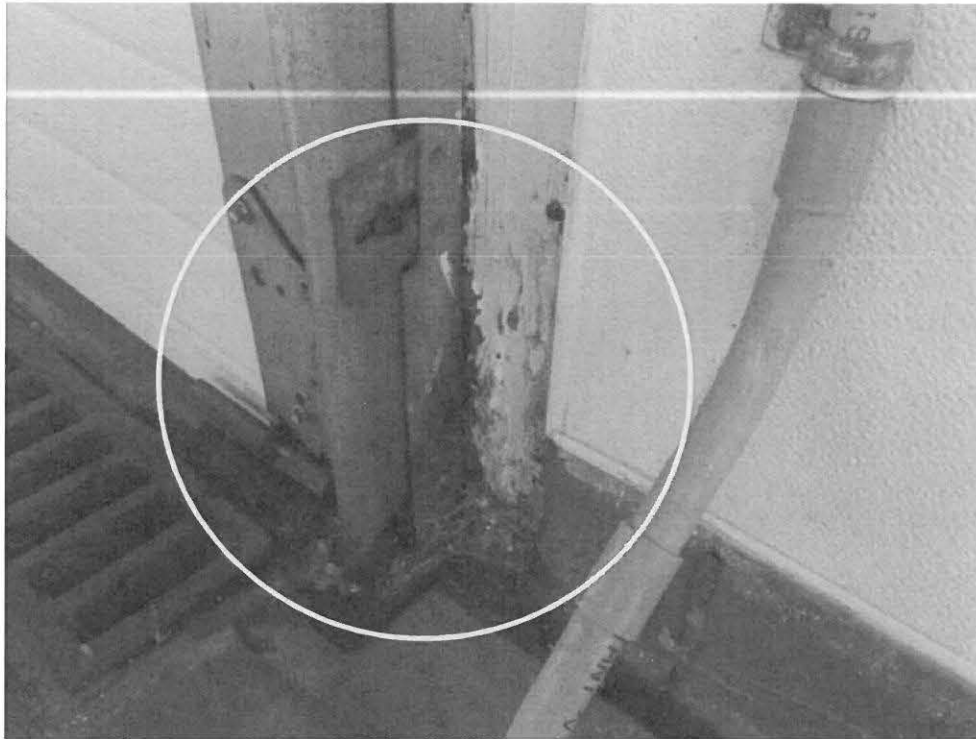
- d. Minor deterioration of wood trim at first floor garage door (Figure 49).

Figure 49: Deterioration of wood trim at garage door.

Repair/Timeframe: Replace deteriorated wood trim (1-3 years).

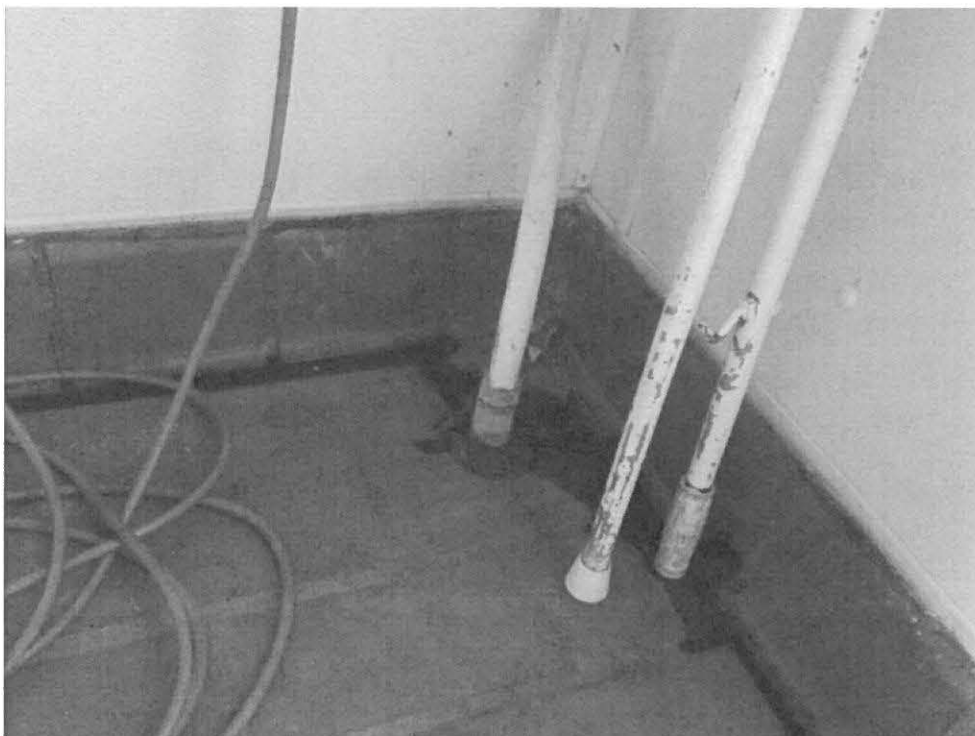
- e. All floor penetrations are not properly sealed and allow water from floor cleaning to leak into the basement (Figure 50).

Figure 50: Unsealed penetrations allowing leaking into basement.

Repair/Timeframe: Install new sealant around penetrations (0-1 years).
