Sheboygan City Hall - Sheboygan, WI
 Part I Space List Summary
 March 27, 2006 - updated June 2015

Condition Assessment Report-DRAFT

Subject: **City Hall Property Condition Assessment DRAFT Report
828 Center Avenue, Sheboygan, Wisconsin**

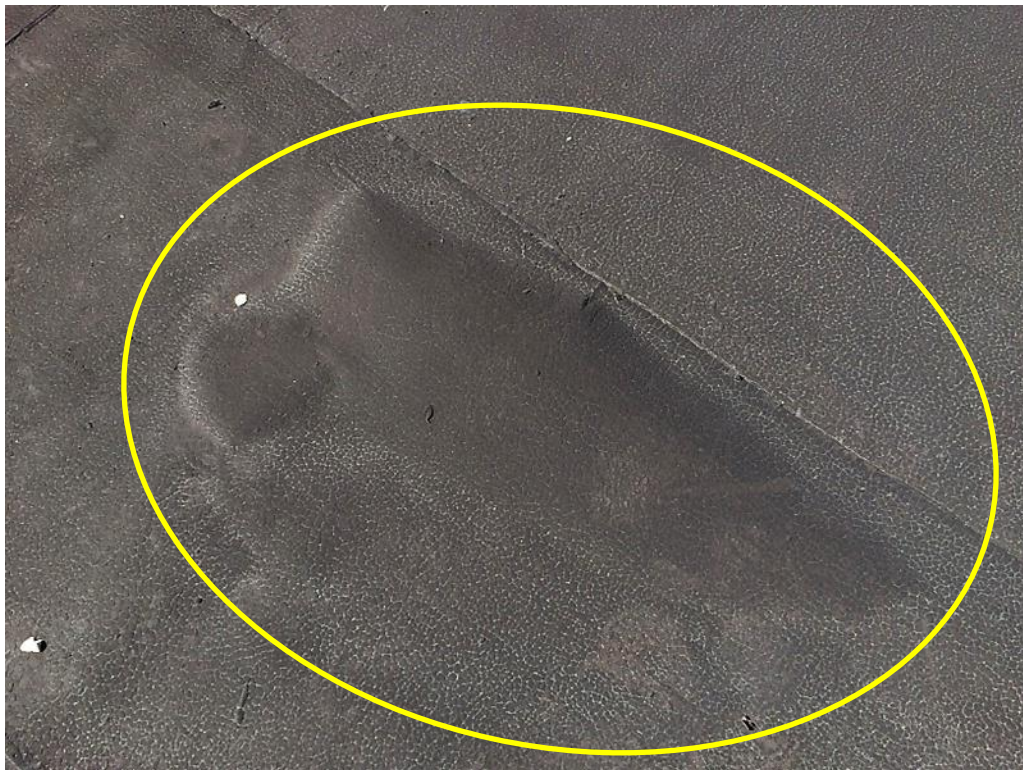
- a. Significant membrane alligator cracking (Figure 25).

Figure 25: Deteriorated/asphalt cracking at modified bitumen membrane surface.

Repair/Timeframe: Replace roof system (1-3 years).

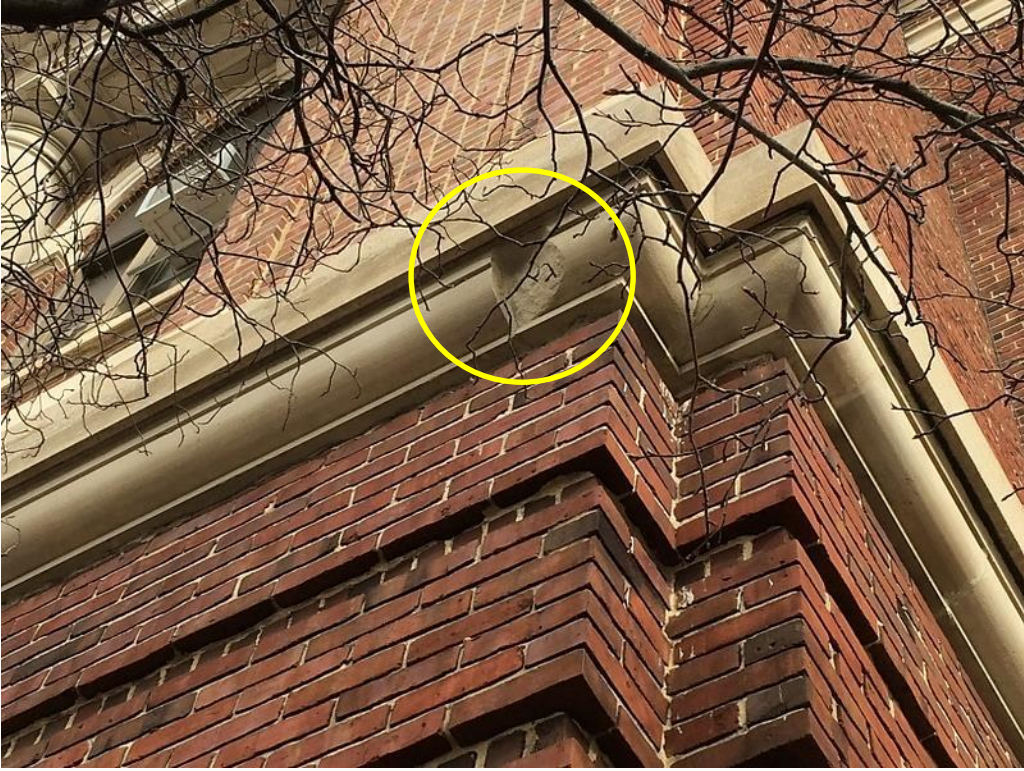
- c. Spalled stone units at several locations (Figure 44-45).

Figure 44: Spalled Stone

Repair/Timeframe: Perform Dutchmen repair of spalls (1-3 years).

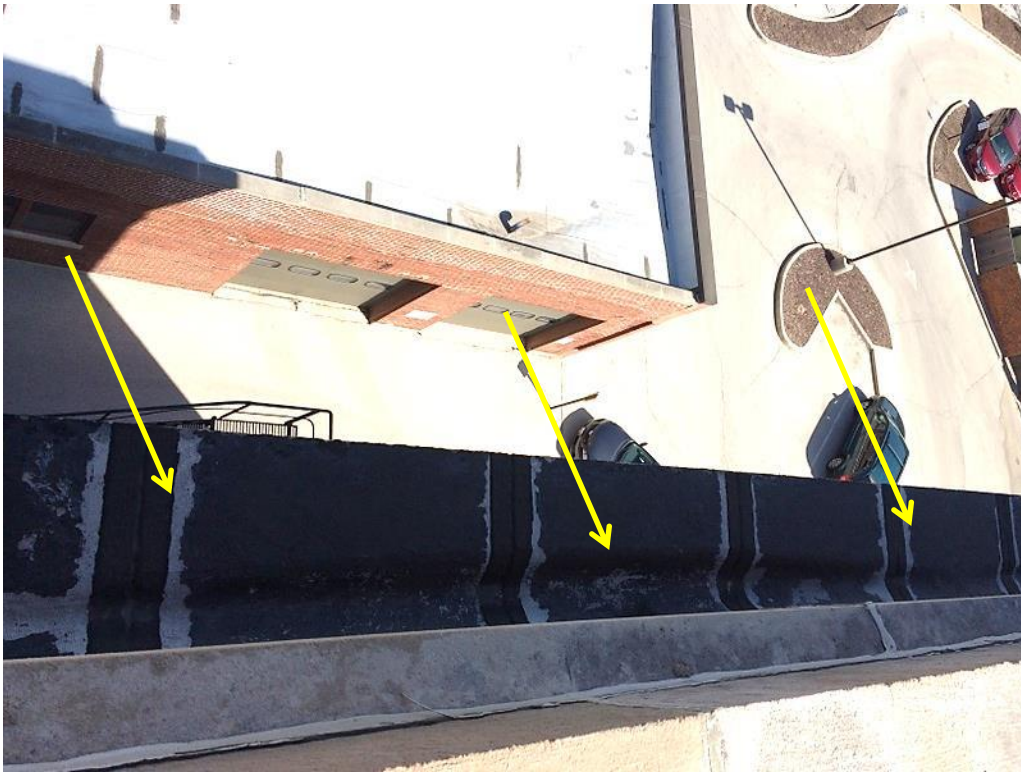
- d. 100% mortar joint failure at all stone bands (Figure 46).

Figure 46: Deteriorated stone mortar joints with deteriorated sealant over mortar.

Repair/Timeframe: Removed existing mortar joints to a depth of a minimum of $\frac{3}{4}$ " and install new mortar. Install sealant at all skyward facing joints (1-3 years).

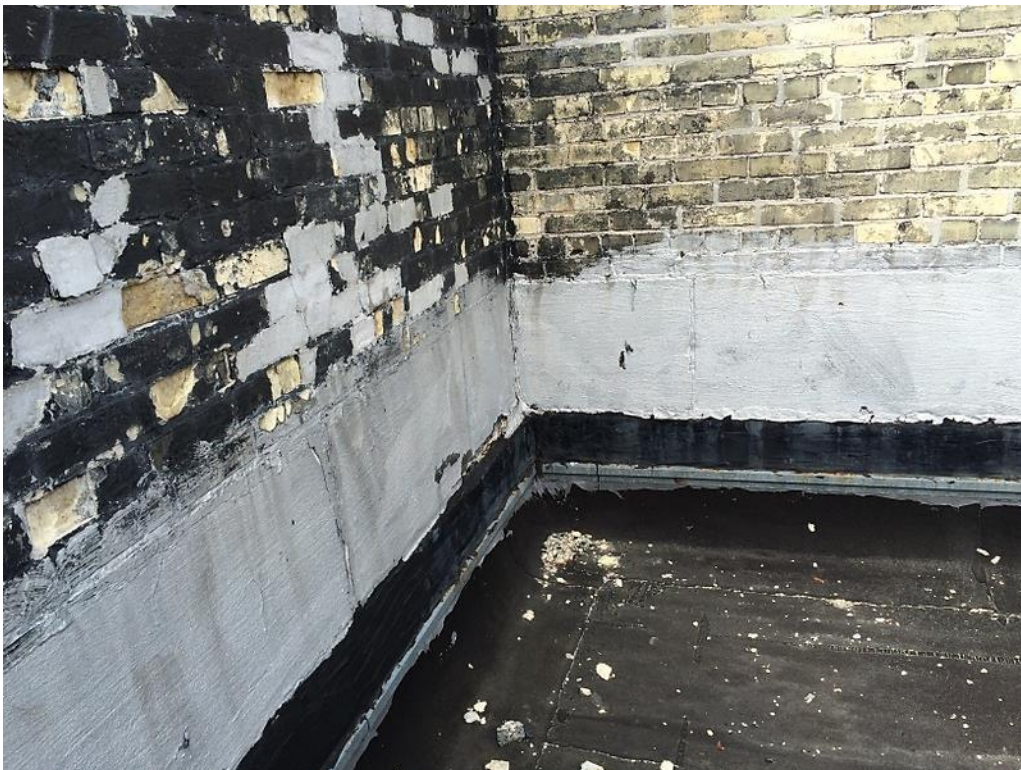
- c. Deteriorating asphalt coating on skyward stone cornice face (Figure 47).

Figure 47: Deteriorated asphalt coating on skyward facing cornice/gutter.

Repair/Timeframe: Install sheet metal coping or liquid membrane coating over top of stone cornice (1-3 years).

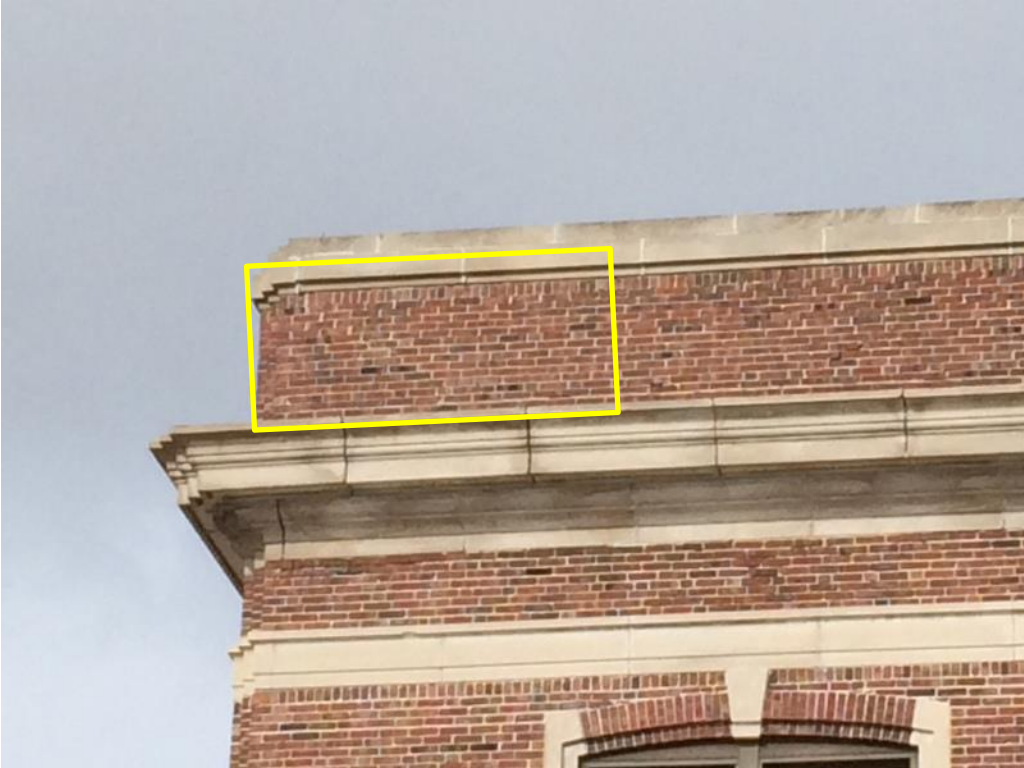
- a. Deteriorated brick at the inside face of all parapets (Figure 48).

Figure 48: Deteriorated brick at inside face of parapet

Repair/Timeframe: Replace deteriorated brick units (1-3 years).

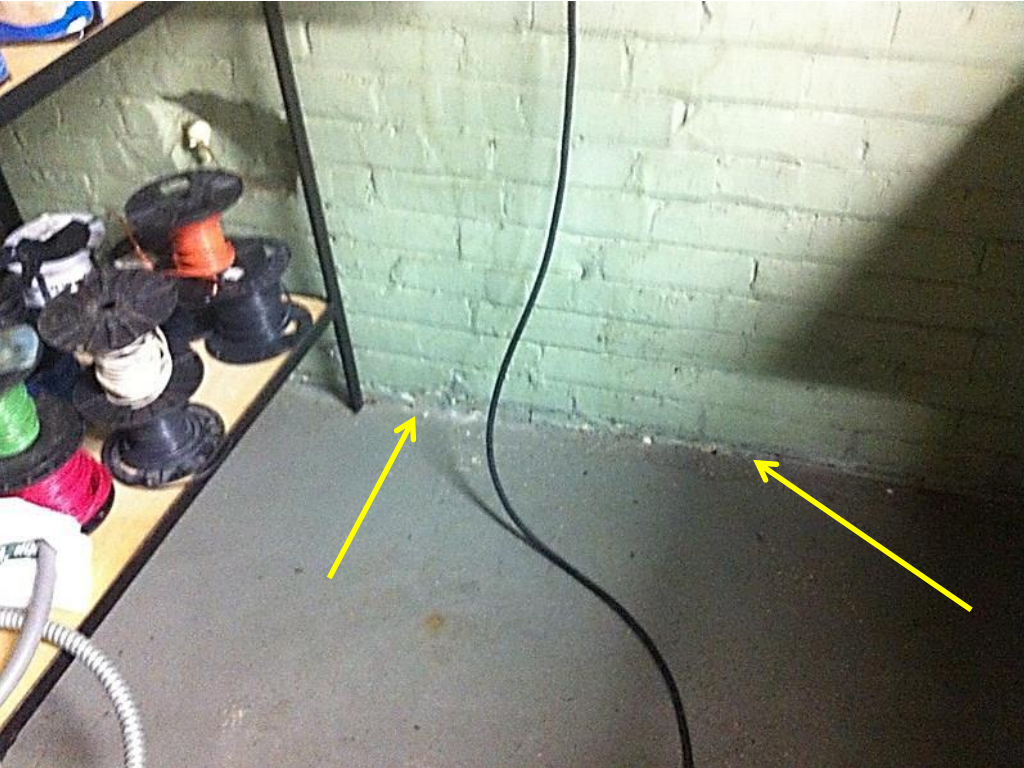
Figure 49: Out of plane brick movement

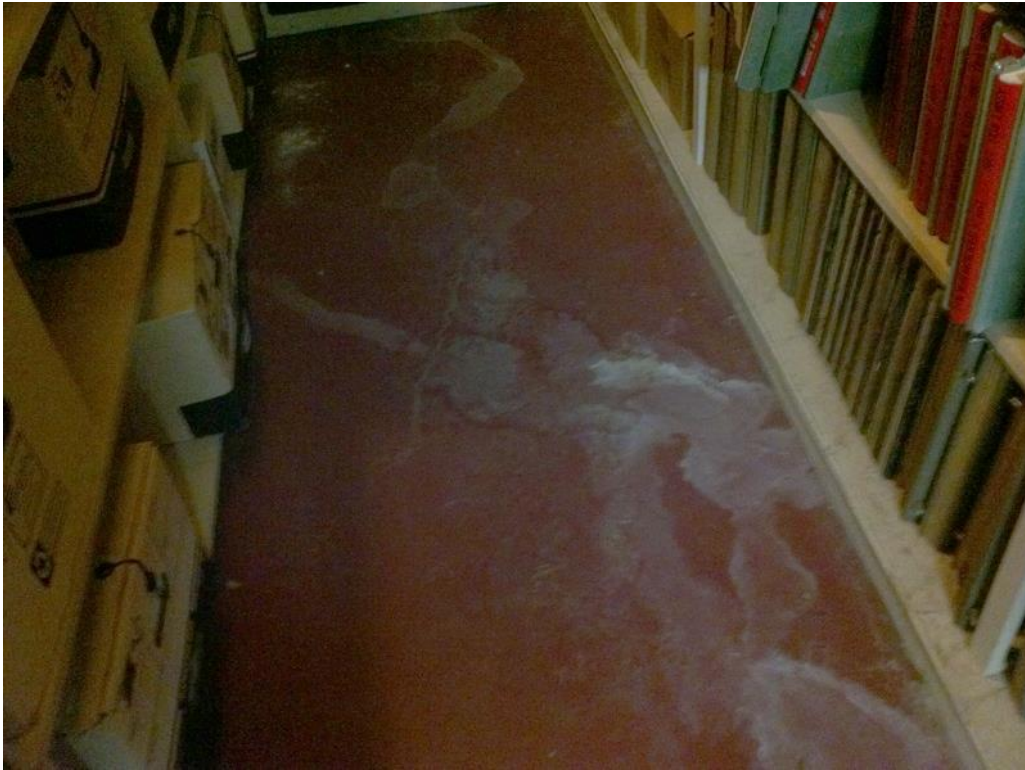
- a. Leaks present along foundation wall causing efflorescence at multiple locations (Figures 50 & 51).

Figure 50: Leaks present along foundation wall

Repair/Timeframe: Replace deteriorated brick units, grind out and repoint deteriorated mortar joints (3-5 years).

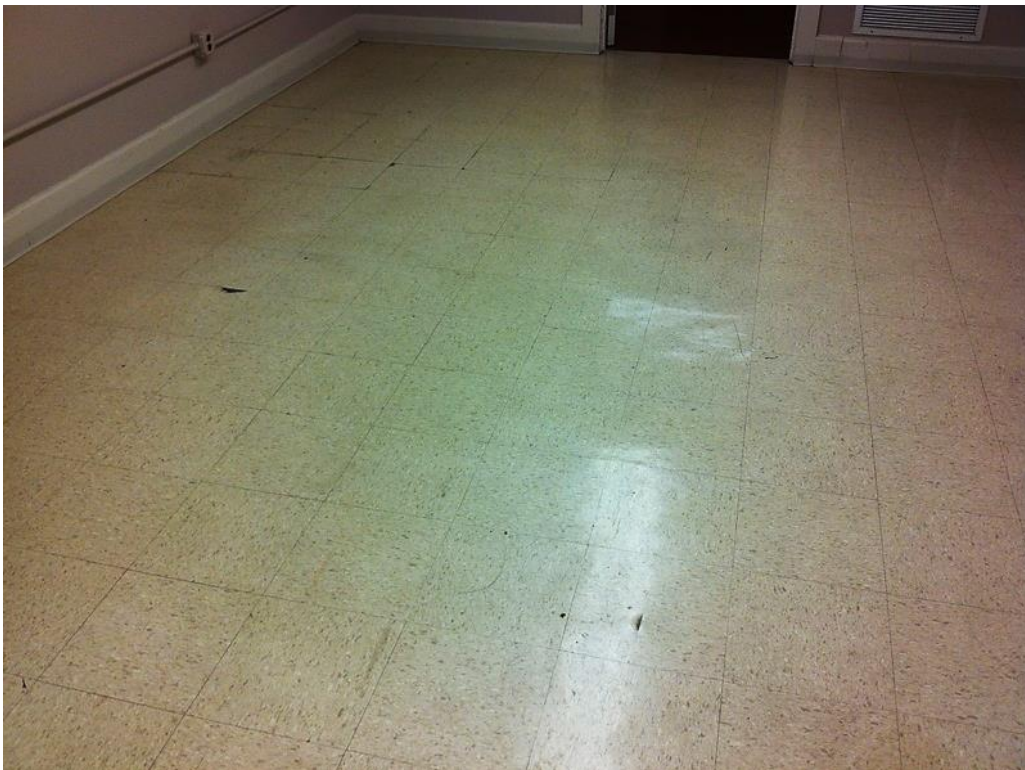
Figure 51: Efflorescence/water staining along basement floor

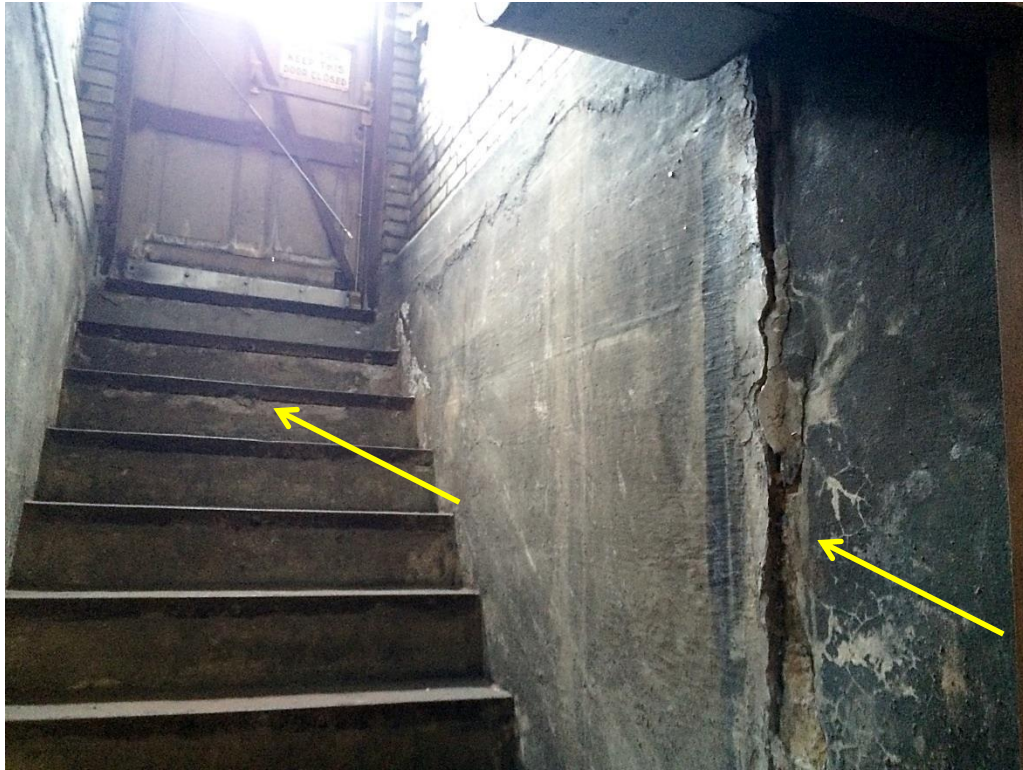
j. Basement exit stairwell leading to back alley on the north elevation in deteriorated condition with the following observations: opened joint between stair and building walls, spalled concrete steps and foundation wall cracking (Figures 60 - 62).

Figure 60: Deteriorating building foundation in stairwell

Repair/Timeframe: Perform concrete spall and crack repairs and install sealant joints between stair and building walls (1-3 years).

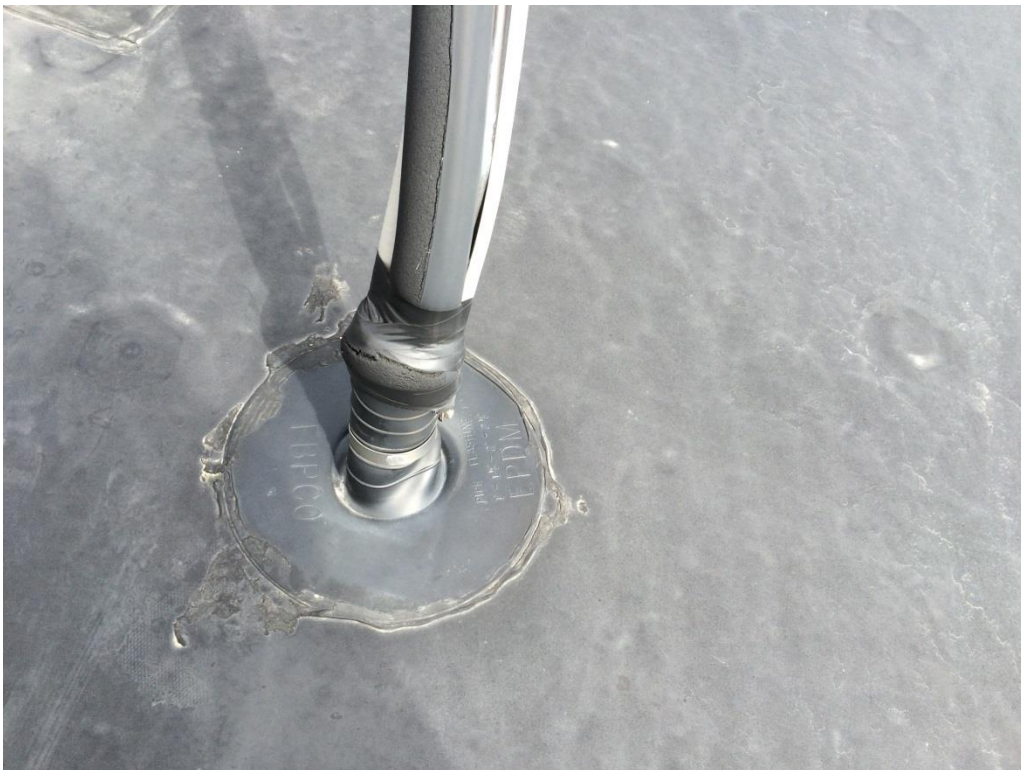
Figure 15: Deteriorated seal at A/C line penetration.

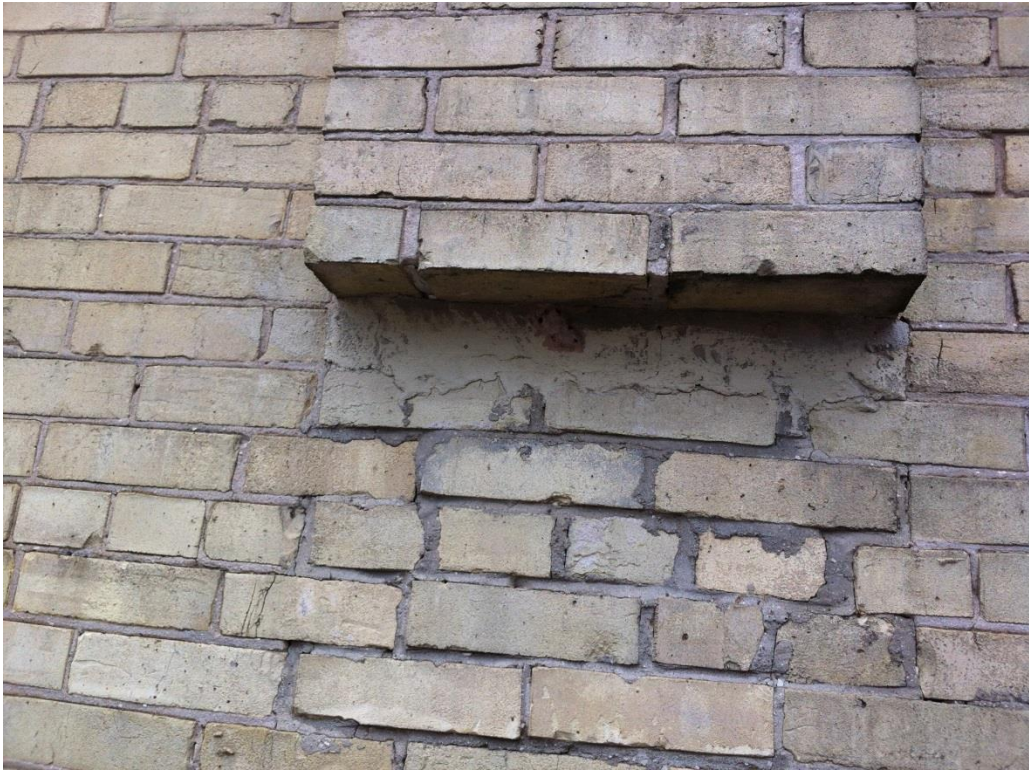
Figure 26: Loose brick unit.

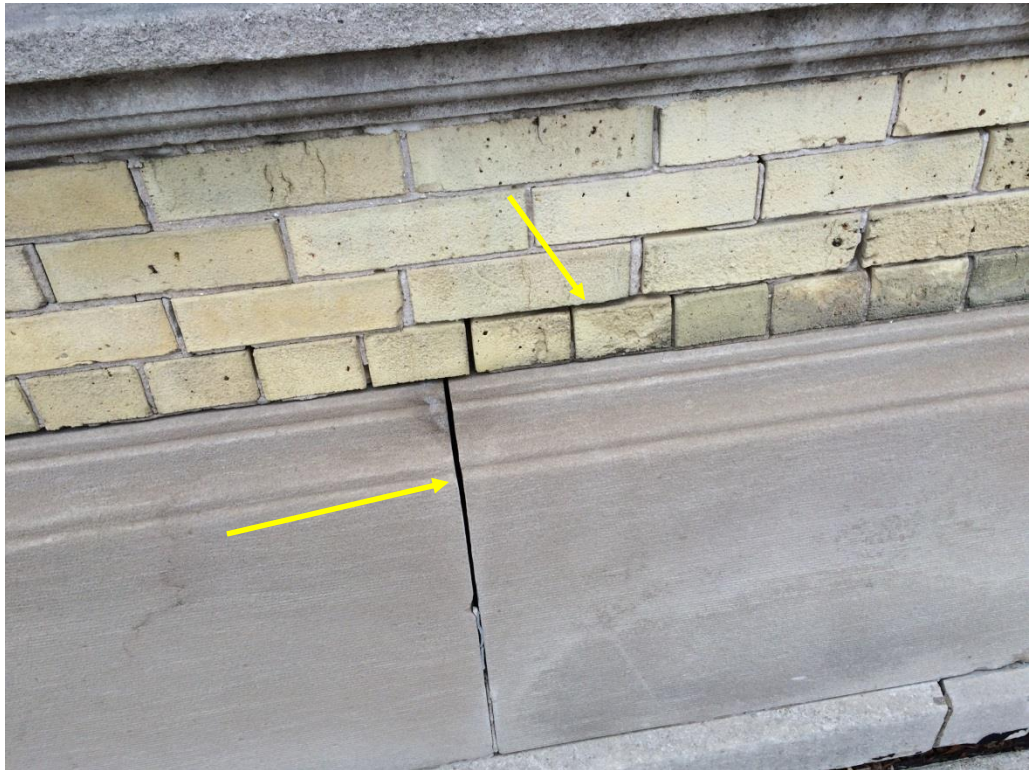
Figure 27: Deteriorated mortar joints.

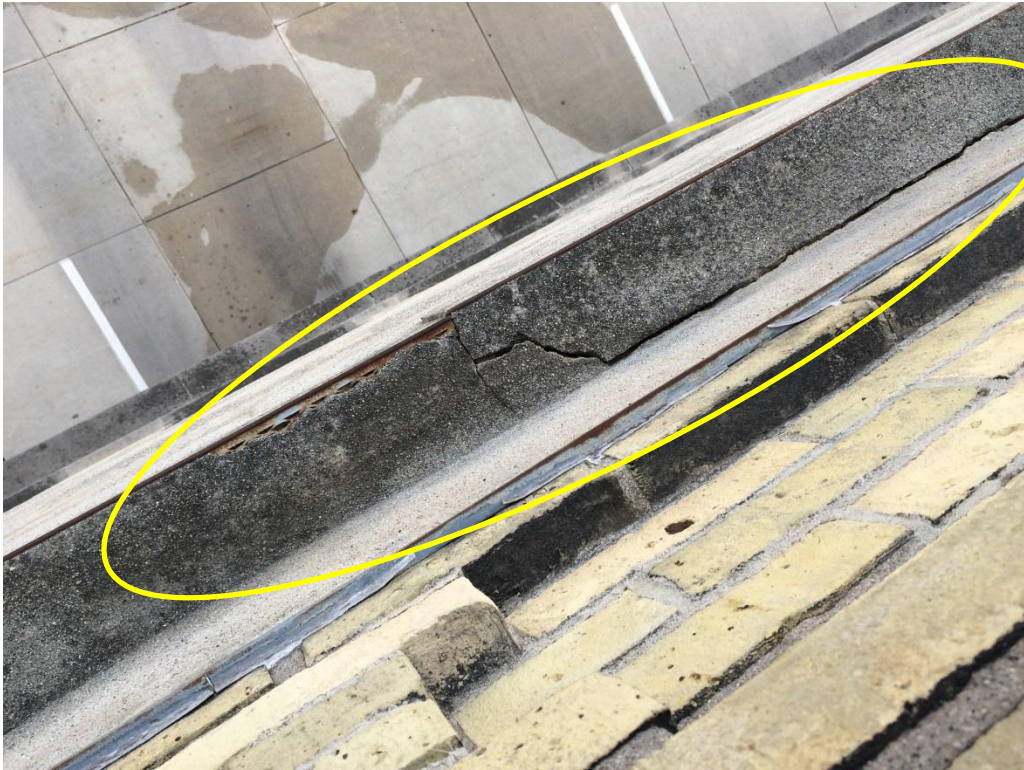
Figure 28: Deteriorated and open mortar joints.

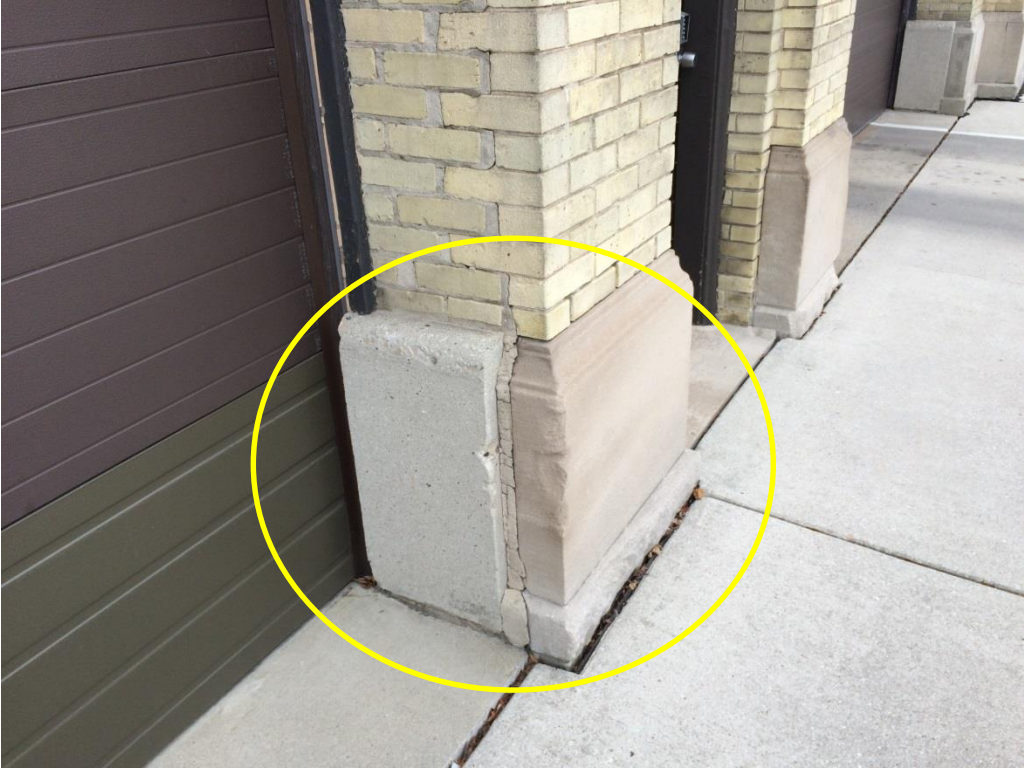
Figure 32: Cracked stone unit.

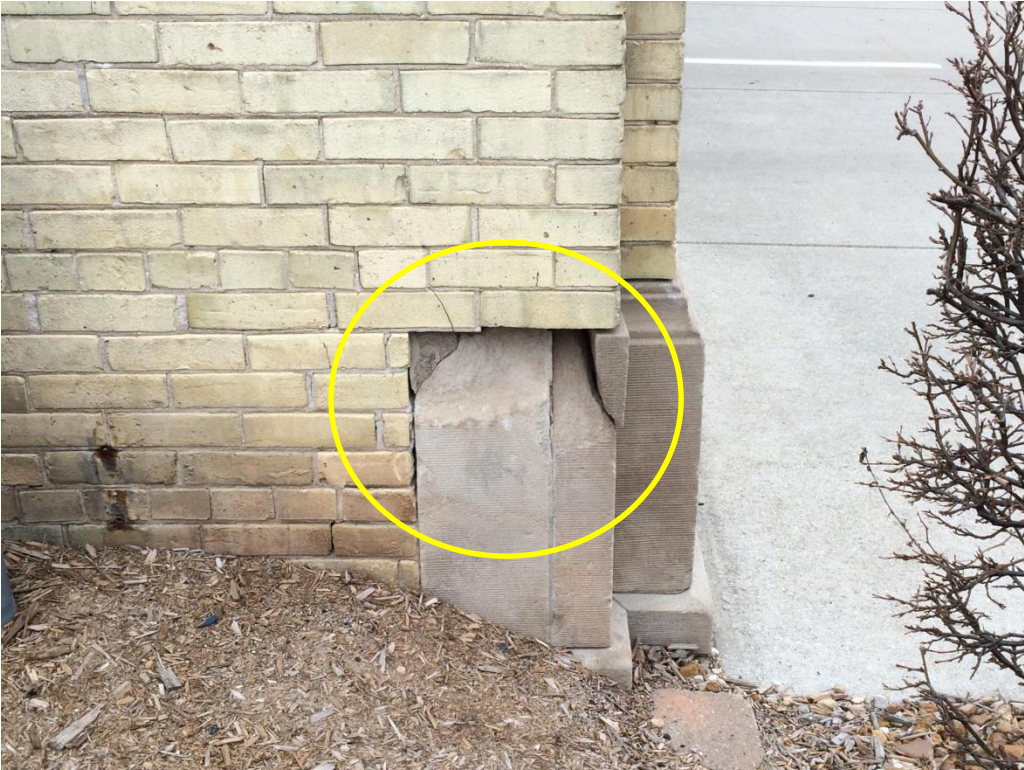
Figure 33: Stone deterioration.

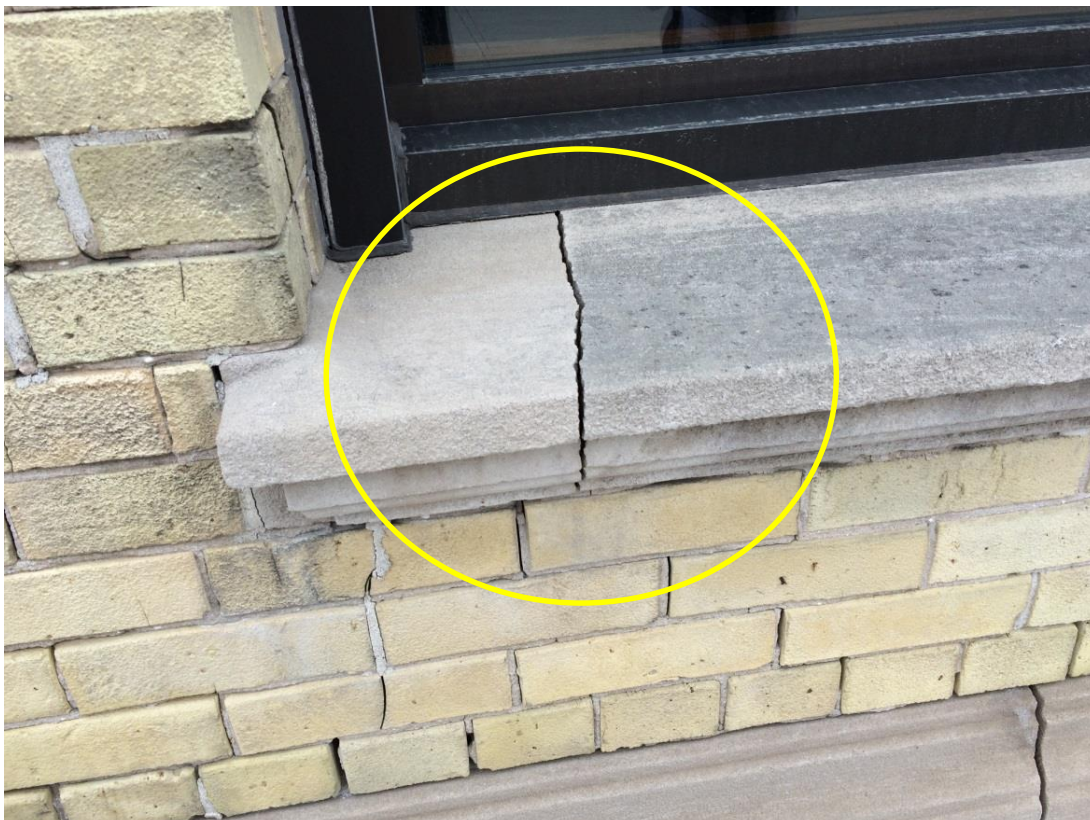
Figure 35: Deteriorated sill.

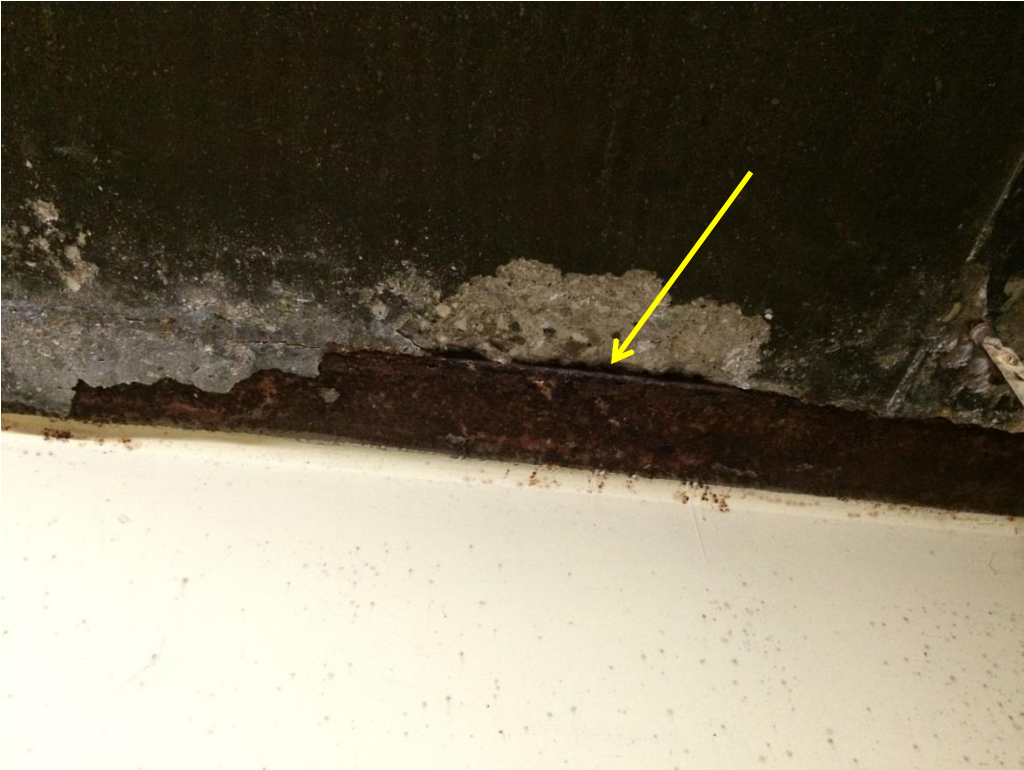
Figure 37: Corrosion of steel beam.

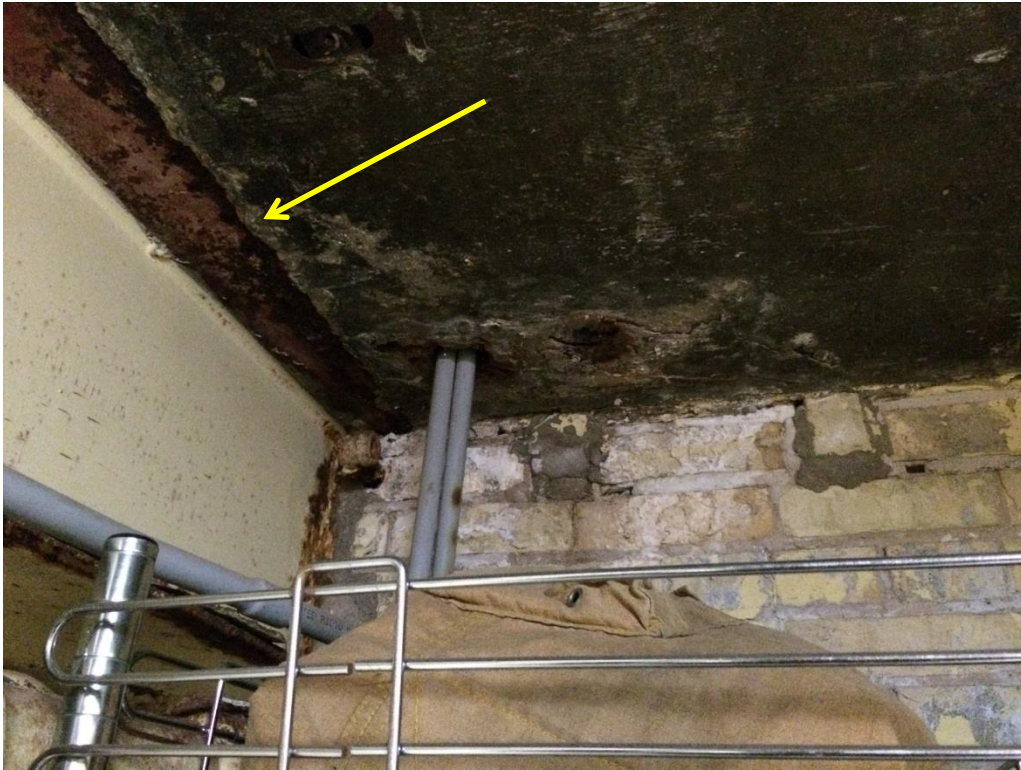
Figure 38: Steel corrosion.

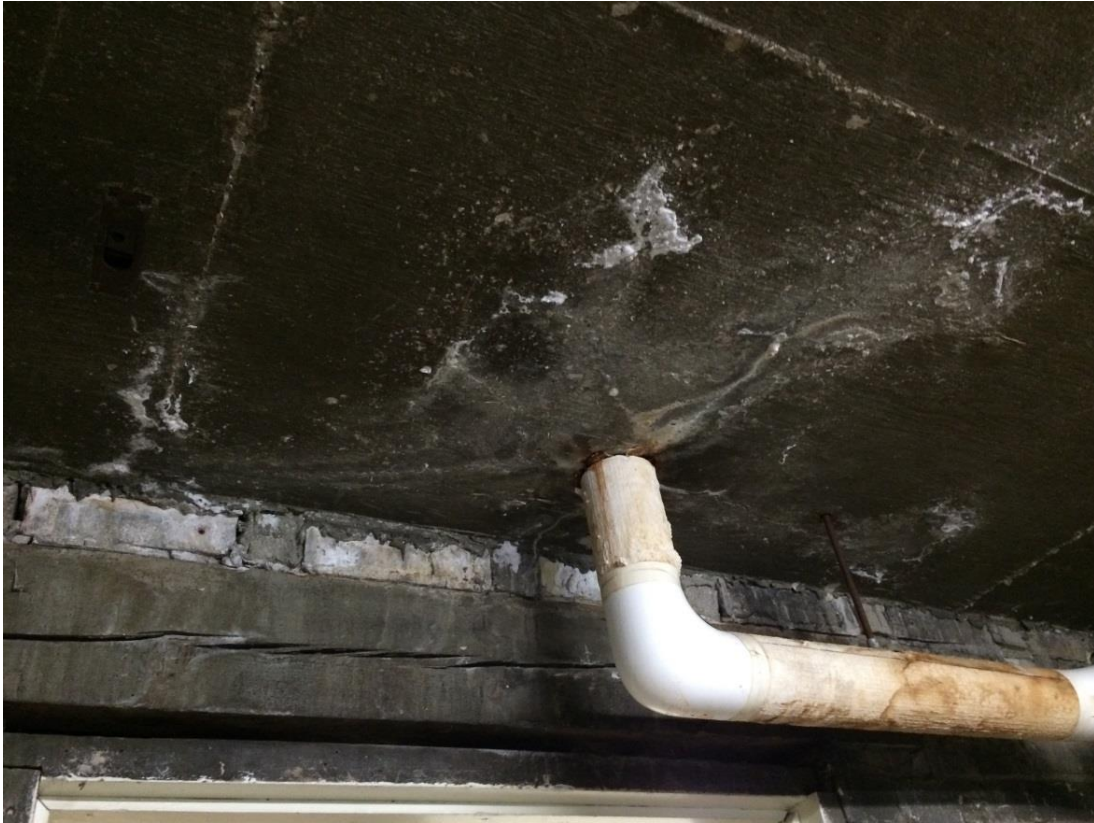
Figure 44: Paint failure.

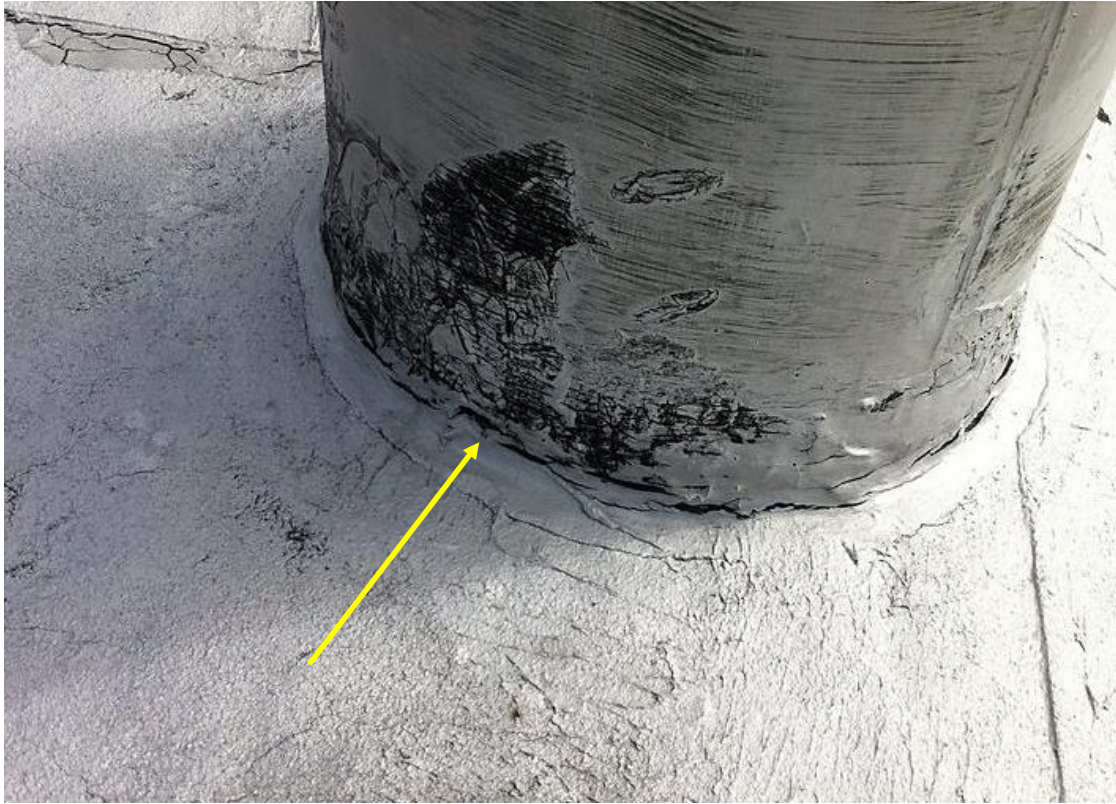
Figure 14: Membrane cracking and bubbling.

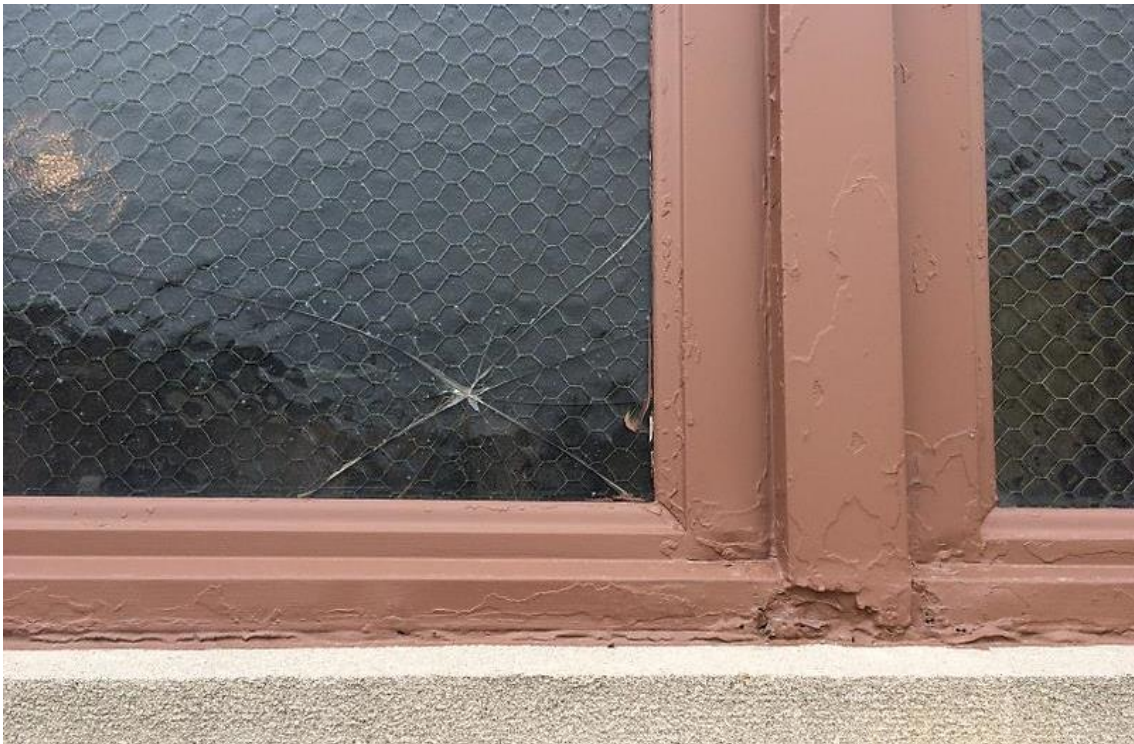
Figure 17: Window sealant deterioration.

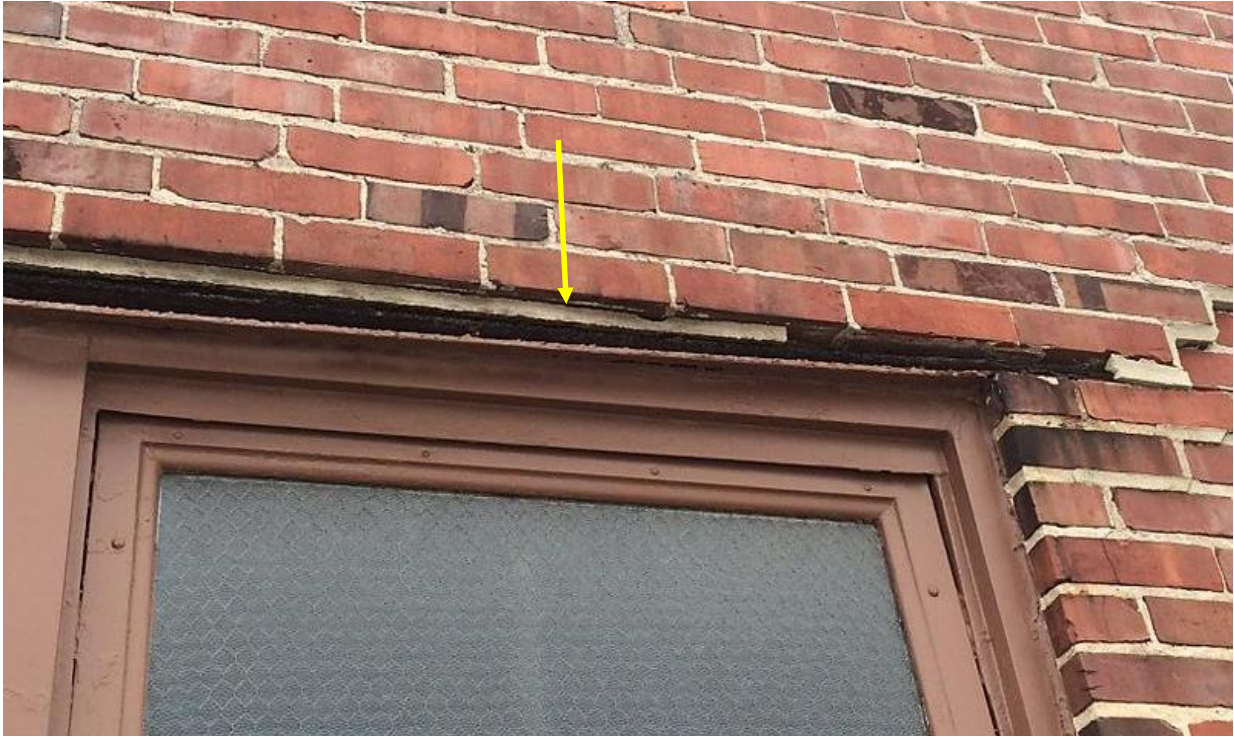
Figure 26: Corroded steel window lintels.

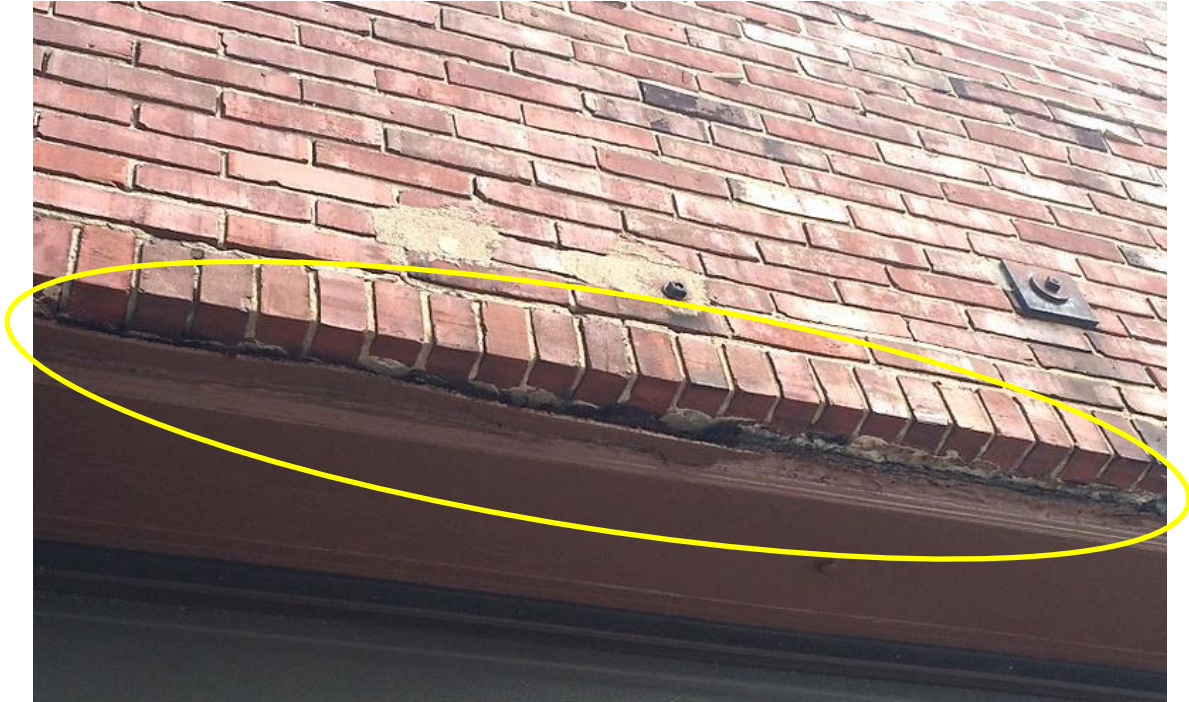
Figure 28: Corroded steel door lintel.

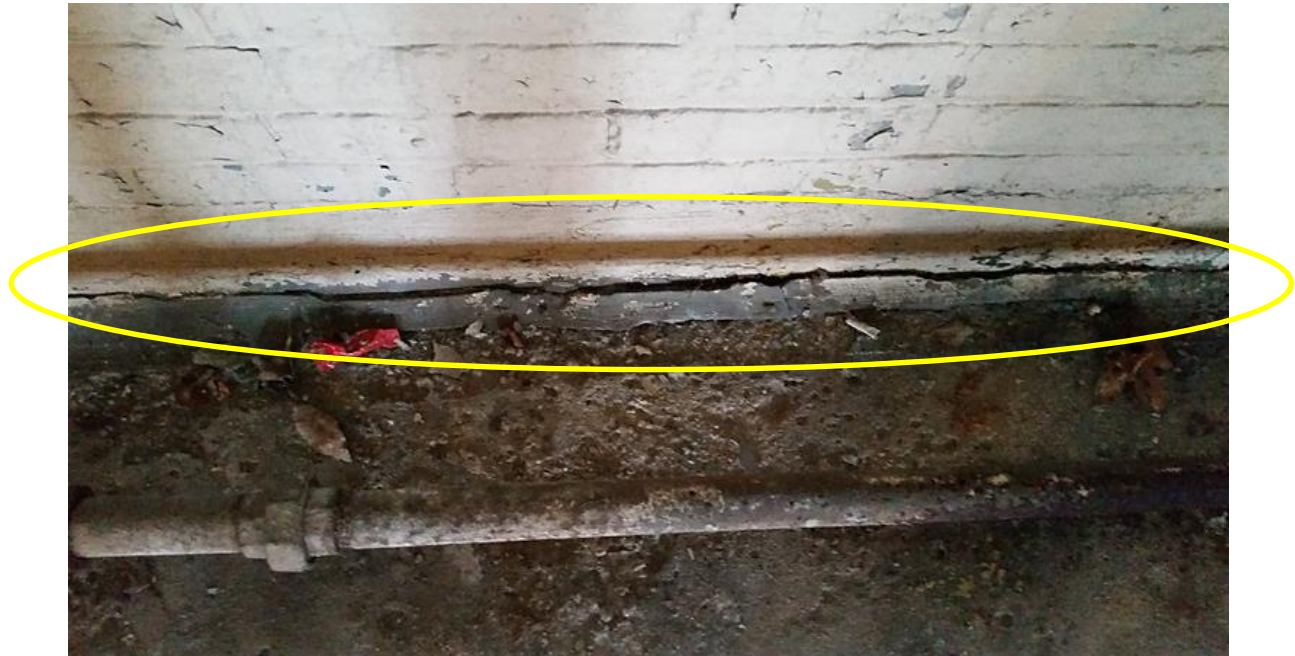
Figure 36: Deteriorating concrete floor.
