**\*\*\*ATTACHMENTS\*\*\***

# The City of Sheboygan City Hall North Parking Garage

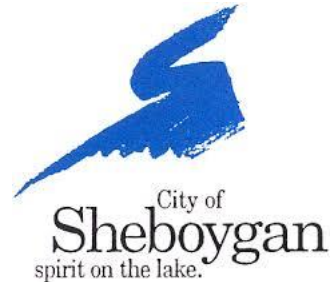
**Sheboygan City Hall North Parking Garage**  
**828 Center Avenue**  
**Sheboygan, WI 53018**

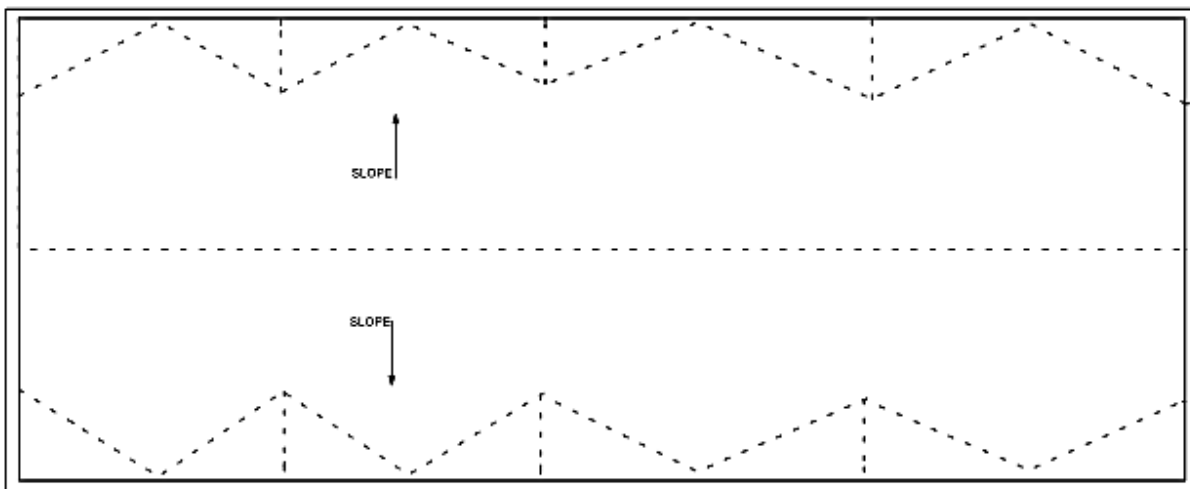
Figure 8: North parking garage roof plan.

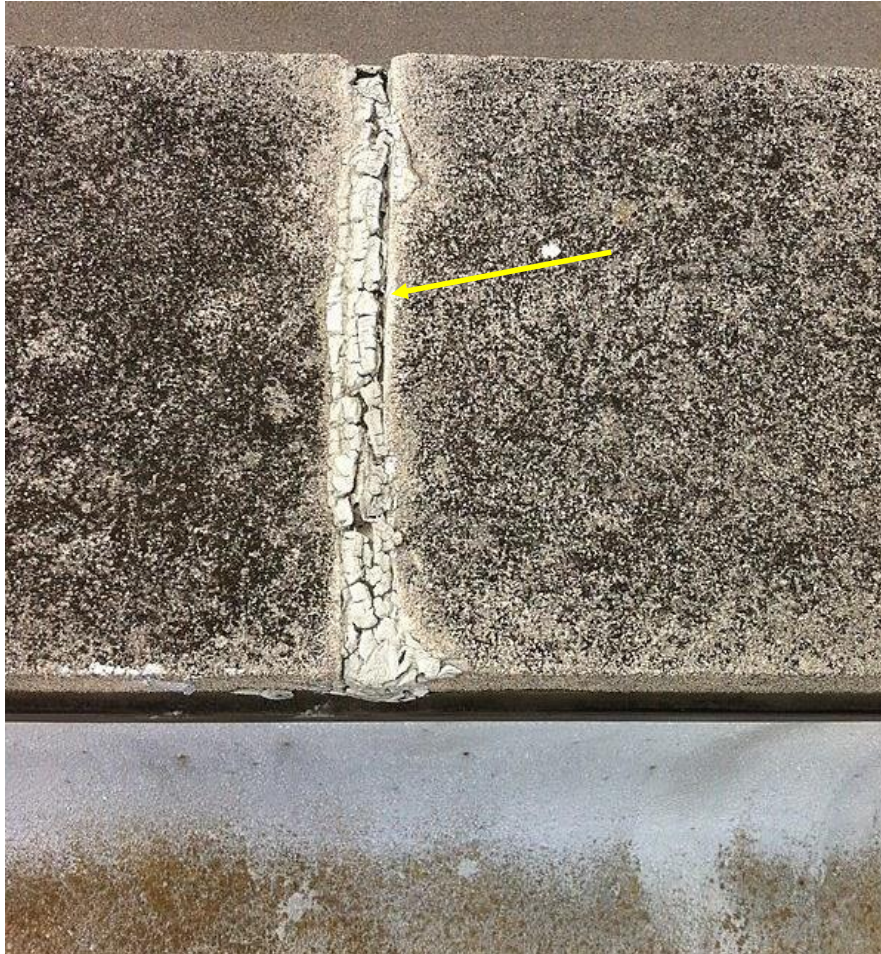
Figure 9: Failed skyward facing stone coping joint.

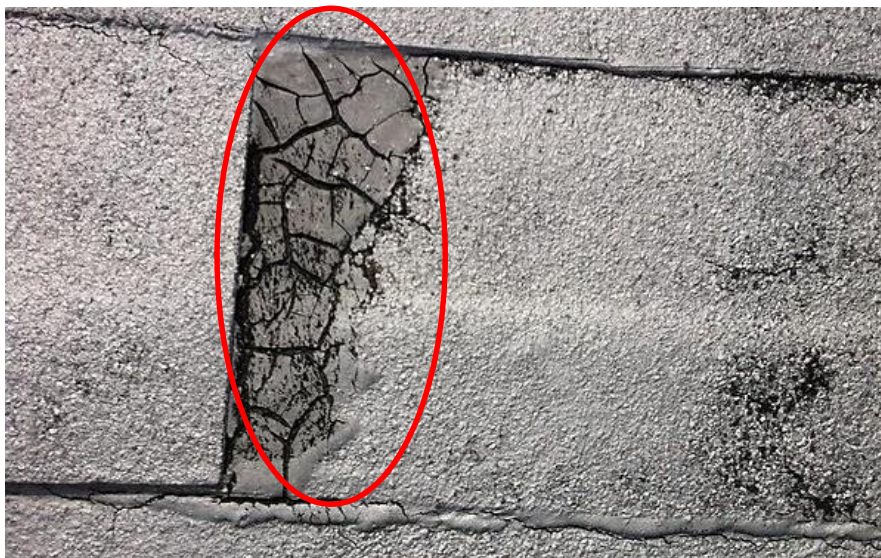
Figure 10: Alligator cracking.

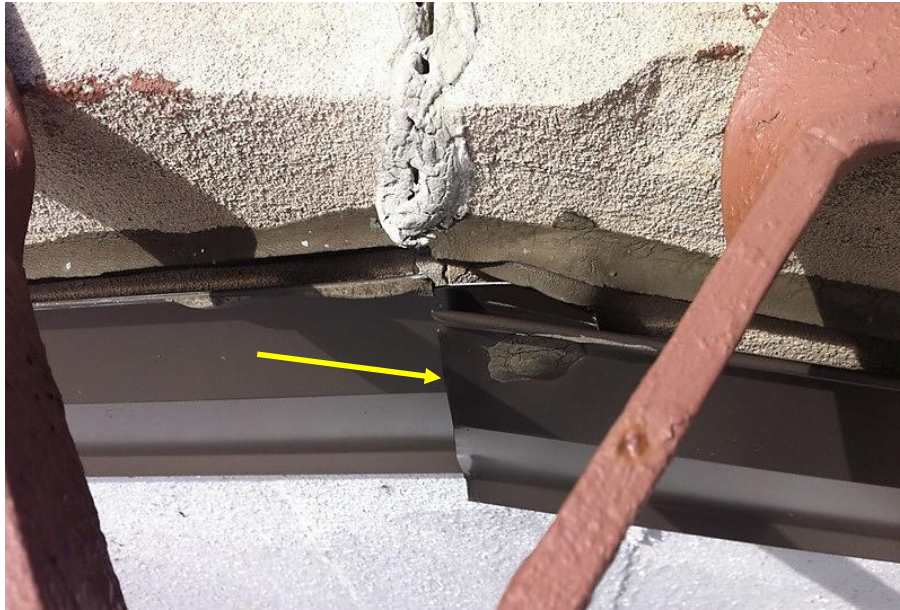
Figure 11: Open joint between metal counter flashings.

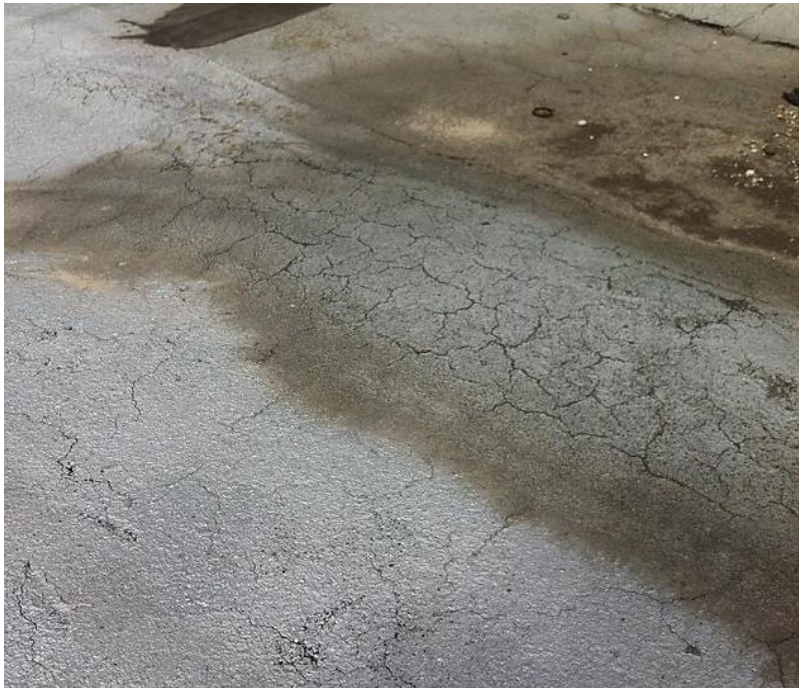
Figure 13: Membrane cracking.

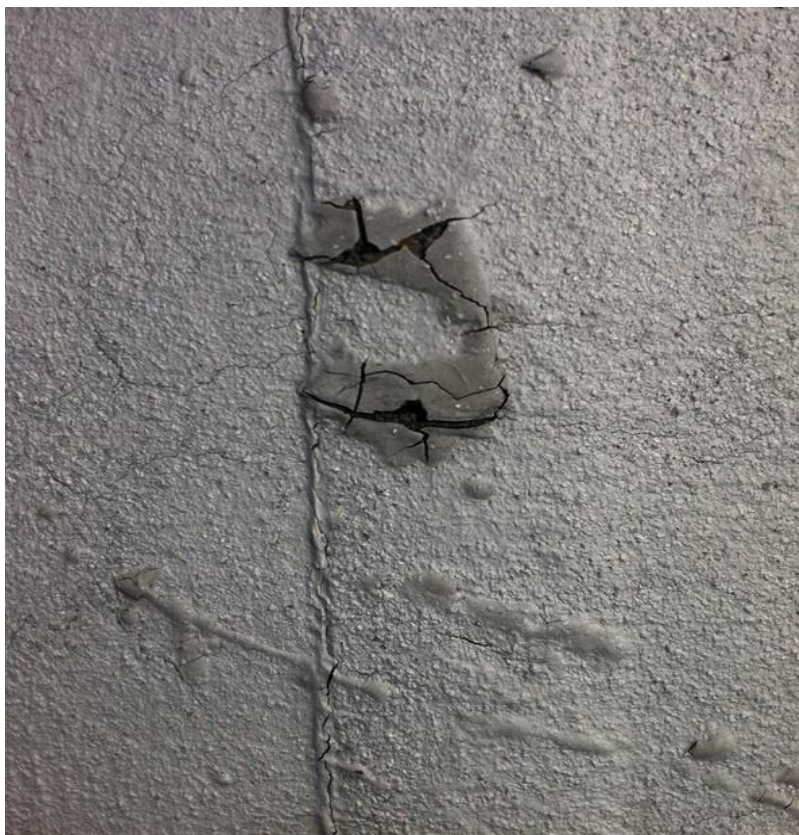
Figure 14: Membrane cracking and bubbling.

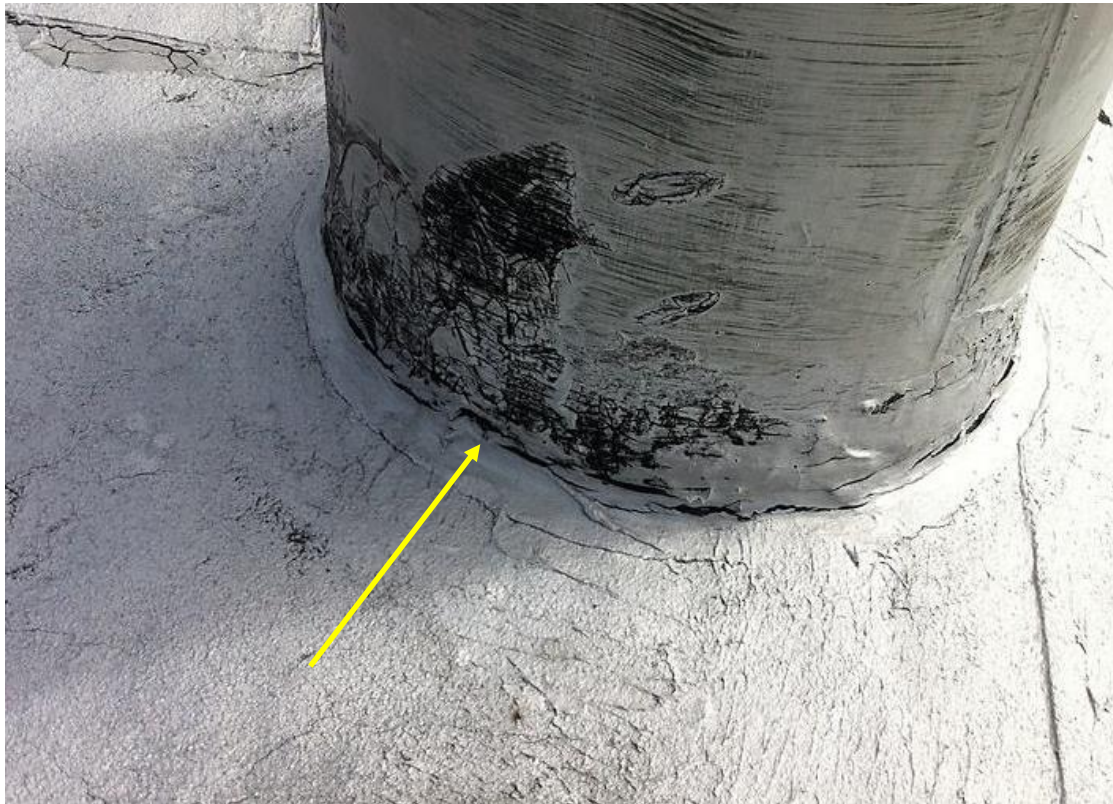
Figure 15: Failed joint at penetration.

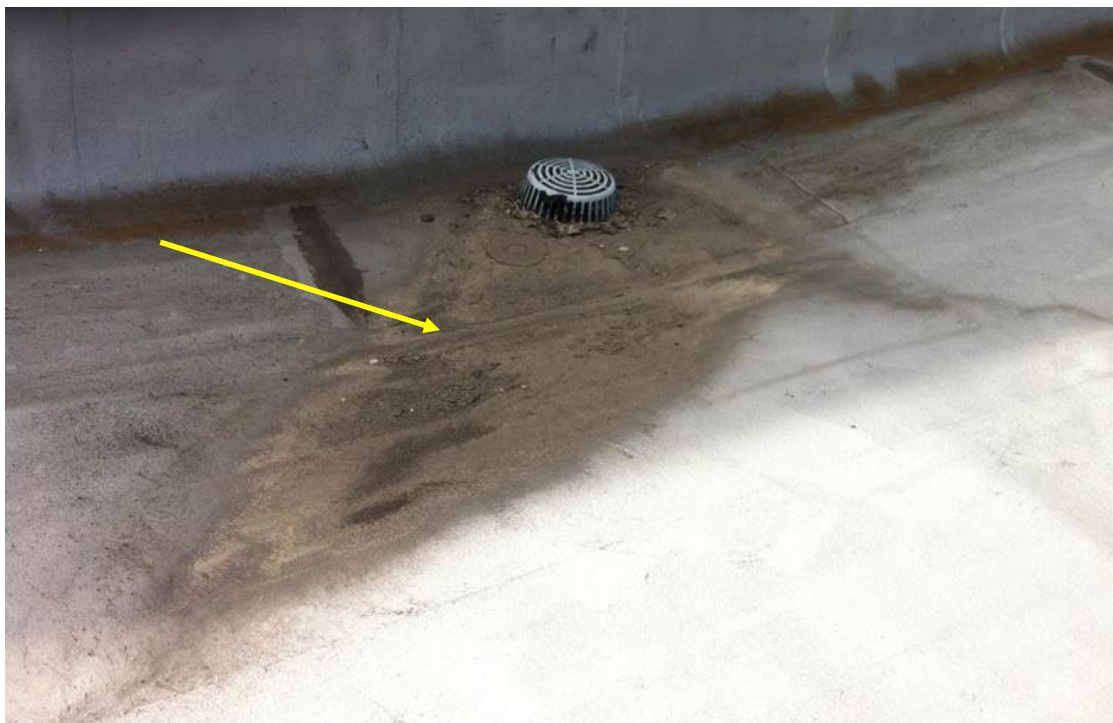
Figure 16: Ponding at roof drain.

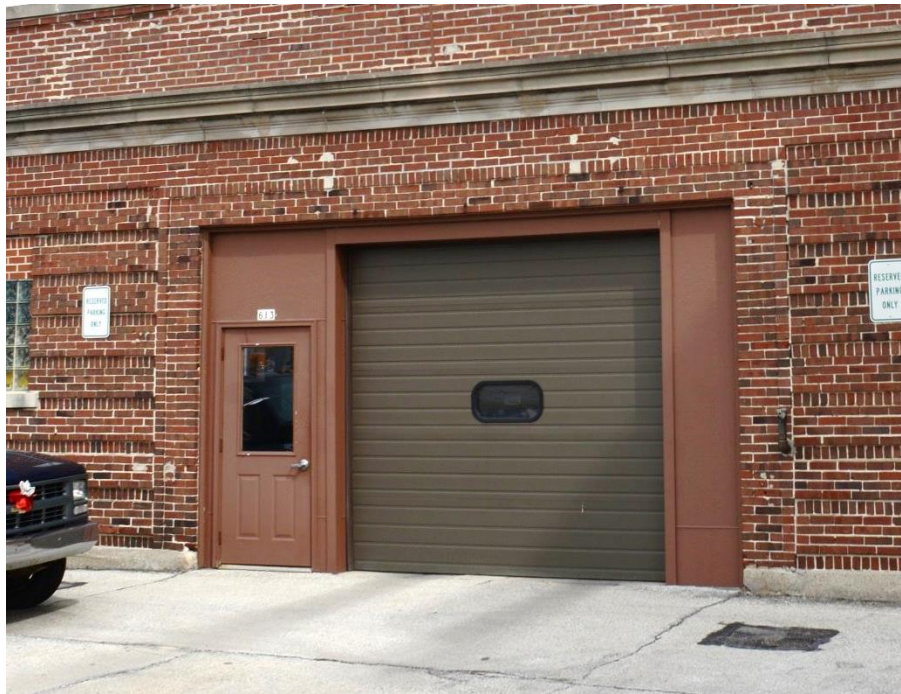
Figure 19: West facade doors.

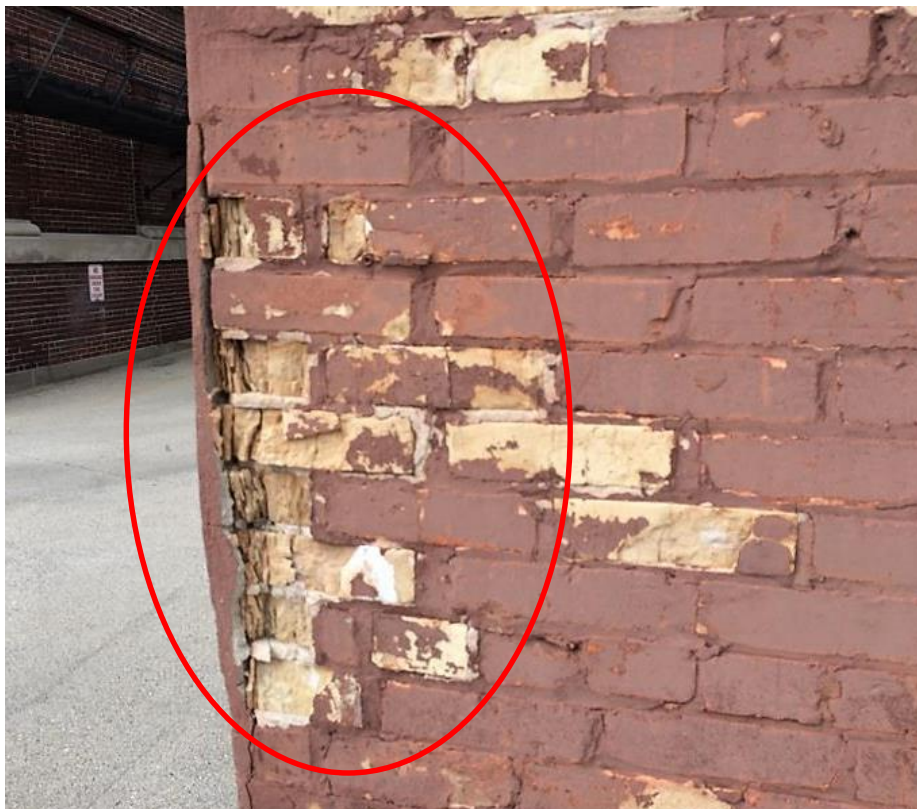
Figure 22: Deteriorated brick masonry.

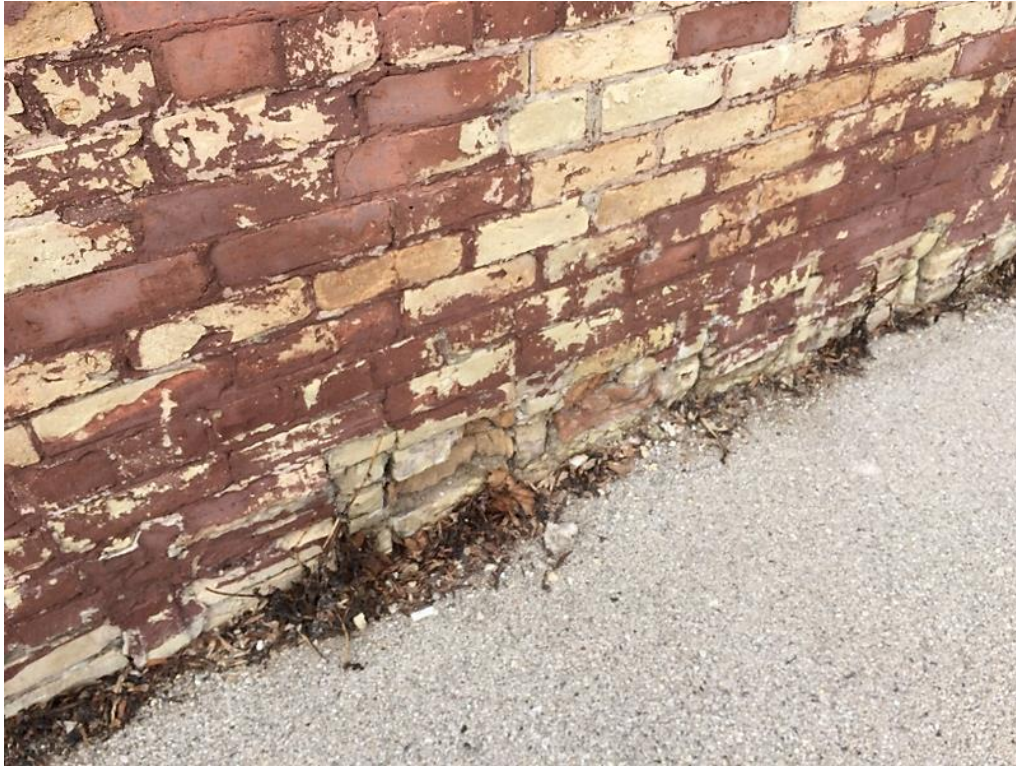
Figure 23: Deteriorated mortar joints.

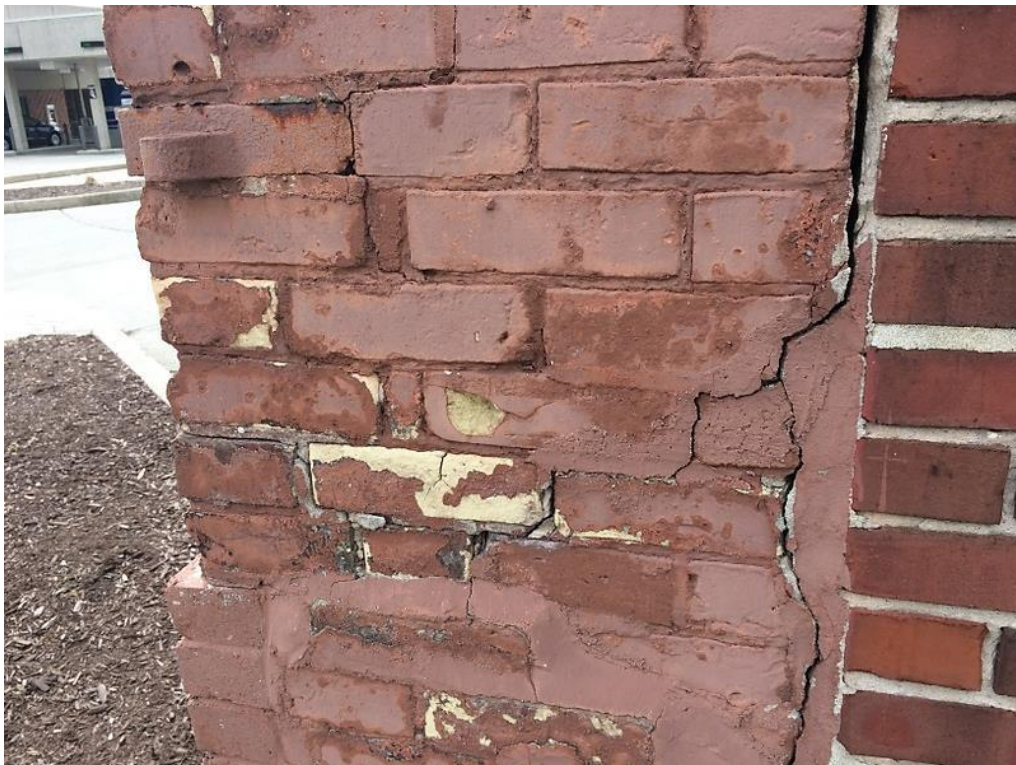
Figure 24: Deteriorated brick.

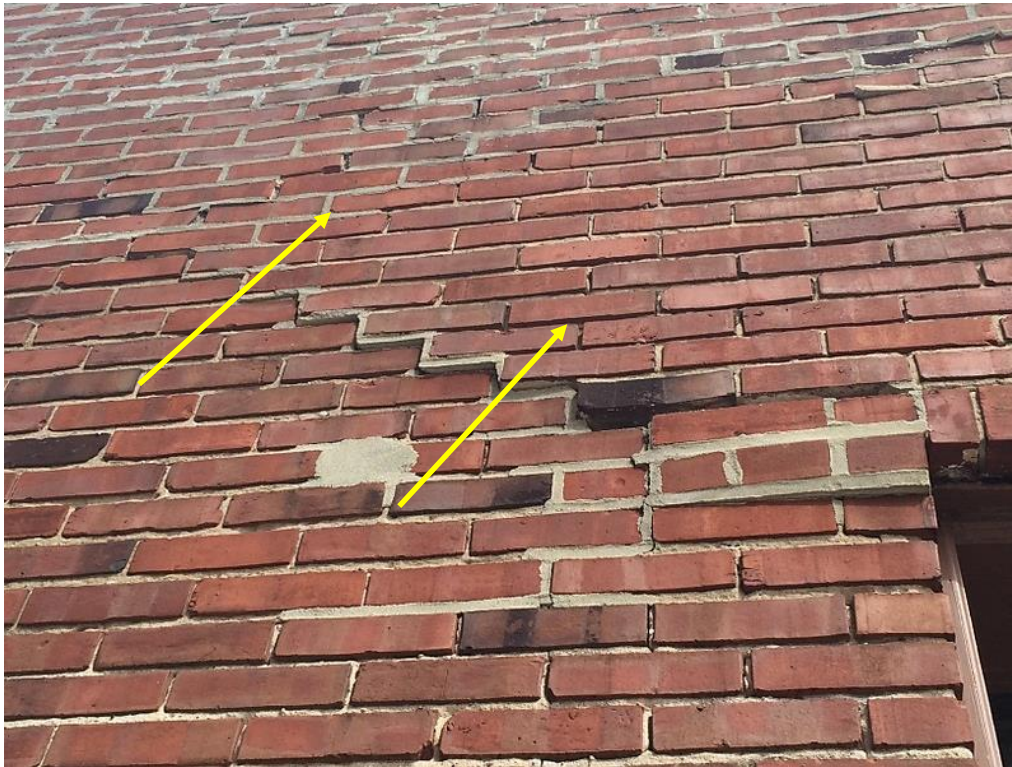
Figure 25: Out of plane brick movement.

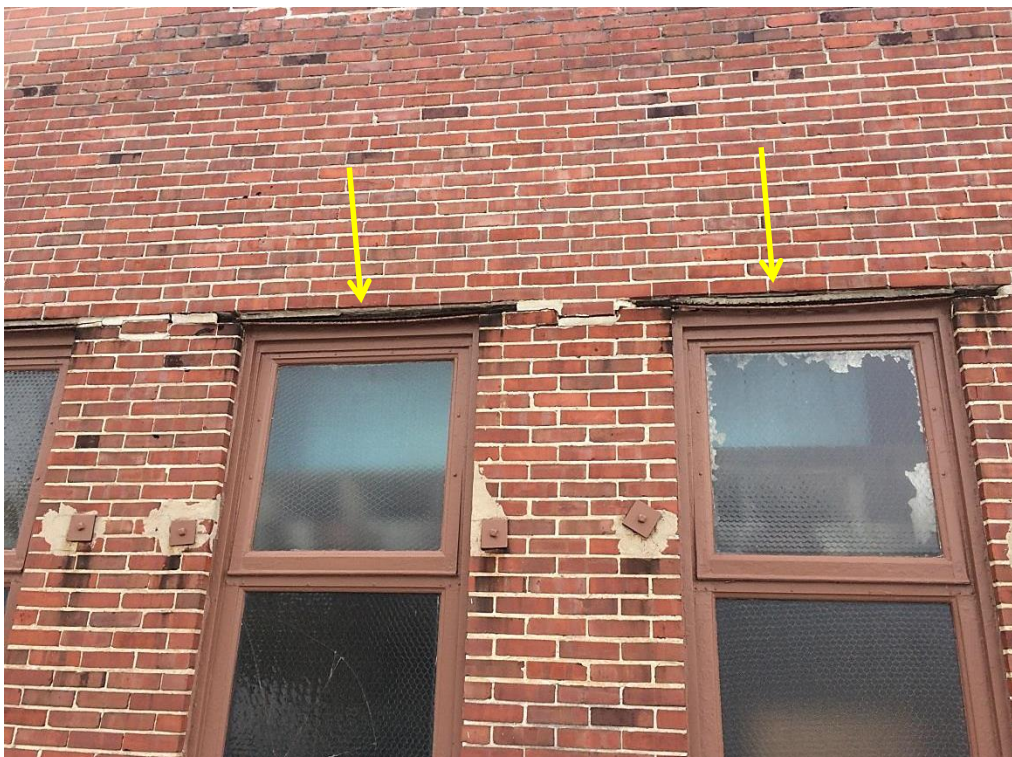
Figure 26: Corroded steel window lintels.

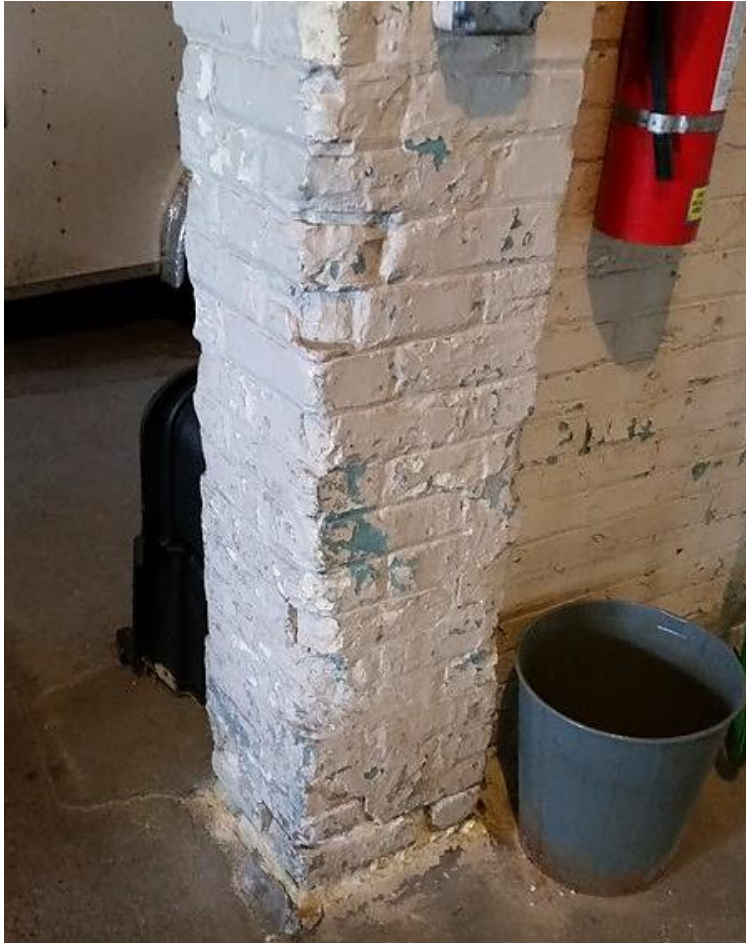
Figure 33: Interior brick deterioration.

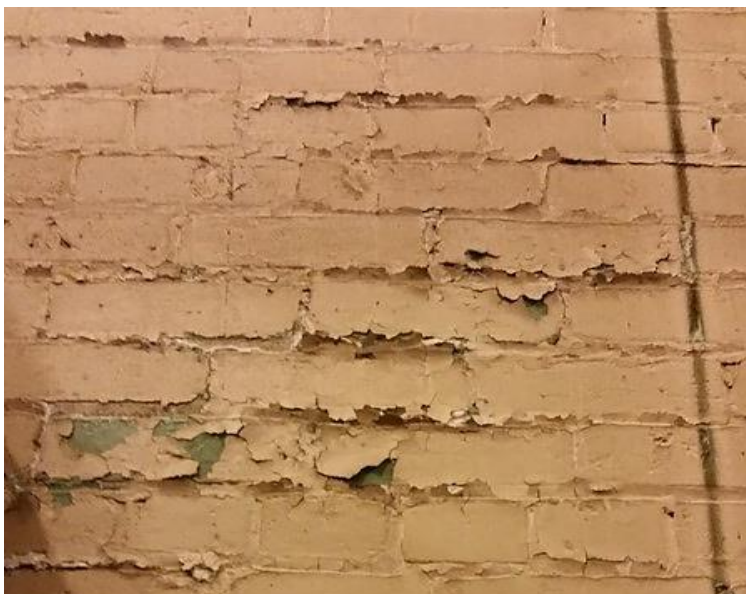
Figure 34: Paint deterioration.

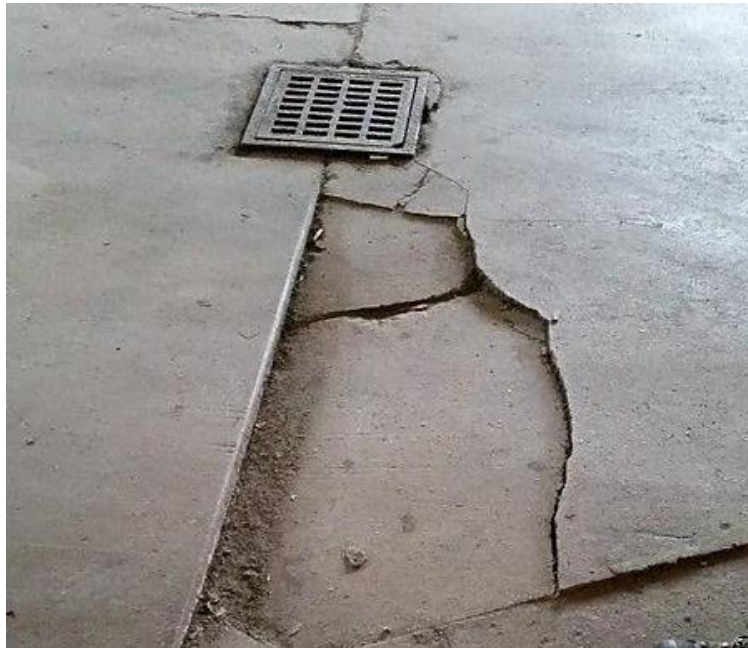
Figure 35: Concrete floor cracking.

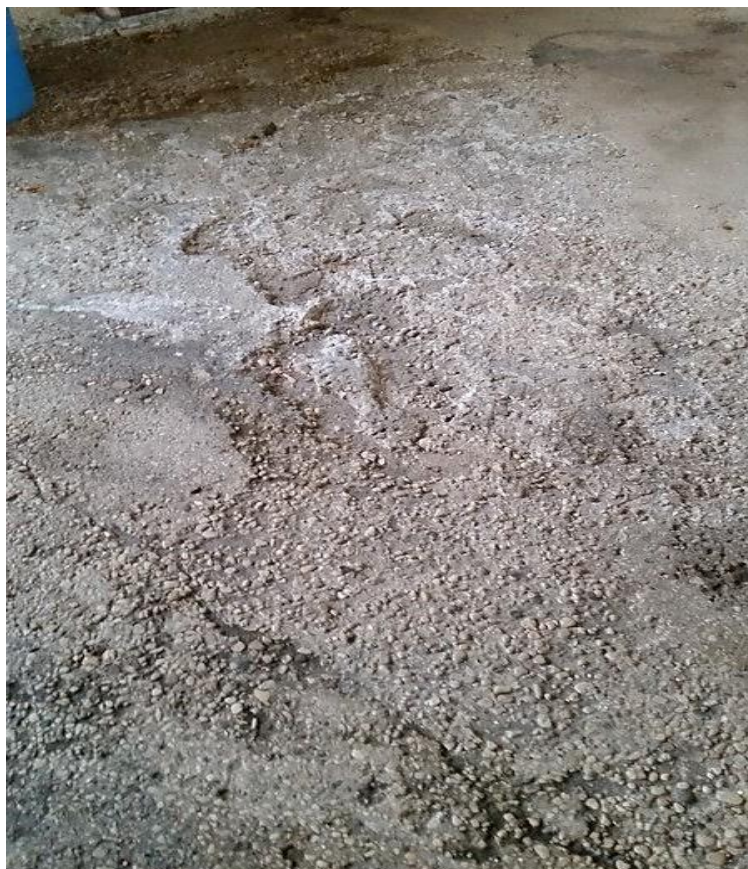
Figure 36: Deteriorating concrete floor.

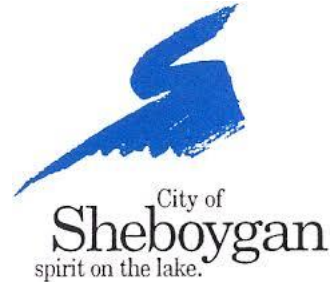
**Sheboygan City Hall**  
**828 Center Avenue**  
**Sheboygan, WI 53018**

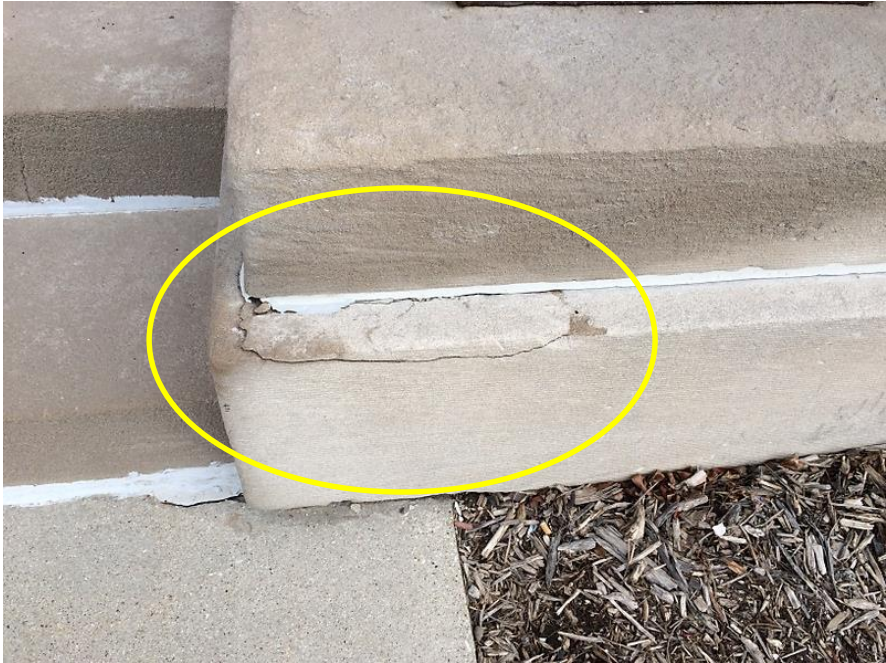
Figure 12: Spalled stone at main entrance, south facade

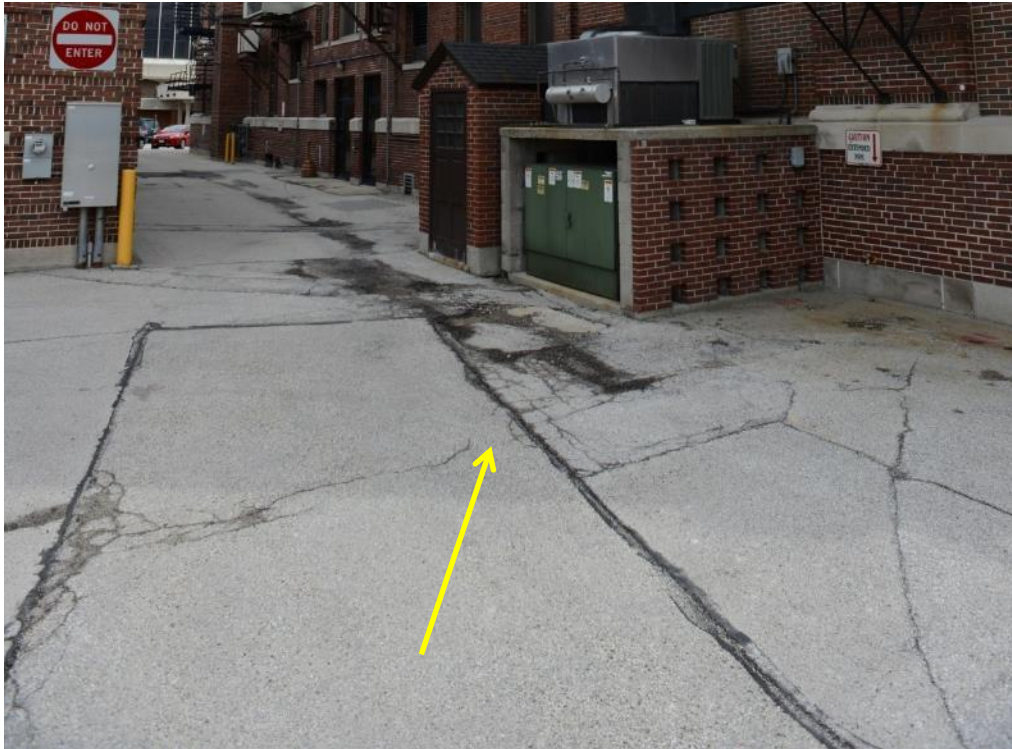
Figure 13: Deteriorating asphalt pavement at alley, north elevation

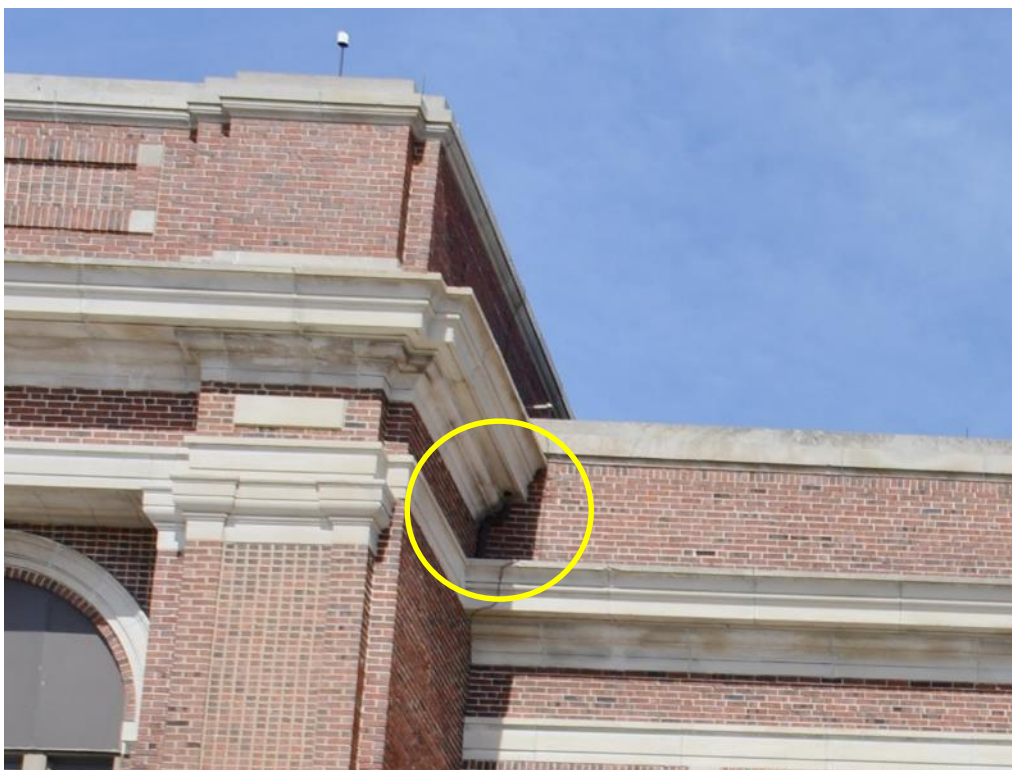
Figure 14: Disconnected downspout, south facade

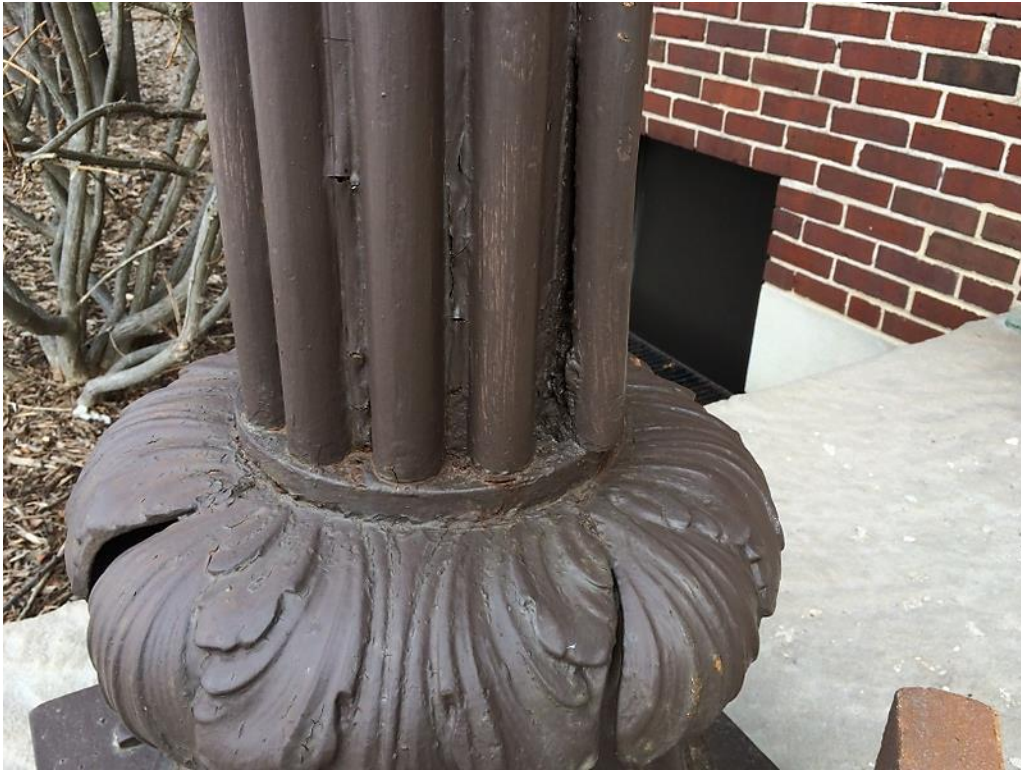
Figure 15: Corrosion/peeling paint on light poles at main entrance on south elevation

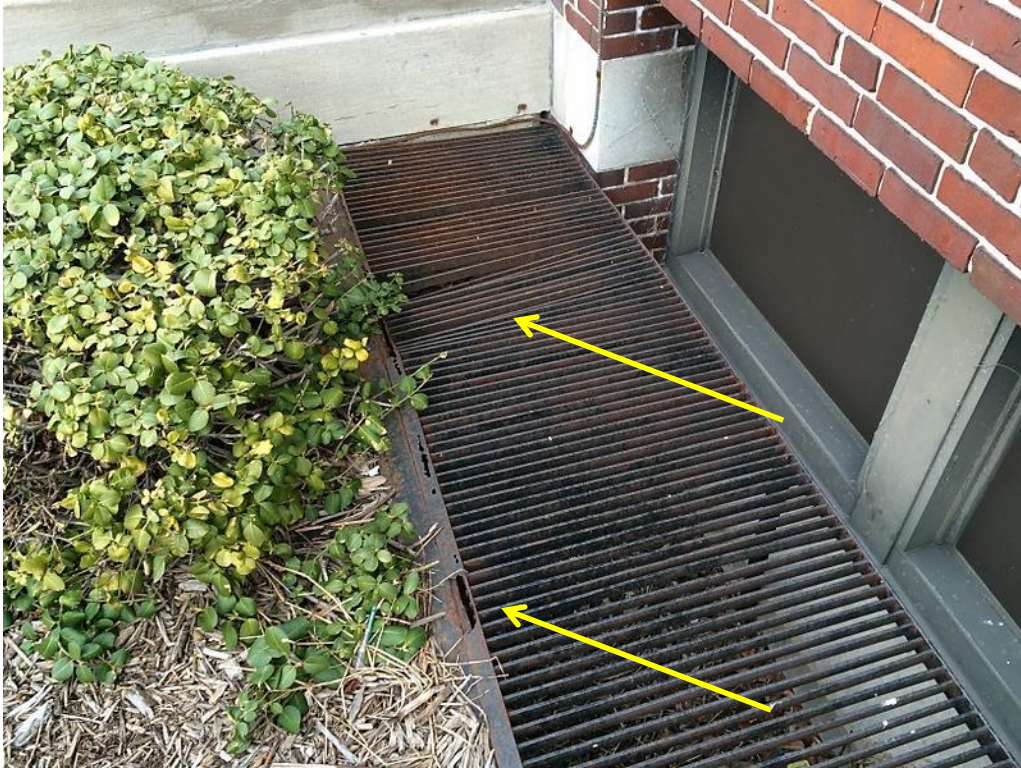
Figure 17: Corroded/damaged window well grate

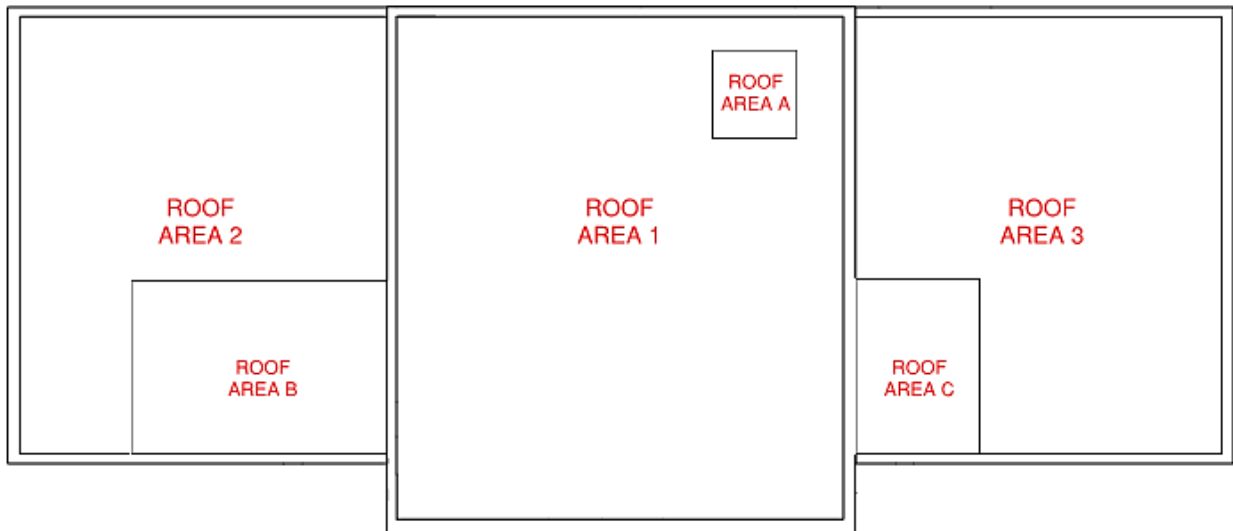
Figure 18: City Hall roof plan

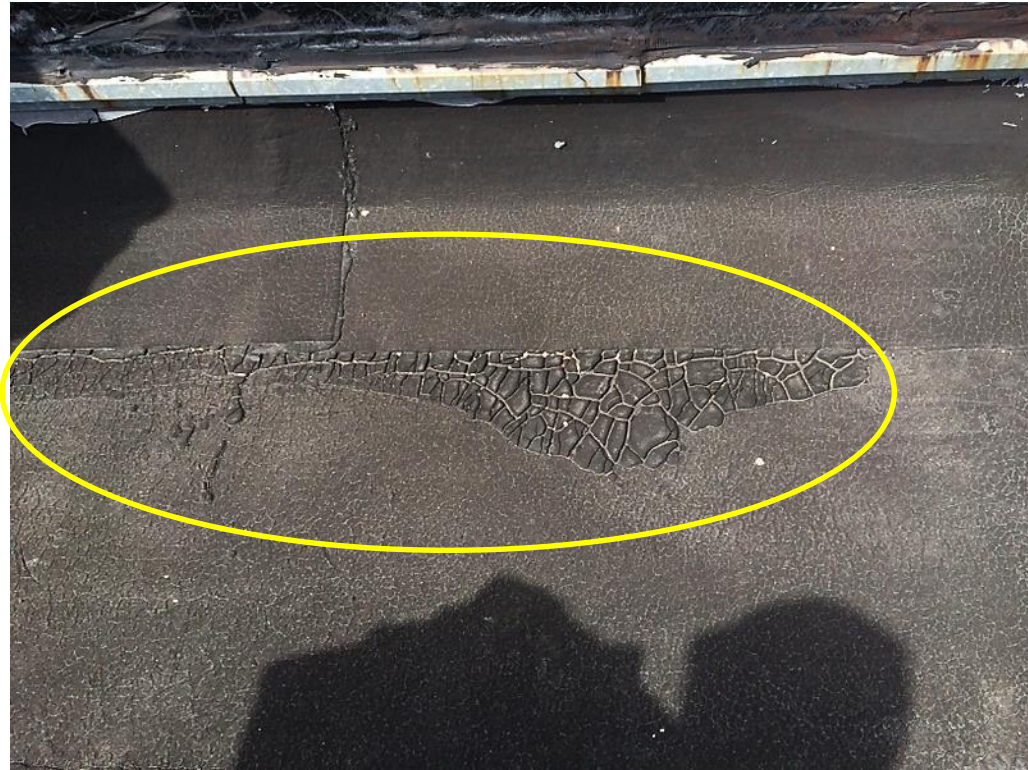
Figure 25: Deteriorated/asphalt cracking at modified bitumen membrane surface.

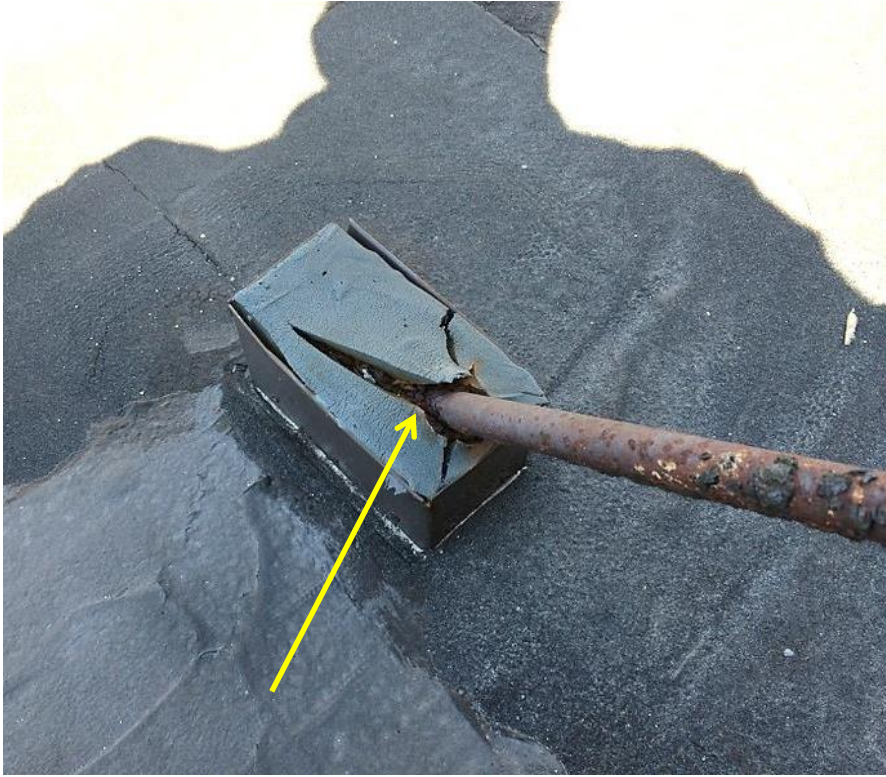
Figure 27: Deteriorated pitch pocket

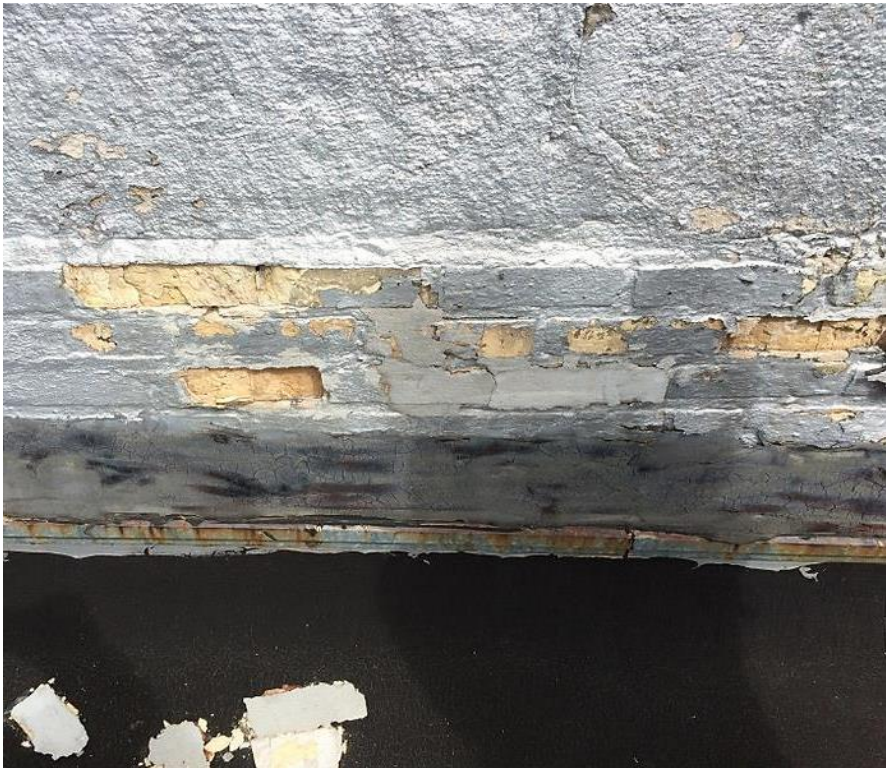
Figure 28: Failed aluminum coating above counter flashing

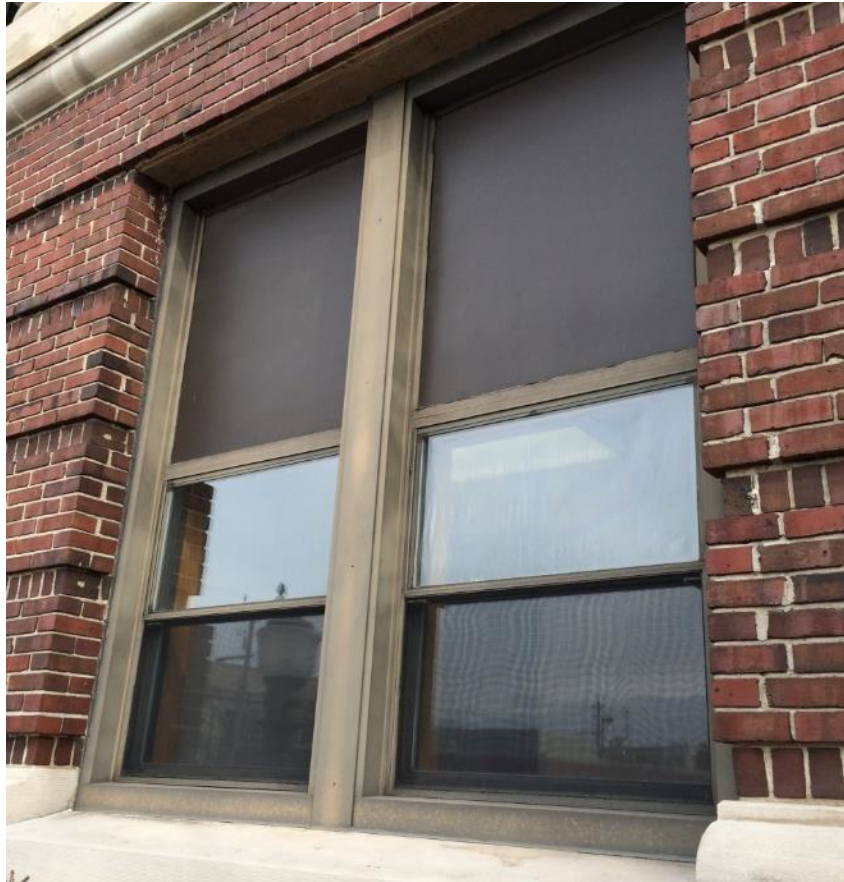
Figure 29: Typical window system

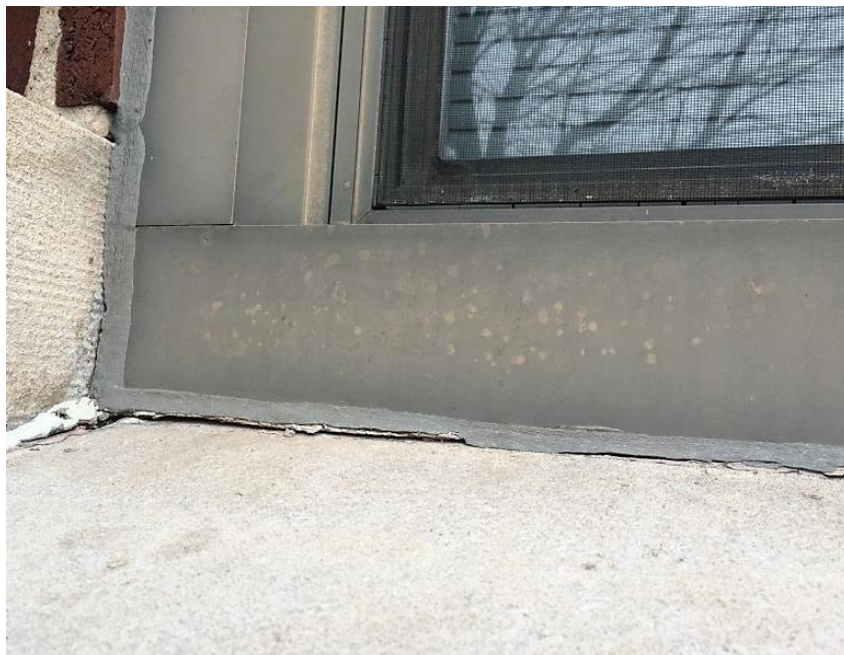
Figure 30: Deteriorated sealant at window perimeter

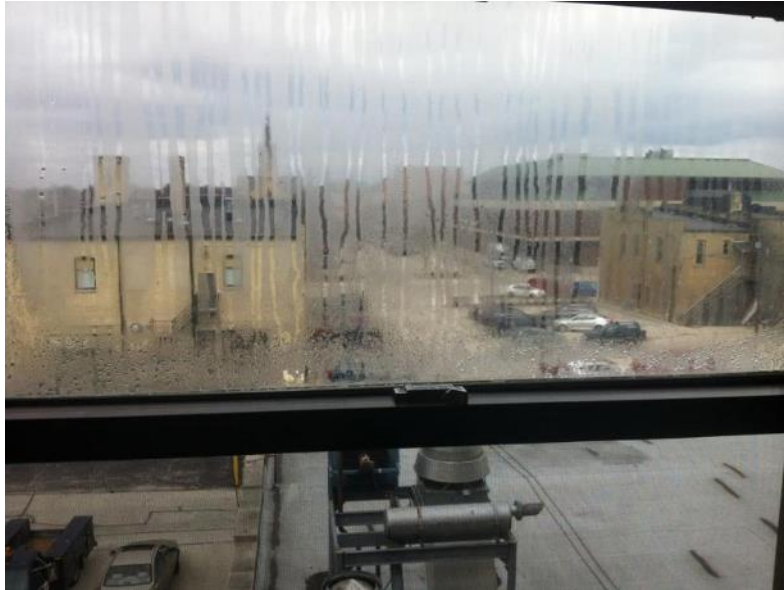
Figure 31: Condensation in between window panes of IGU.

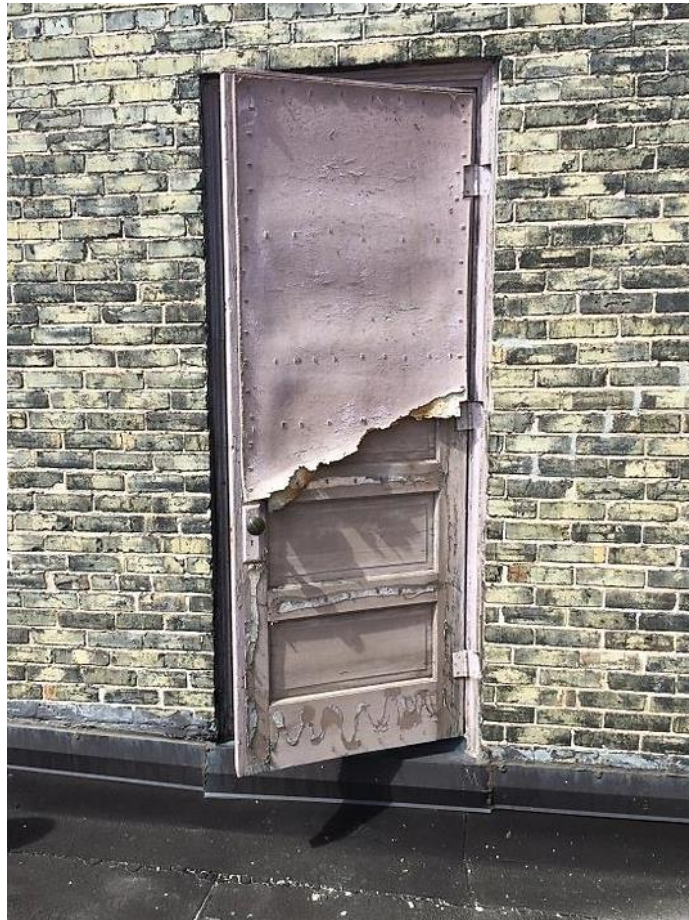
Figure 34: Damaged roof access door

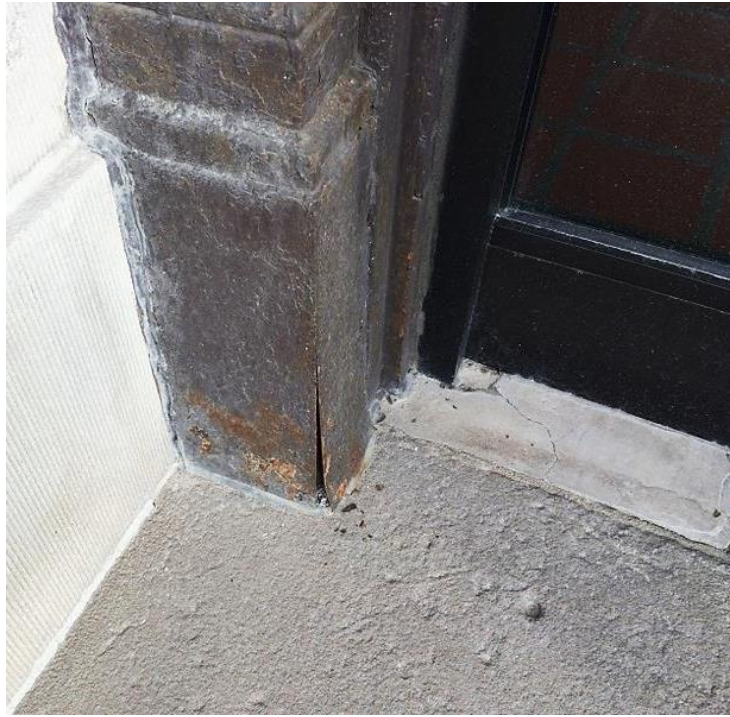
Figure 35: Corroded and deteriorated door frame

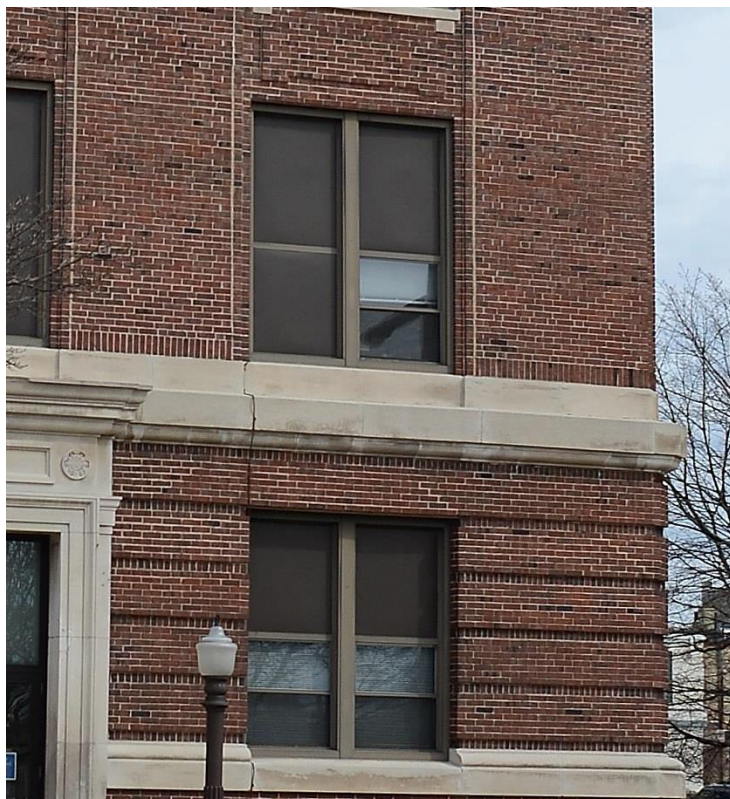
Figure 36: Typical brick coursing
