**\*\*\*ATTACHMENTS\*\*\***

# The City of Sheboygan City Hall North Parking Garage

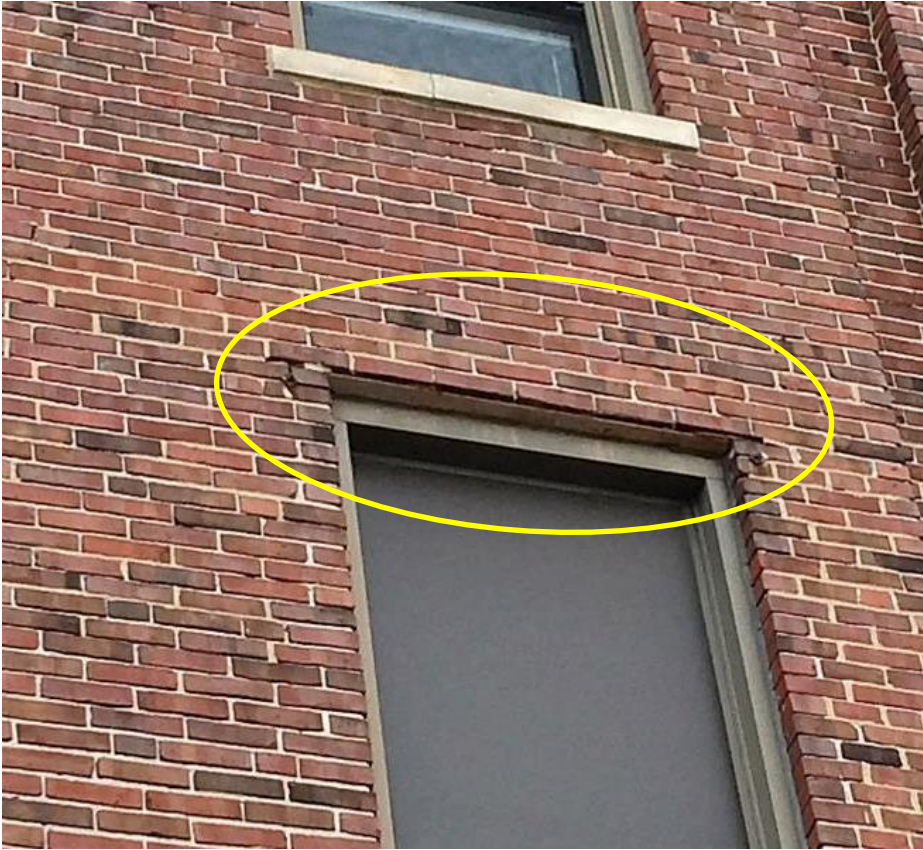
Figure 37: Corroded lintel causing brick movement.

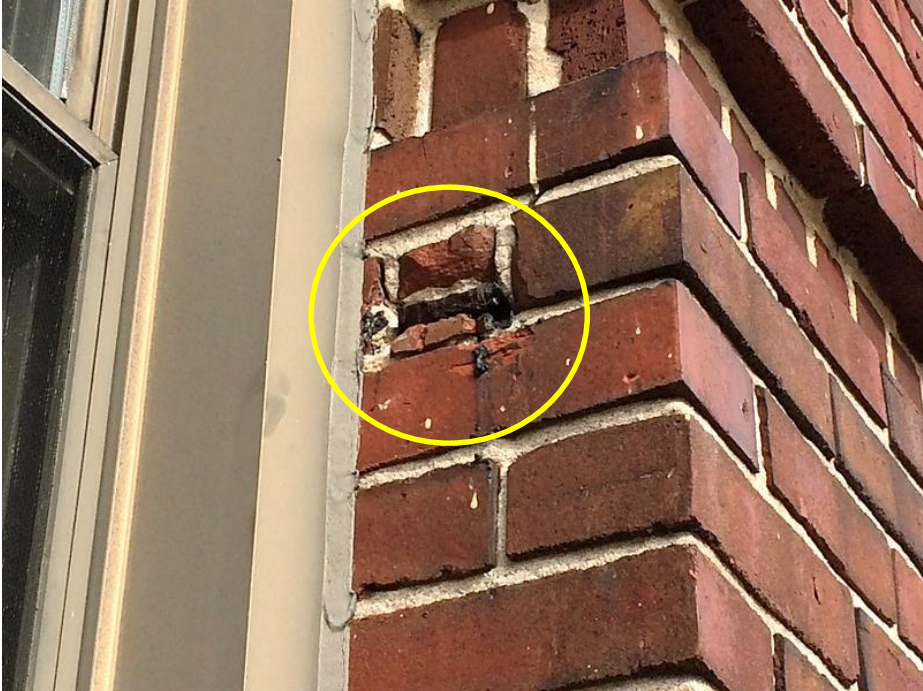
Figure 38: Corroding embedded steel at window jamb

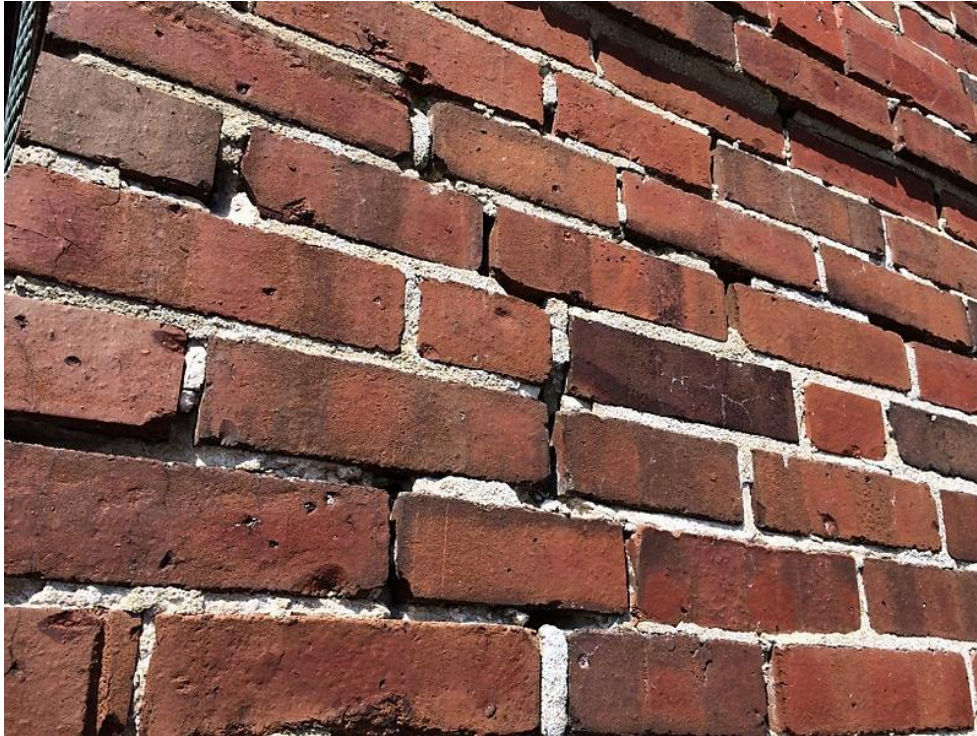
Figure 41: Brick/mortar deterioration on building facade

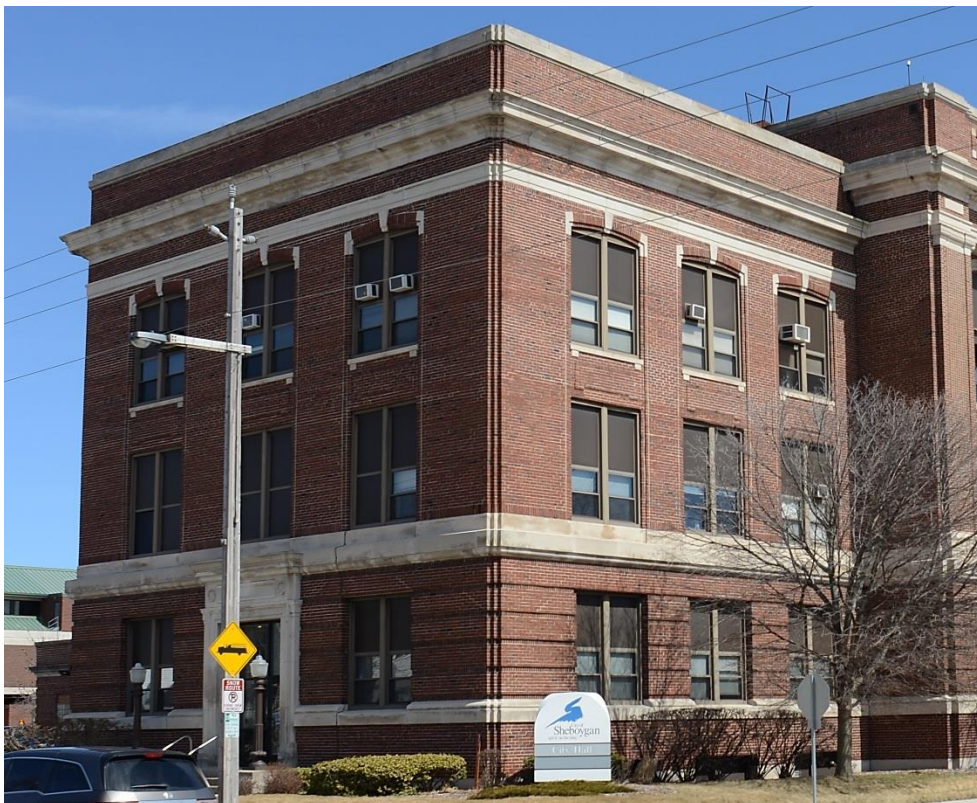
Figure 42: Limestone architectural elements wrap all building facades

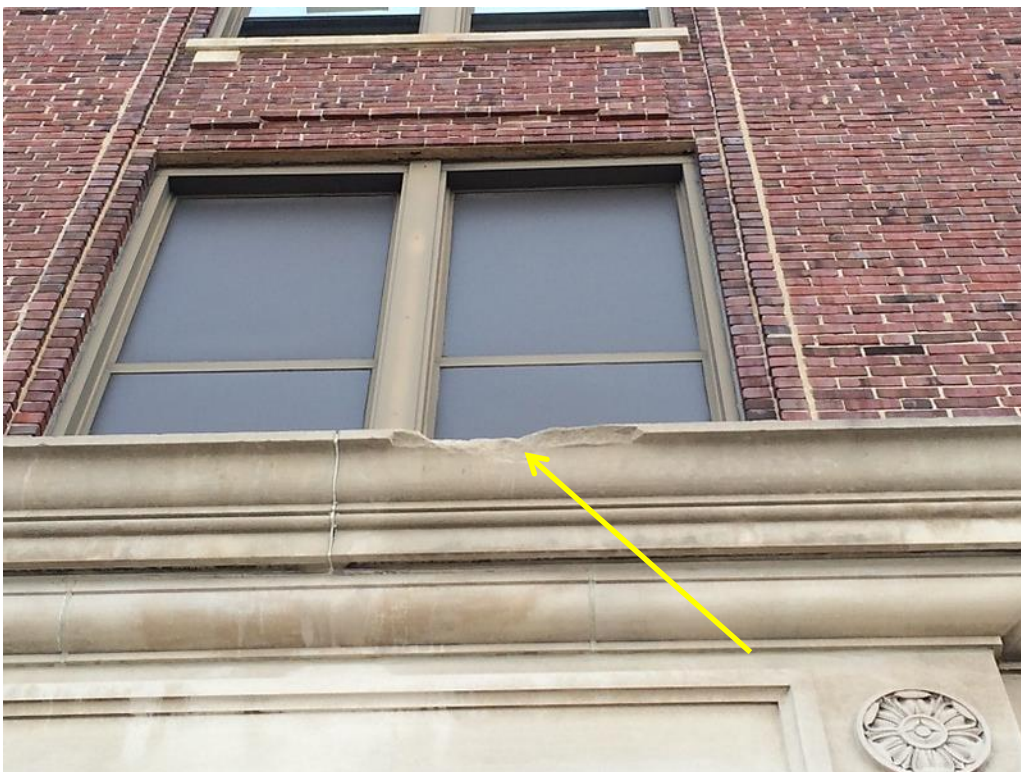
Figure 44: Spalled Stone

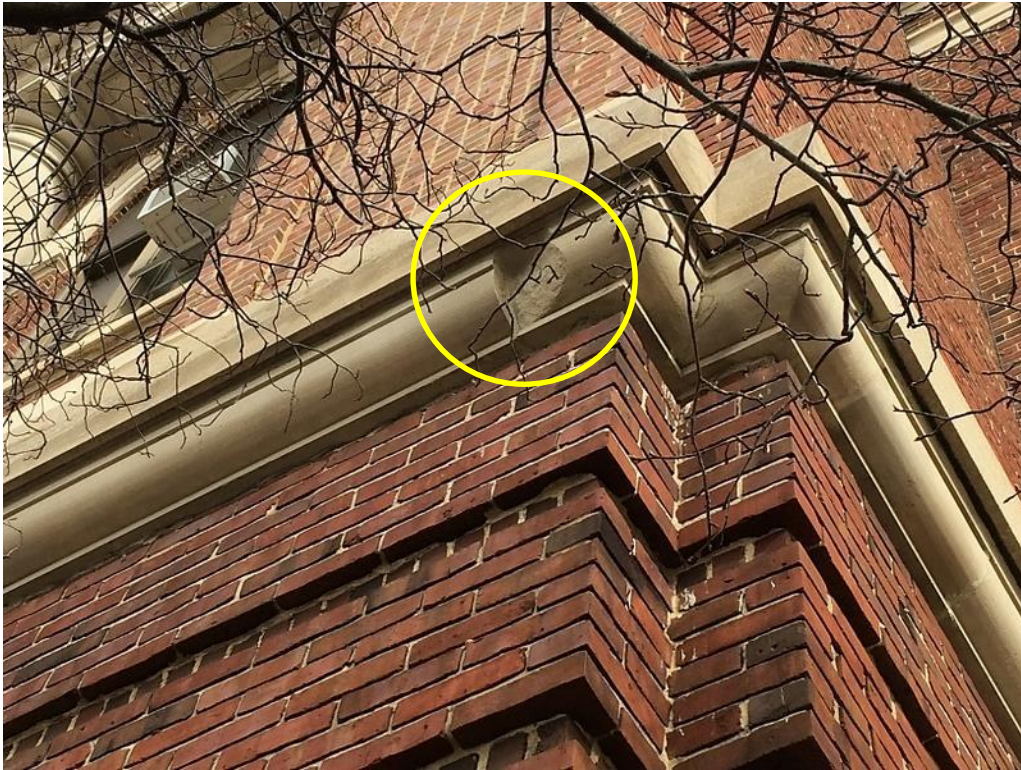
Figure 45: Spalled stone

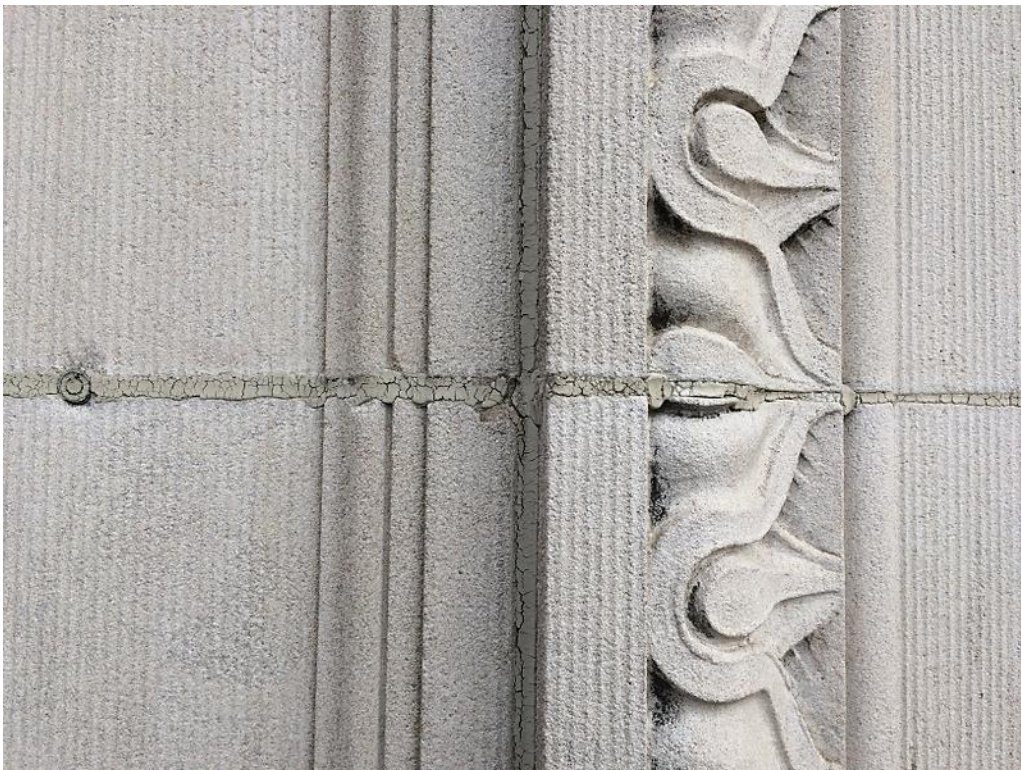
Figure 46: Deteriorated stone mortar joints with deteriorated sealant over mortar.

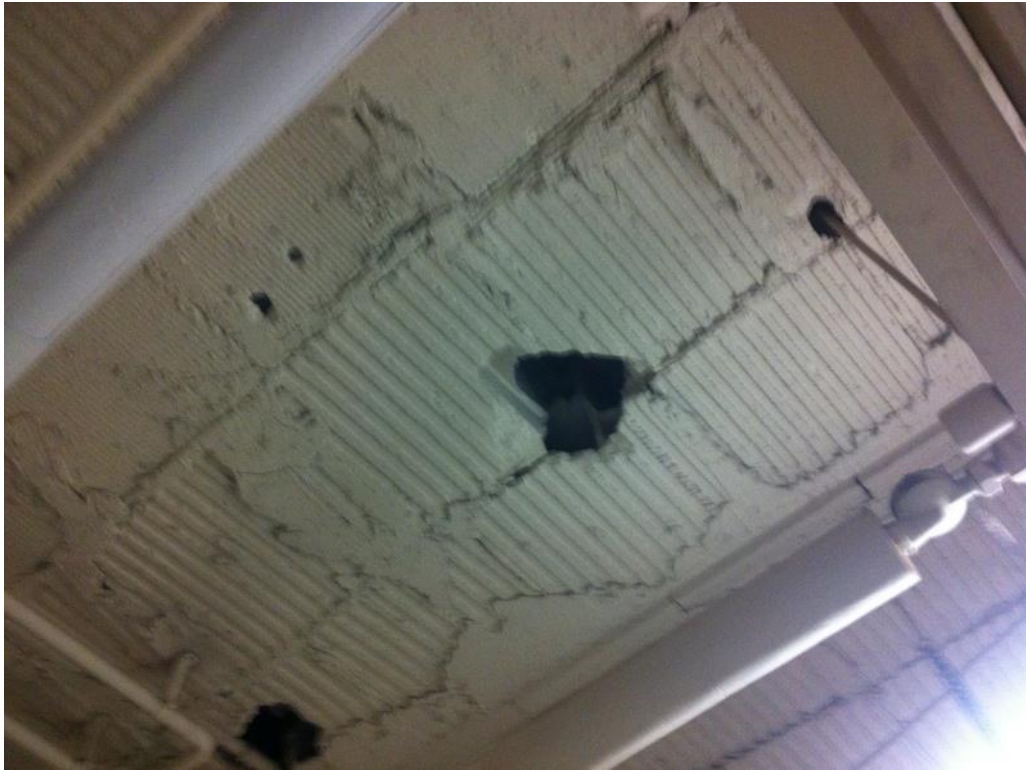
Figure 57: Hole in clay tile ceiling

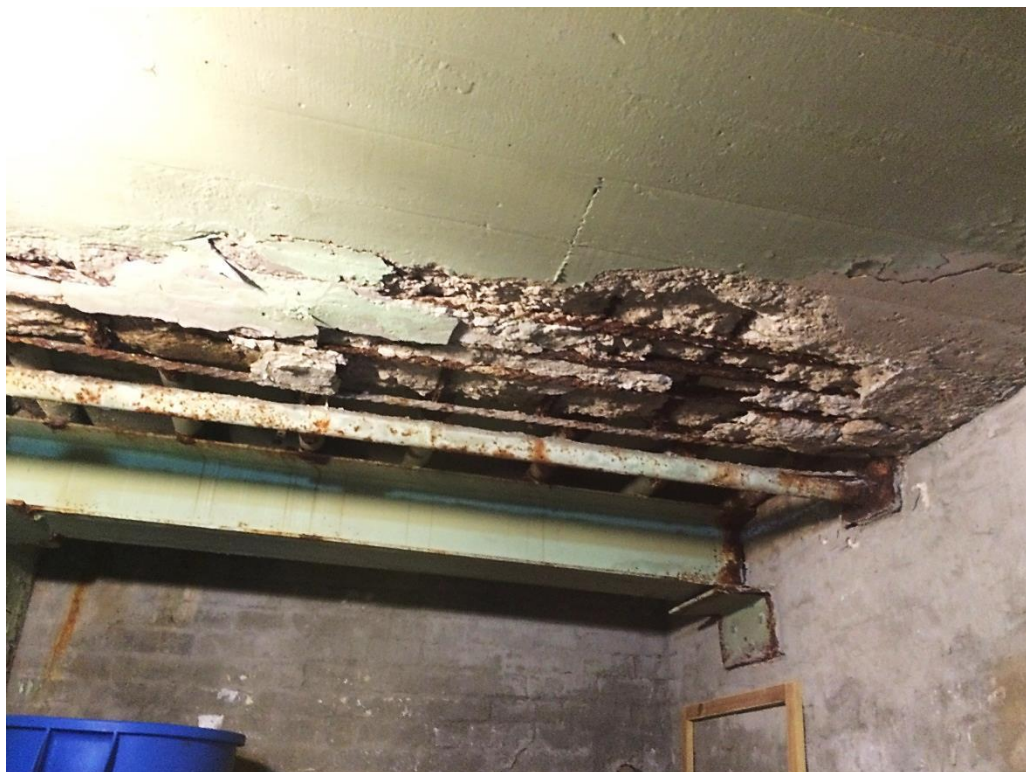
Figure 58: Exposed rebar/structure deterioration in vault below alley.

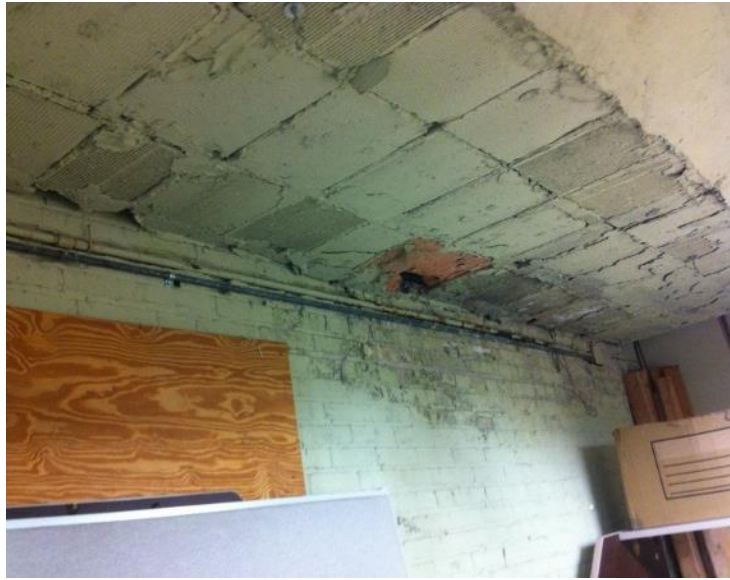
Figure 59: Deterioration, water leakage beneath west entrance stair

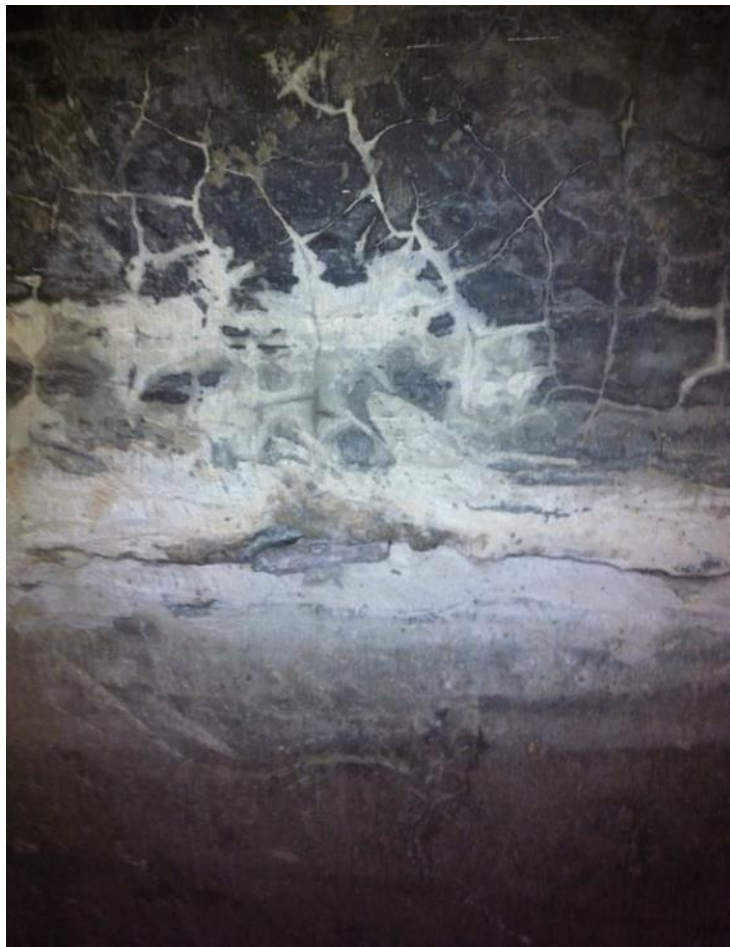
Figure 60: Deteriorating building foundation in stairwell

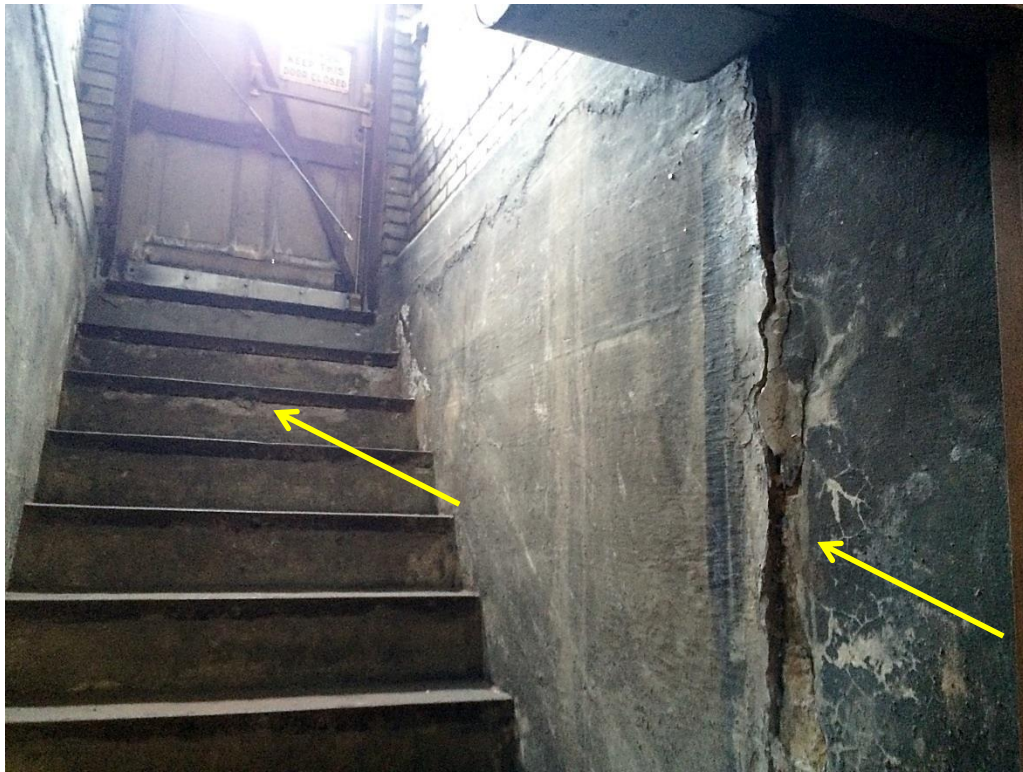
Figure 61: Opened wall joint and spalled steps in north basement exit stairwell

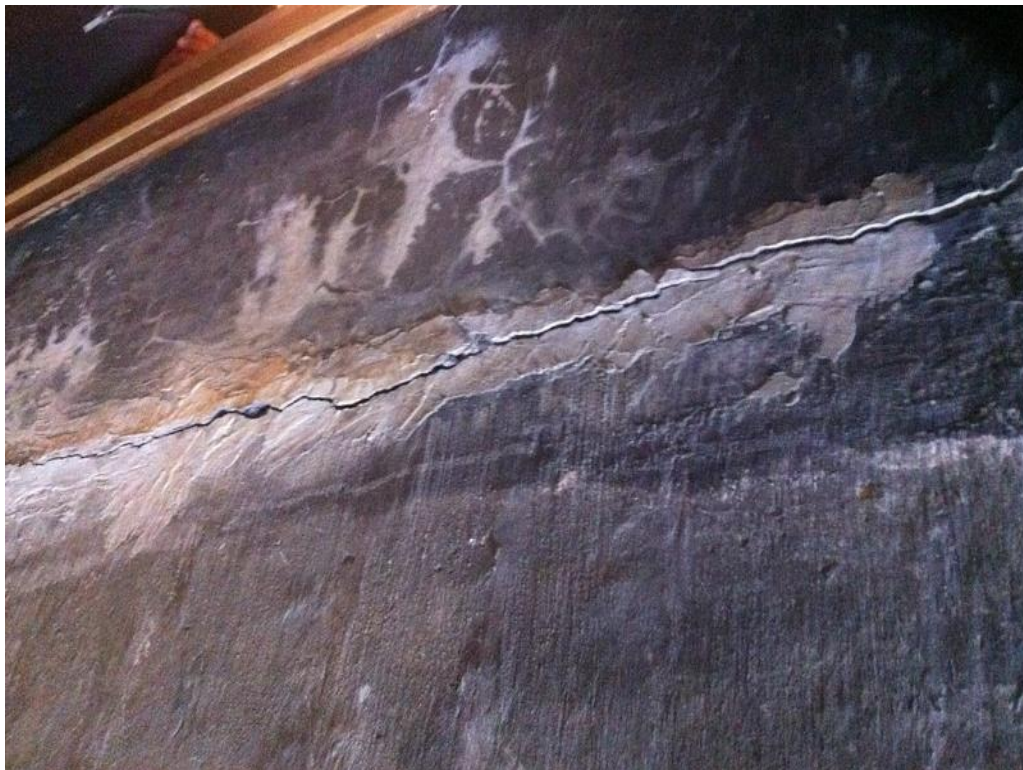
Figure 62: Foundation cracking in north basement exit stairwell

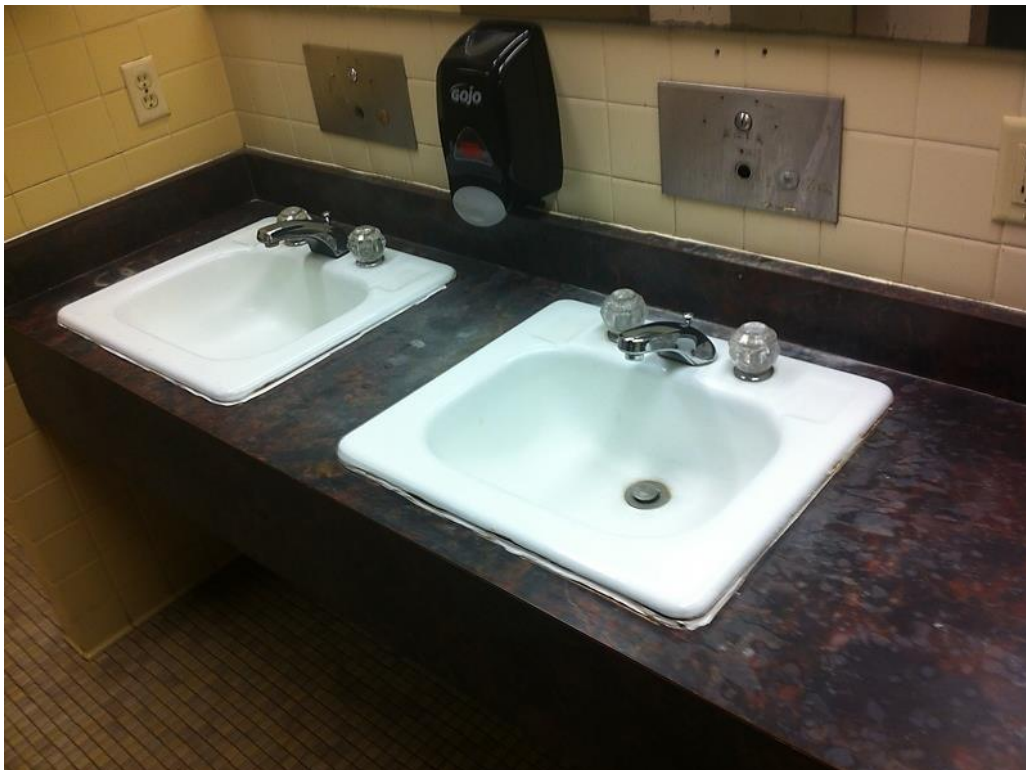
Figure 66: Aged bathroom fixtures

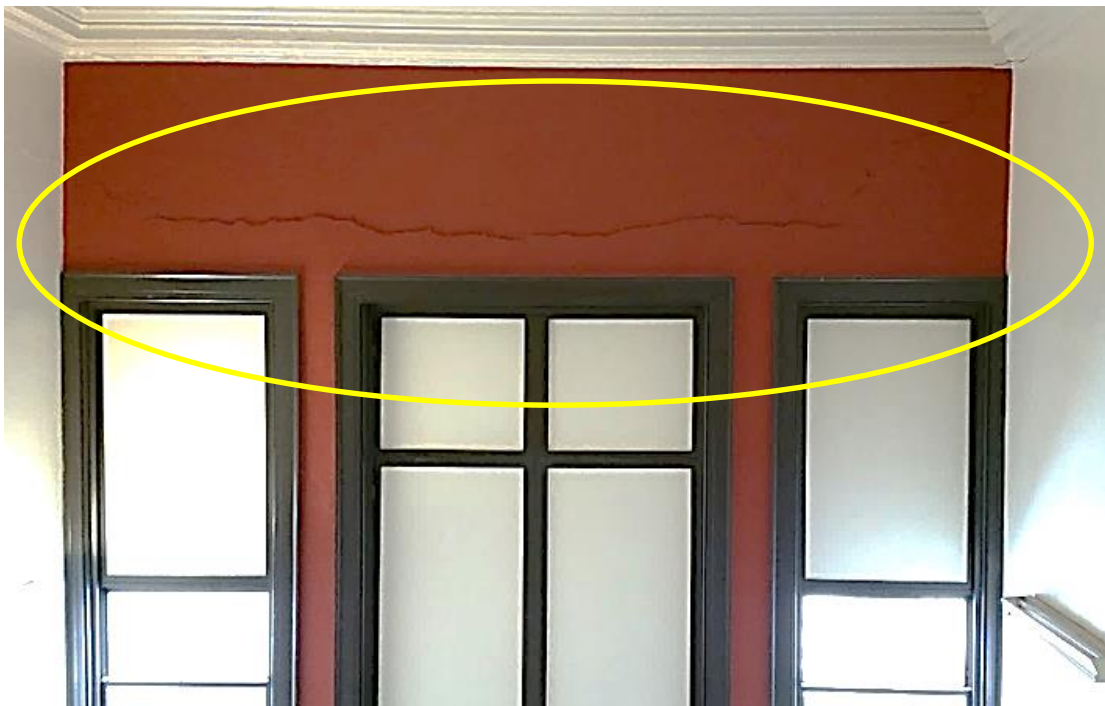
Figure 70: Significant wall cracking in stairwell at fourth floor on north facade

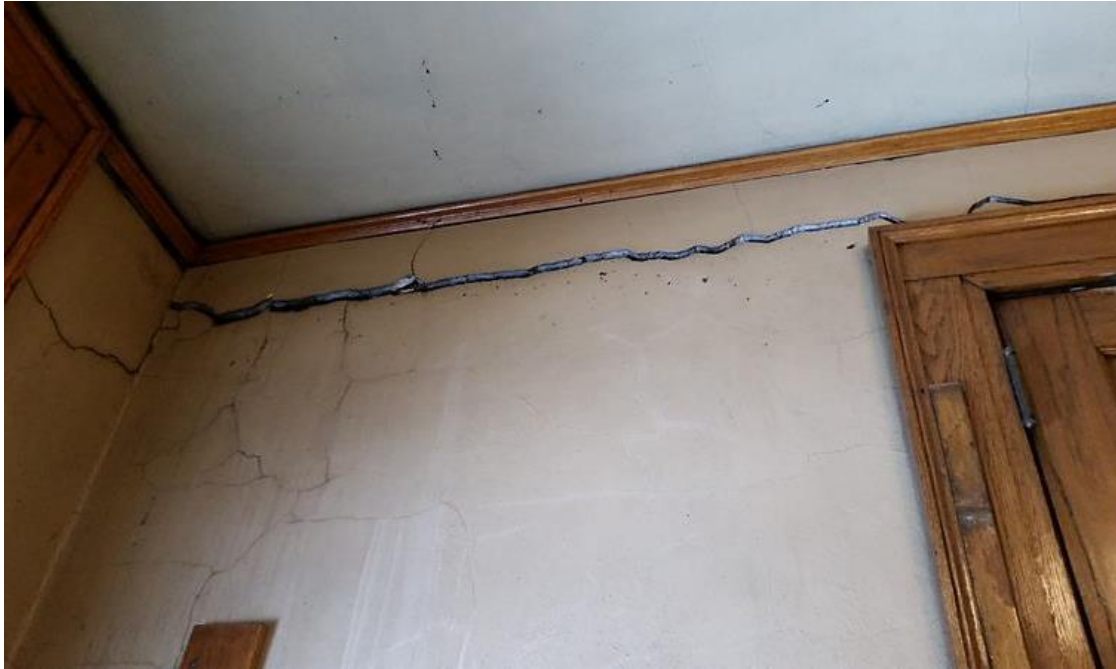
Figure 71: Significant wall cracking at fourth floor on east wall that returns to exterior north wall.

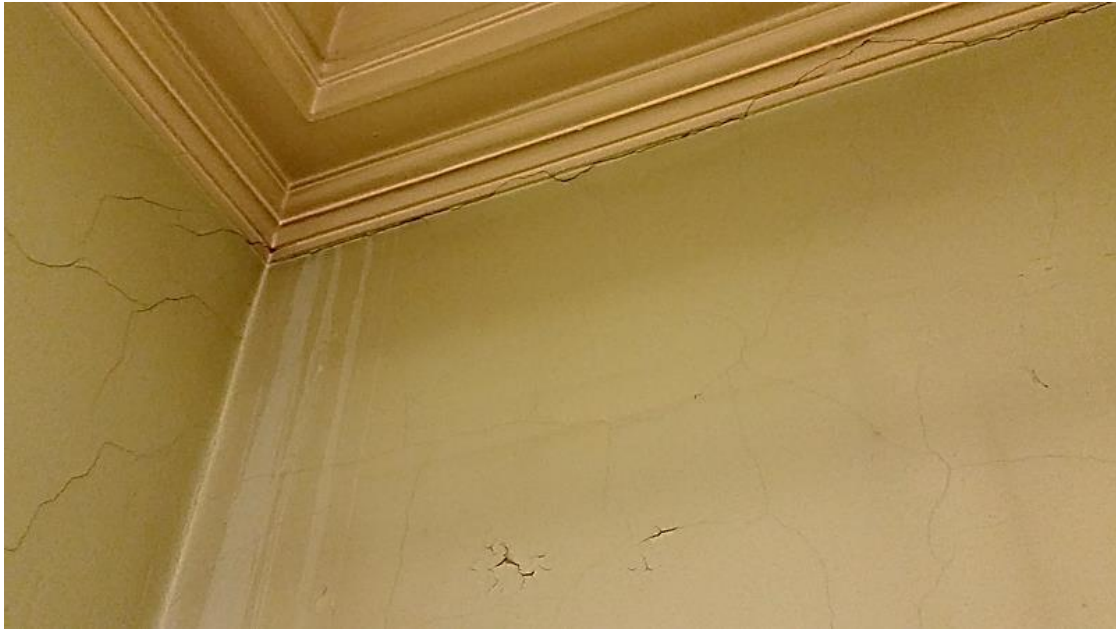
Figure 75: Fourth floor paint cracking

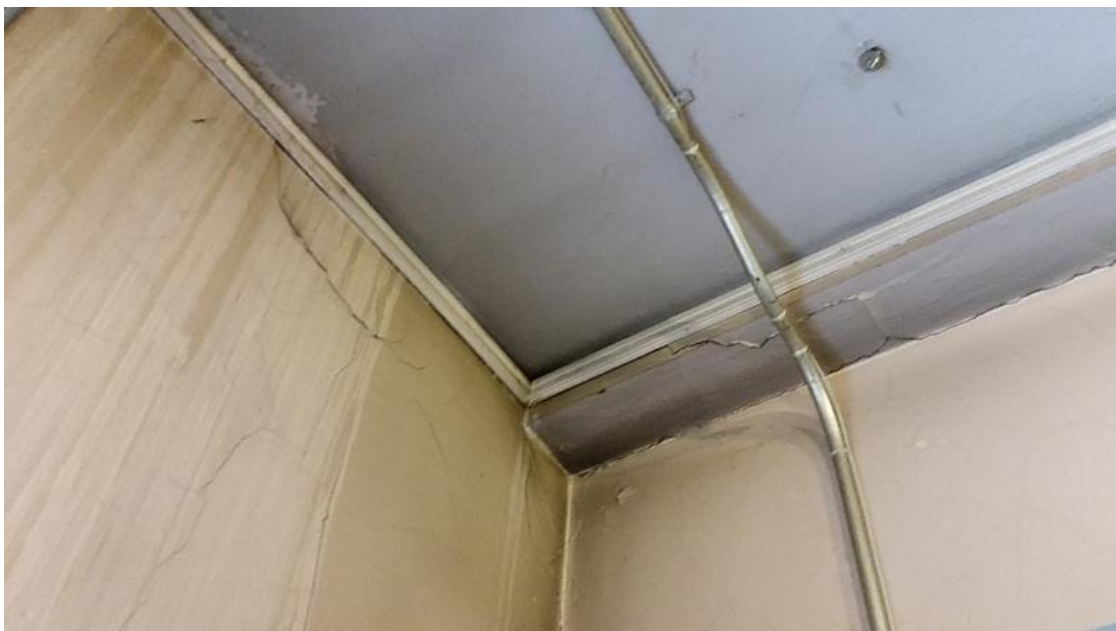
Figure 76: Fourth floor wall paint cracking
