BOARD OF WATERWORKS COMMISSIONERS - 3:30 PM - (Monday, September 21, 2020)

The east settling basin was built in 1959 and is located on the east side of the property on the shoreline. In 1992, extensive concrete repairs were made to extend the life of the structure. These repairs included concrete injection, patching multiple areas of failed concrete, and partial interior coating. Recently, utility staff have conducted inspection work, revealing that multiple concrete injection points have failed and found that the interior coating is also failing.

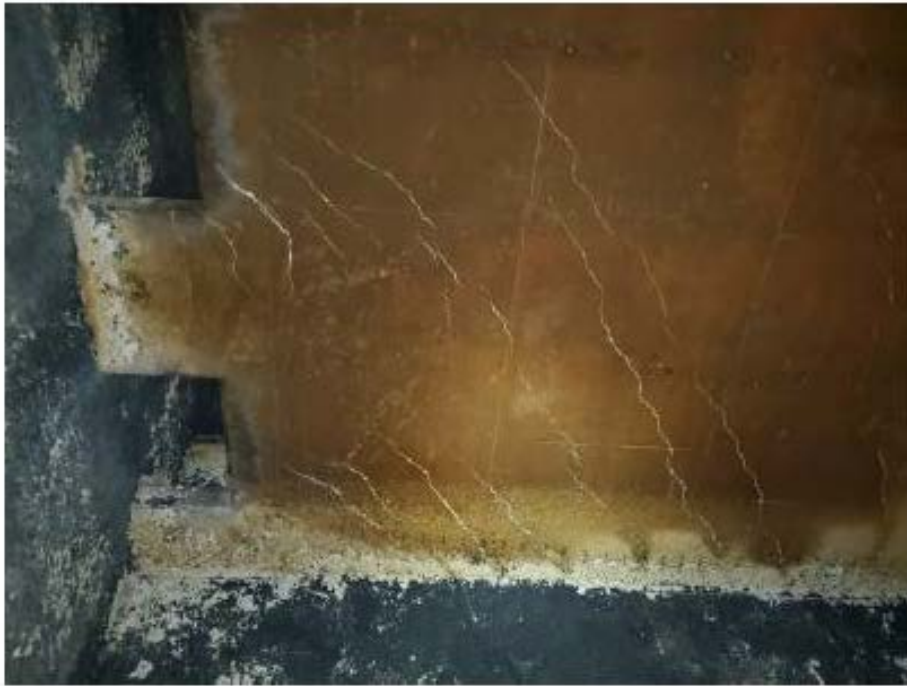
Photograph 1: Diagonal cracking typical at corners in underside of slab ceiling slabs.

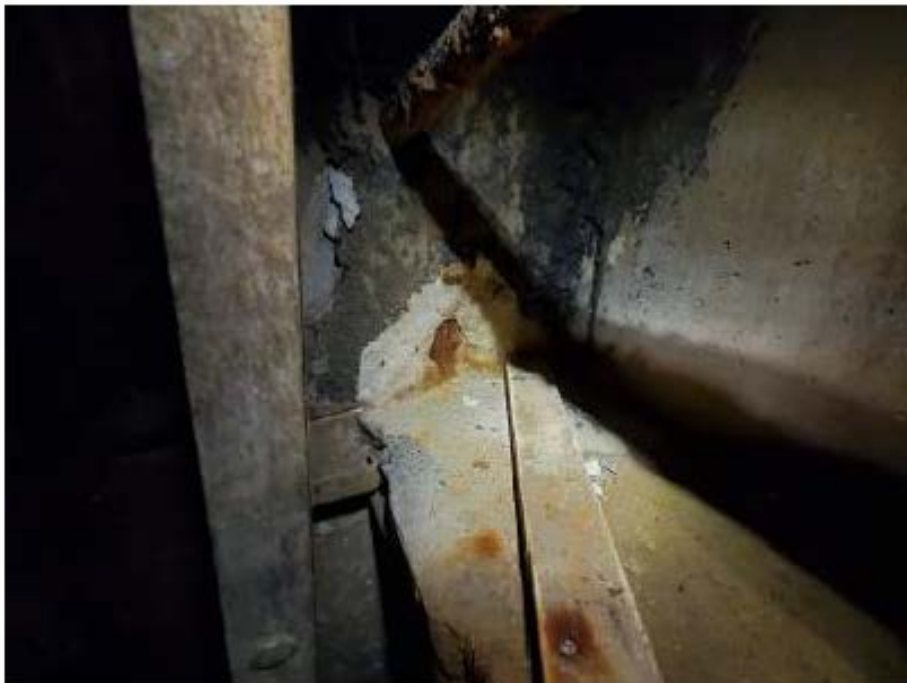
Photograph 2: 2' wide x 1' high spall in south wall of upper east mixing basin at floor.

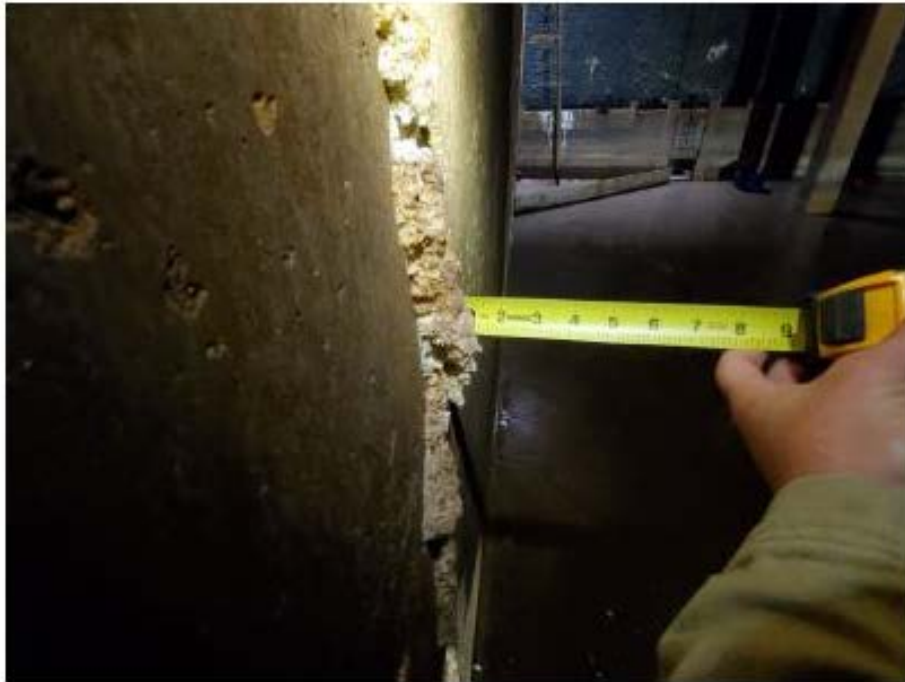
Photograph 3: Efflorescence up to 1.5" thick at interior wall, upper east cell, looking north.

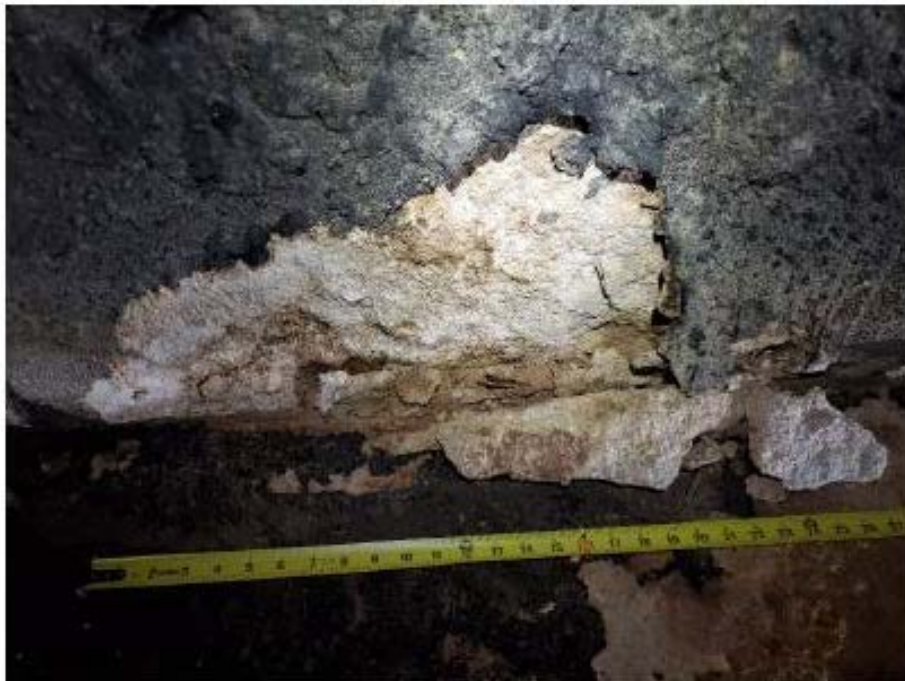
Photograph 4: Delamination and spalls along bottom of upper east cell, typical along north half.

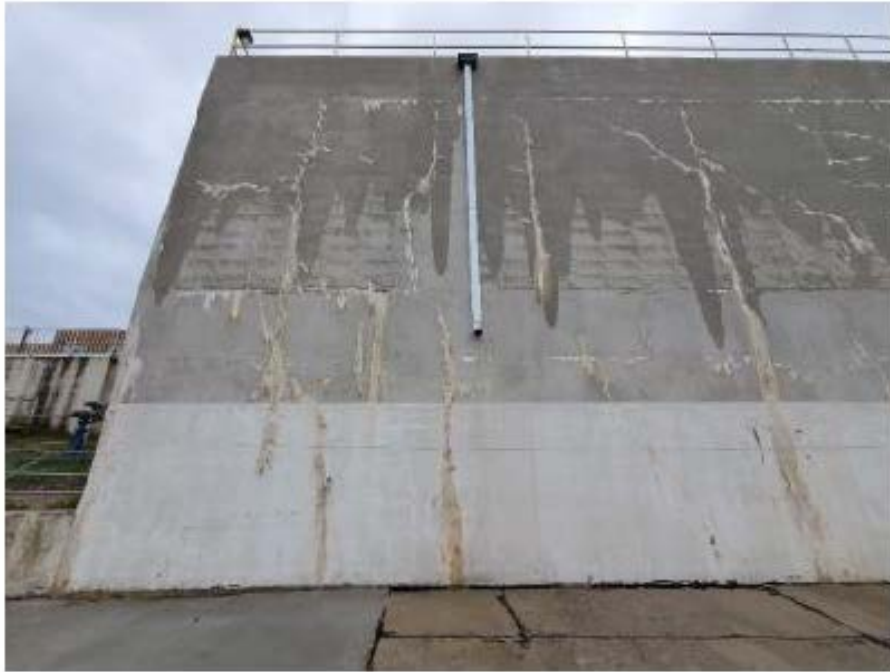
Photograph 11: Typical condition of exterior east wall. South end shown.

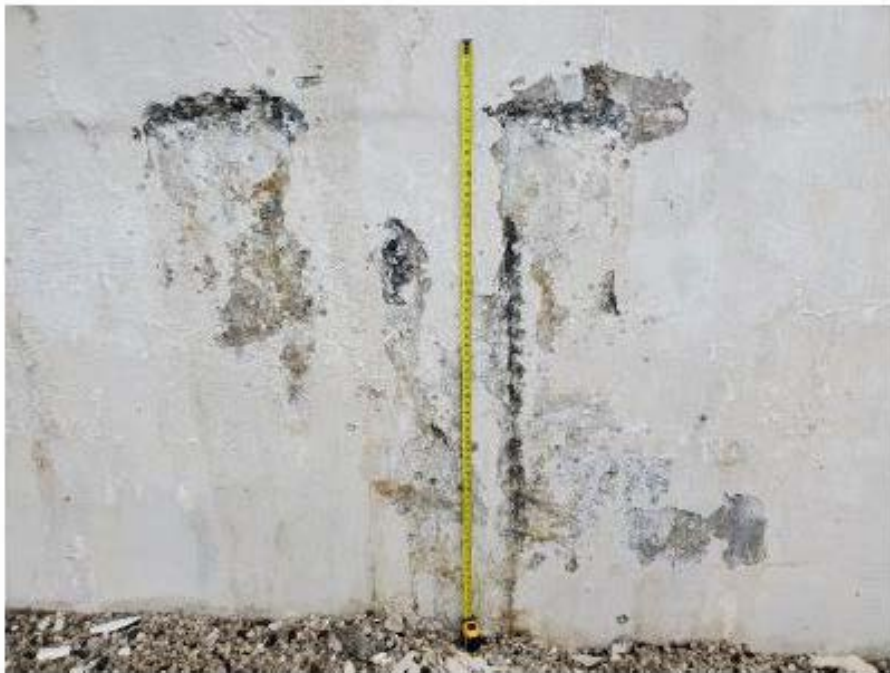
Photograph 12: Condition of exterior concrete wall beneath skim coat on south wall.

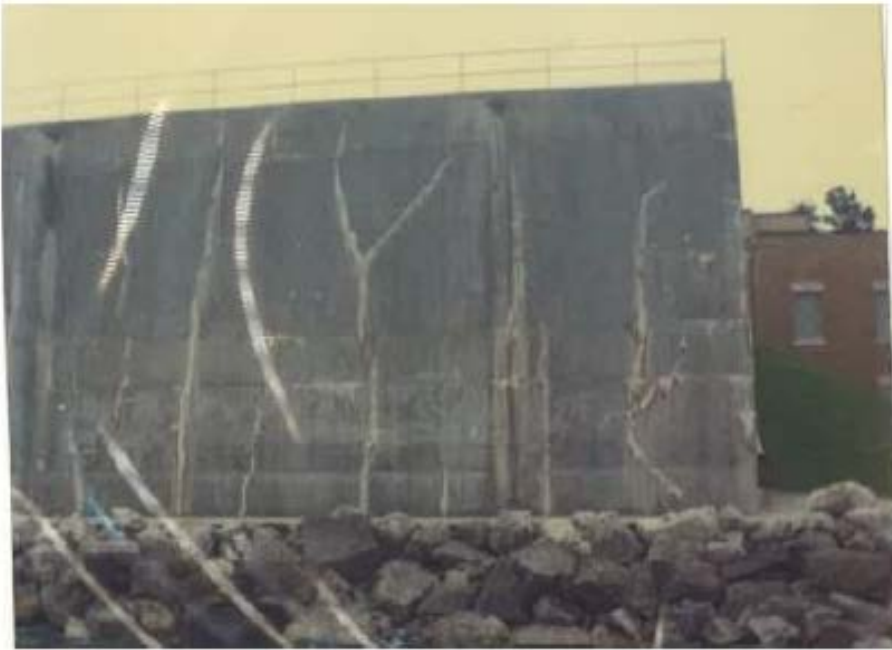
Photograph 31: 1993 Pre-repair photo, north end to scupper 2. .

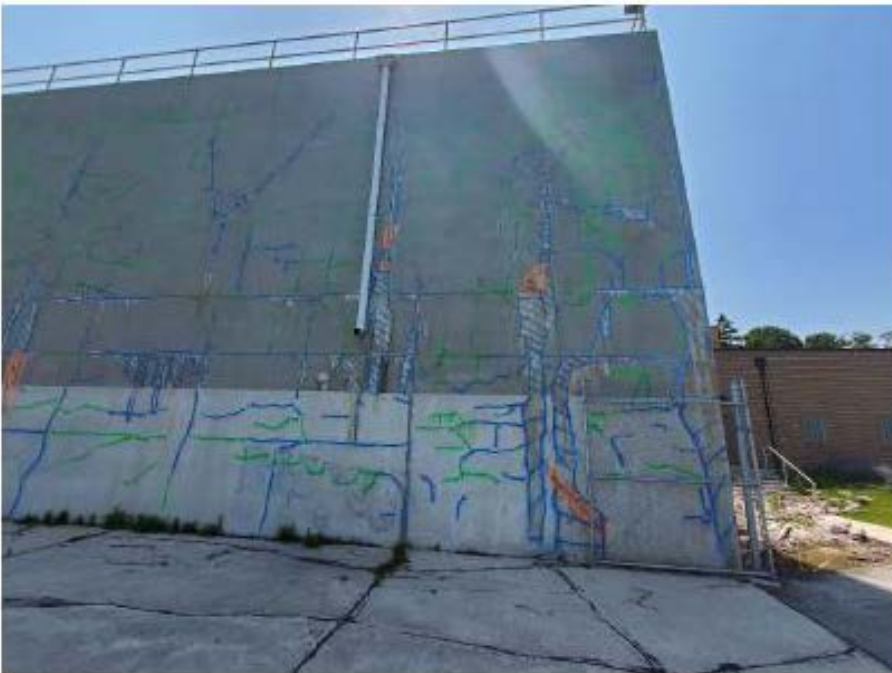
Photograph 32: 2020 Exterior inspection, north end to half panel past scupper 1.

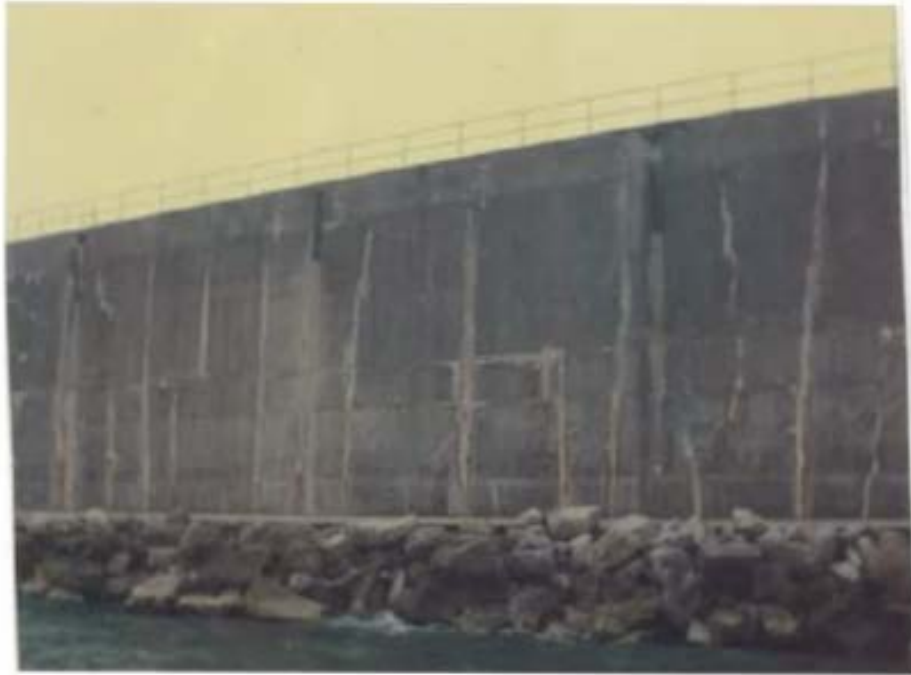
Photograph 33: 1993 Pre-repair photo, scupper 2, 3 and 4 shown.

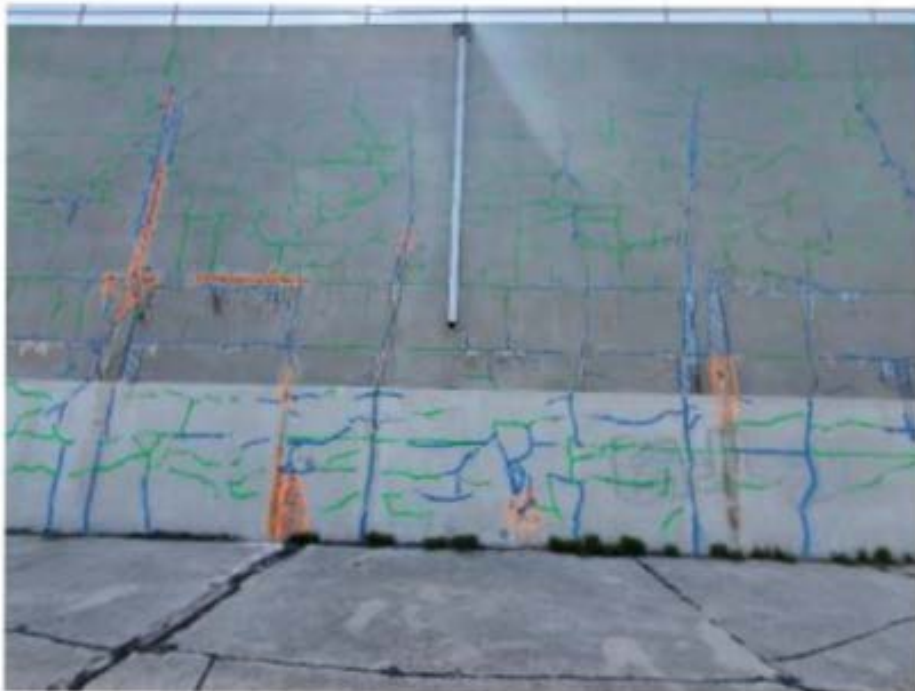
Photograph 34: 2020 Exterior inspection, half panel past scupper 2.

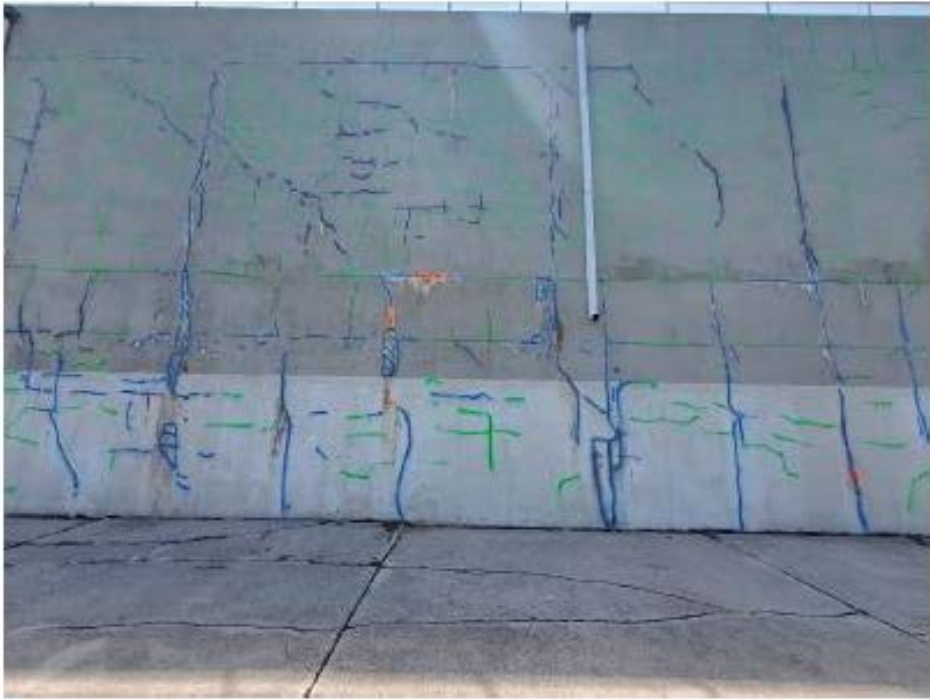
Photograph 37: 2020 Exterior inspection, scupper 4 and 5 shown.

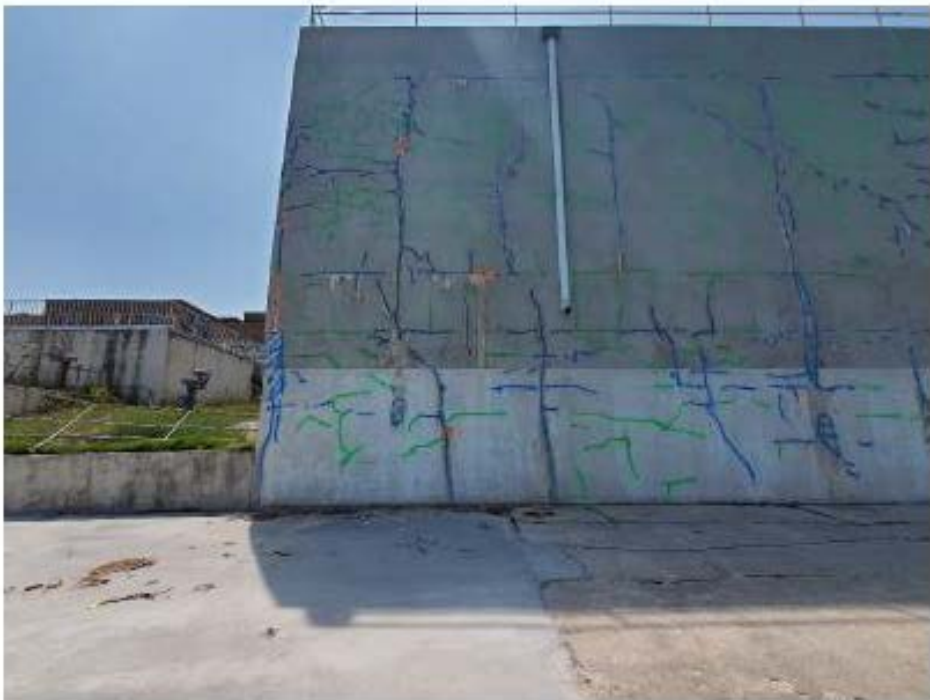
Photograph 38: 2020 Exterior inspection, south end to scupper 5 shown.

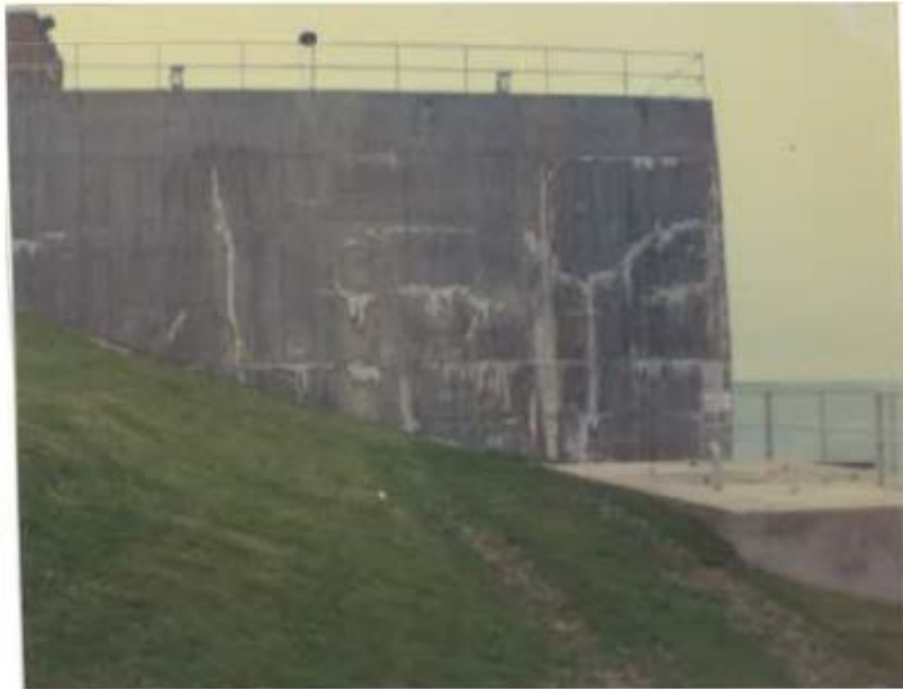
Photograph 39: 1993 Pre-repair photo, south wall shown. .

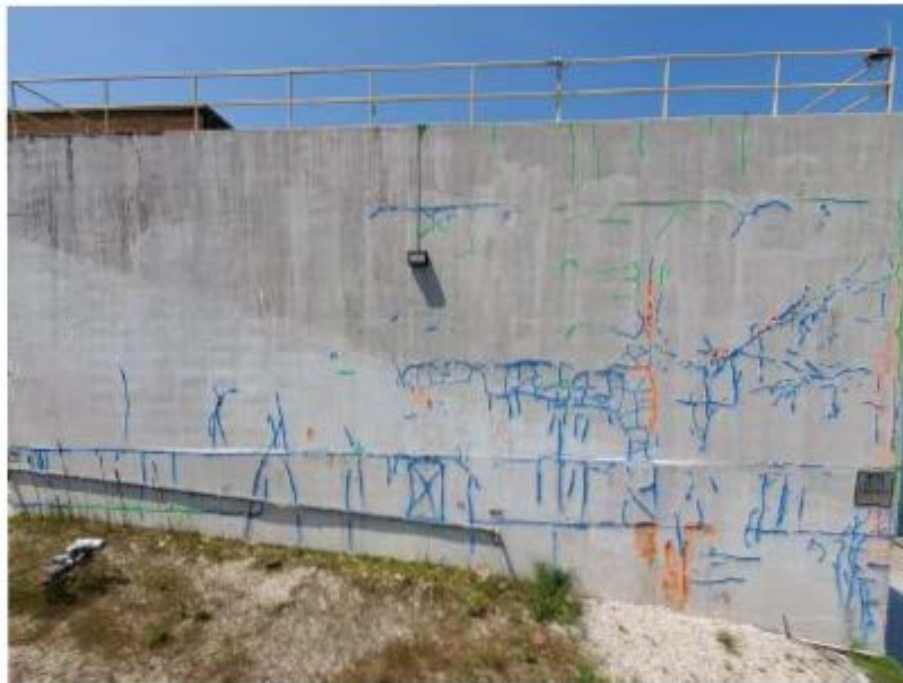
Photograph 40: 2020 Exterior inspection, south wall shown.

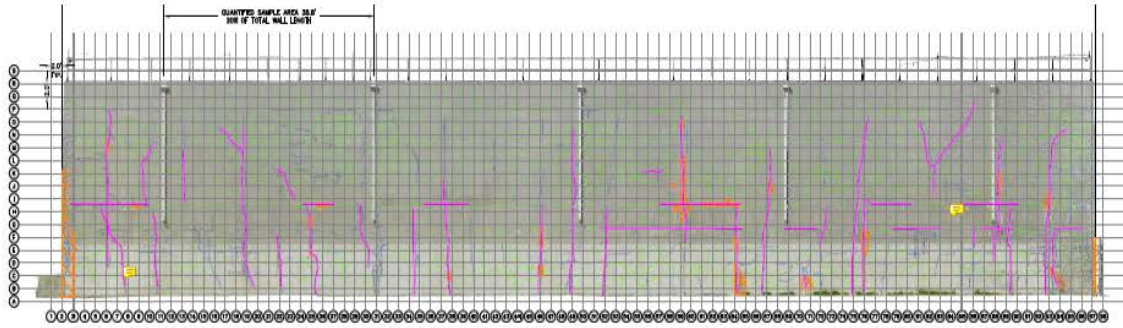
1 EAST ELEVATION
SCALE: 1" = 10'

HAIRLINE CRACKS, NO EFFLORESCENCE	957.91 LF
CRACKS WITH EFFLORESCENCE	282.84 LF
DELAMINATION / SPALLS	1.73 SF

HAIRLINE CRACKS, NO EFFLORESCENCE	2707.95 LF
CRACKS WITH EFFLORESCENCE	1414.2 LF
CRITICAL CRACKS	546.12 LF
DELAMINATION / SPALLS	8.5 SF

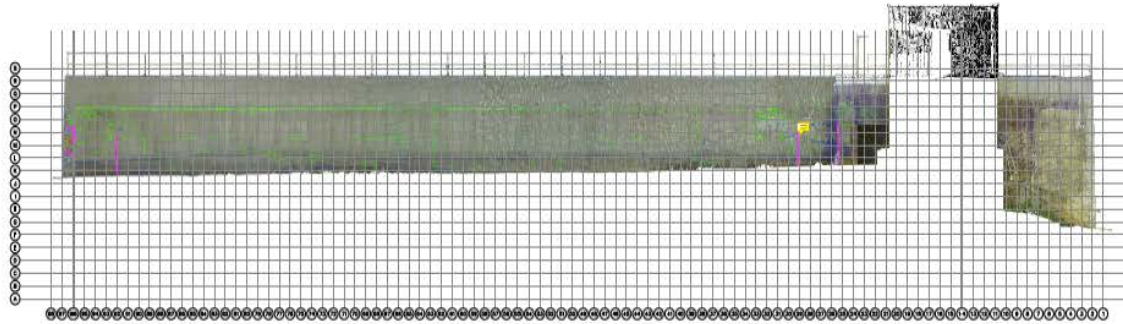
2 WEST ELEVATION
SCALE: 1" = 10'

HAIRLINE CRACKS, NO EFFLORESCENCE	286.48 LF
CRACKS WITH EFFLORESCENCE	176.72 LF
CRITICAL CRACKS	24.95 LF
DELAMINATION / SPALLS	4.26 SF
