*****ATTACHMENTS*****

CITY OF SHEBOYGAN

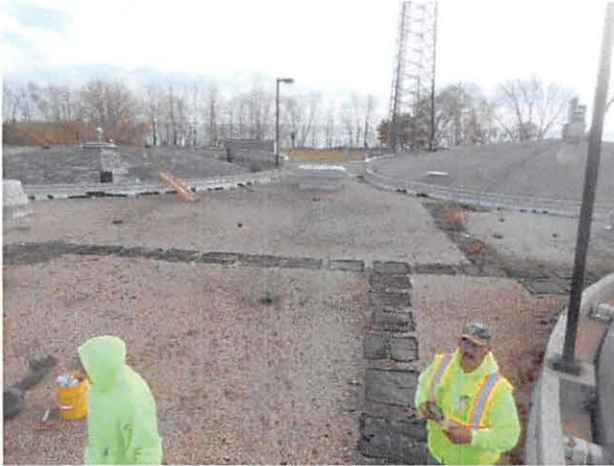
New Water Treatment Roof – Overview Photo

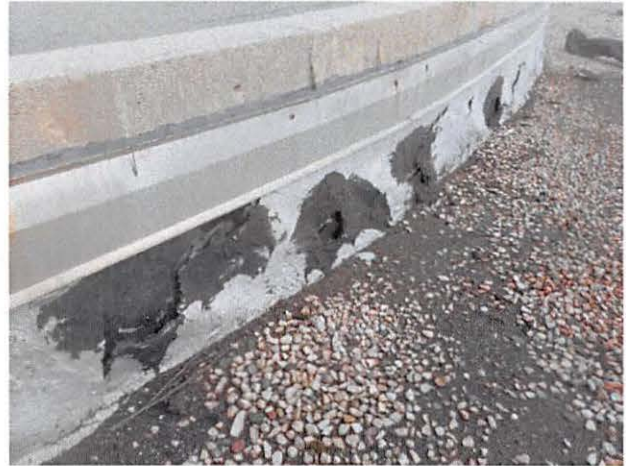
New Water Treatment Roof – Large holes in flashing around entire roof perimeter. Roof in failure mode and scheduled for replacement in 2018.

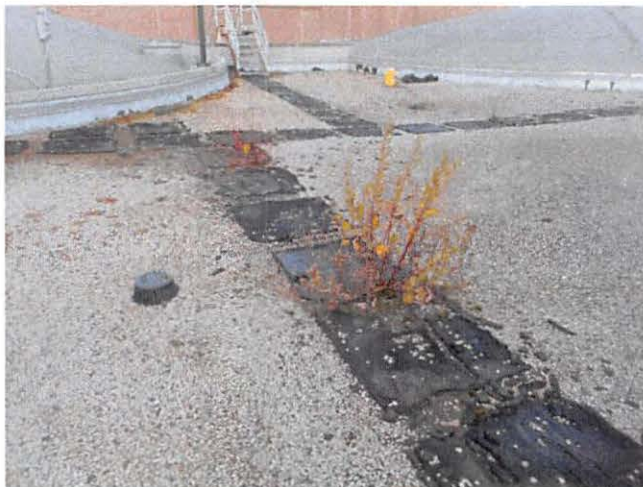
New Water Treatment Roof – Heavy vegetative growth occurring throughout roof system.

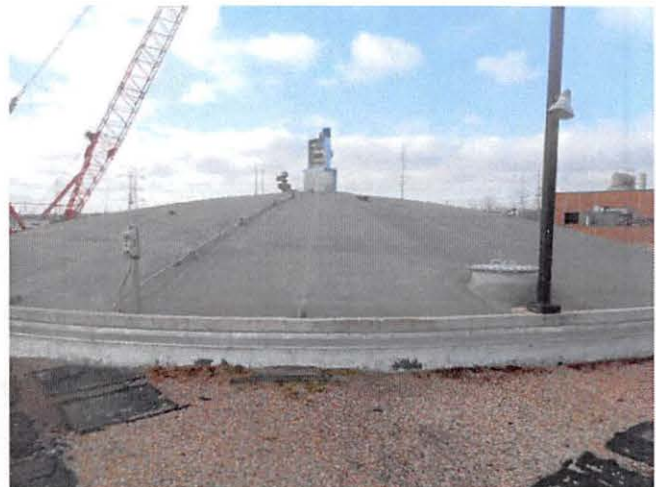
New Water Treatment Roof – 3 of 4 large digesters covered with spray foam insulation. 4th digester is bare metal. Recommend coating all 4 to prevent deterioration seen on Revised digesters.

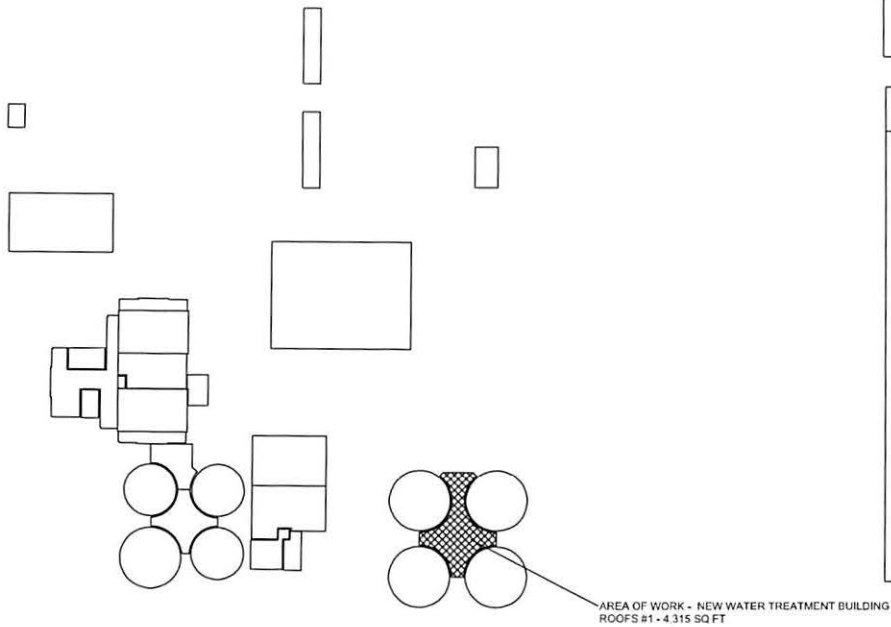
2020 ROOF REPLACEMENT PROJECT
