**National Register of Historic Places
Registration Form**

historic name Badger State Tanning Company Building
other names/site number _____

Badger State Tanning Company Building
Sheboygan, Sheboygan County, Wisconsin

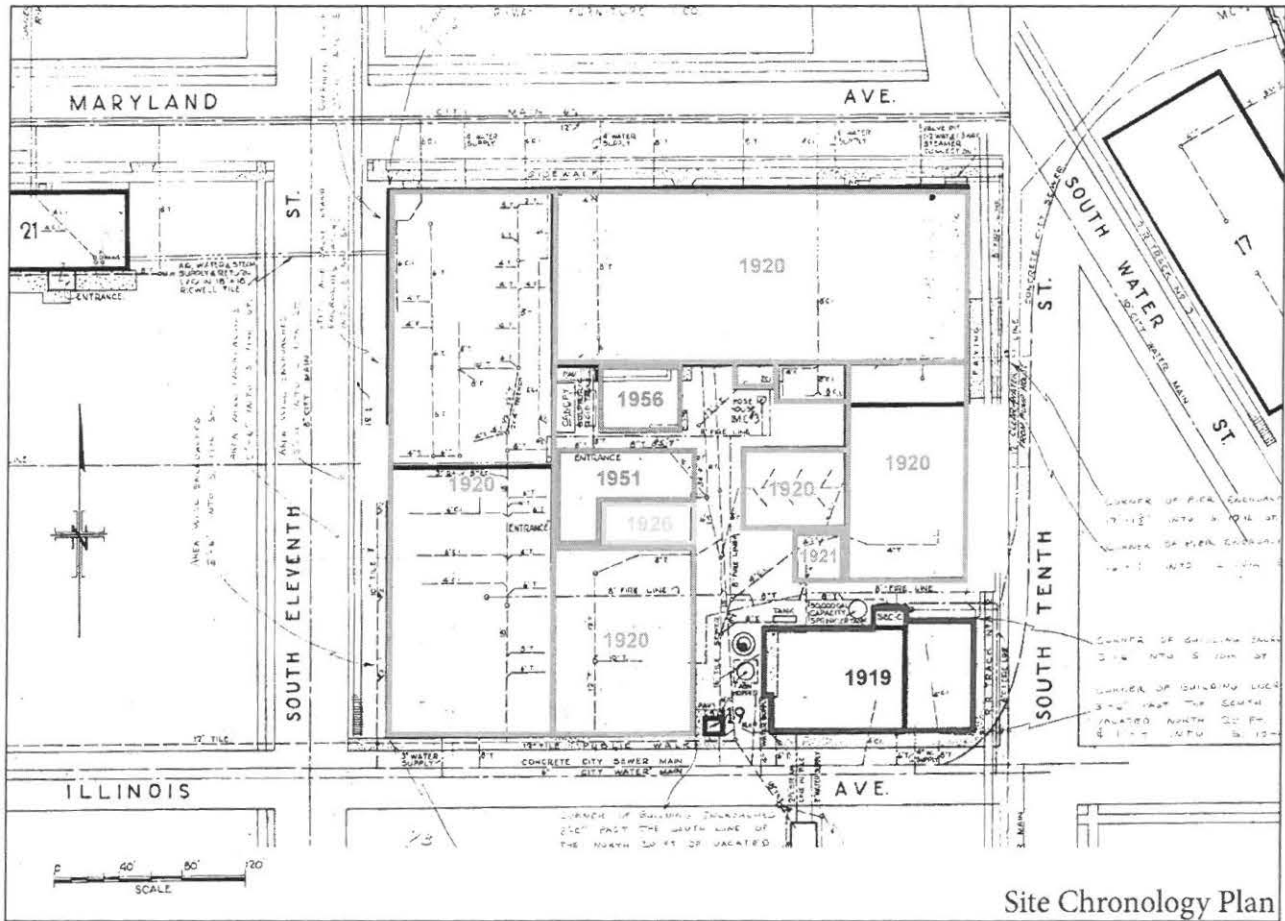
Figure 1: Chronology plan

To avoid confusion when referencing the historic plat map, the description below of the extant main plant known as the Badger State Tanning Company Building references each section by the section number that is assigned on the historic plat map. Consequently, the section numbers are not sequential.

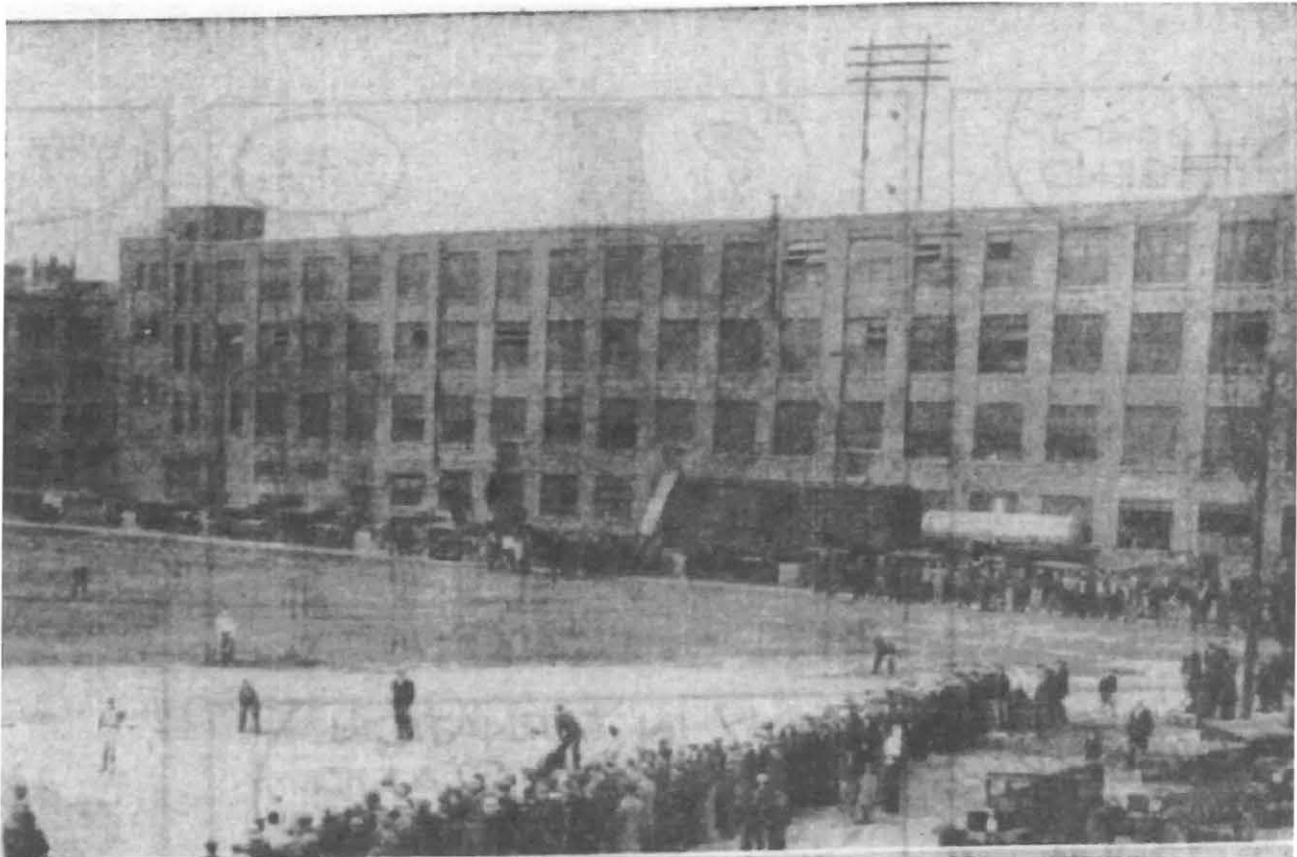
Figure 4: West elevation of main tanning building, c. 1935

Together, Sections 7 and 8 historically comprised the main tannery building where cleaned hides were processed, split, and finished. The rectilinear building is four-stories and mill-type construction with a flat roof and a fifth-floor addition at the southeast corner. All elevations are divided into repeating vertical window bays divided by shallow brick pilasters that extend from the top of the first floor and terminate with a soldier course cap just below the parapet. Corner bays feature no fenestration at the first floor and have a decorative concrete pediment set above the concrete coping; each corner thus gives the impression of a tower. The northwest and southwest corners are stair towers with no fenestration on one wall, and pairs of small window openings on the other. Pedestrian entrances with double-metal doors and a single pane transom above provide access to these stair tower. The north and south elevations are six bays wide, while the long west elevation is sixteen bays. Each bay has a single large window opening per floor, with brick lintels and concrete sills. Bays terminate below the parapet with corbeled brick.

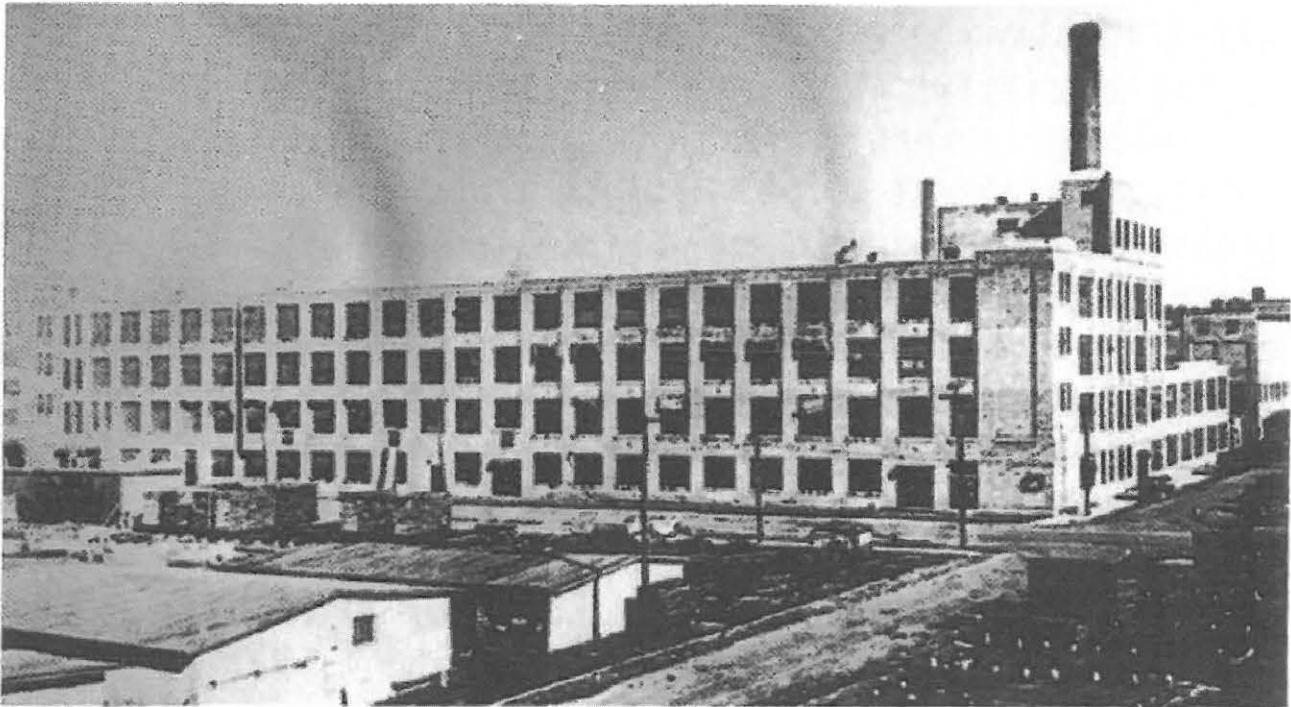
Figure 5: West and south elevations of building, c. 1950s

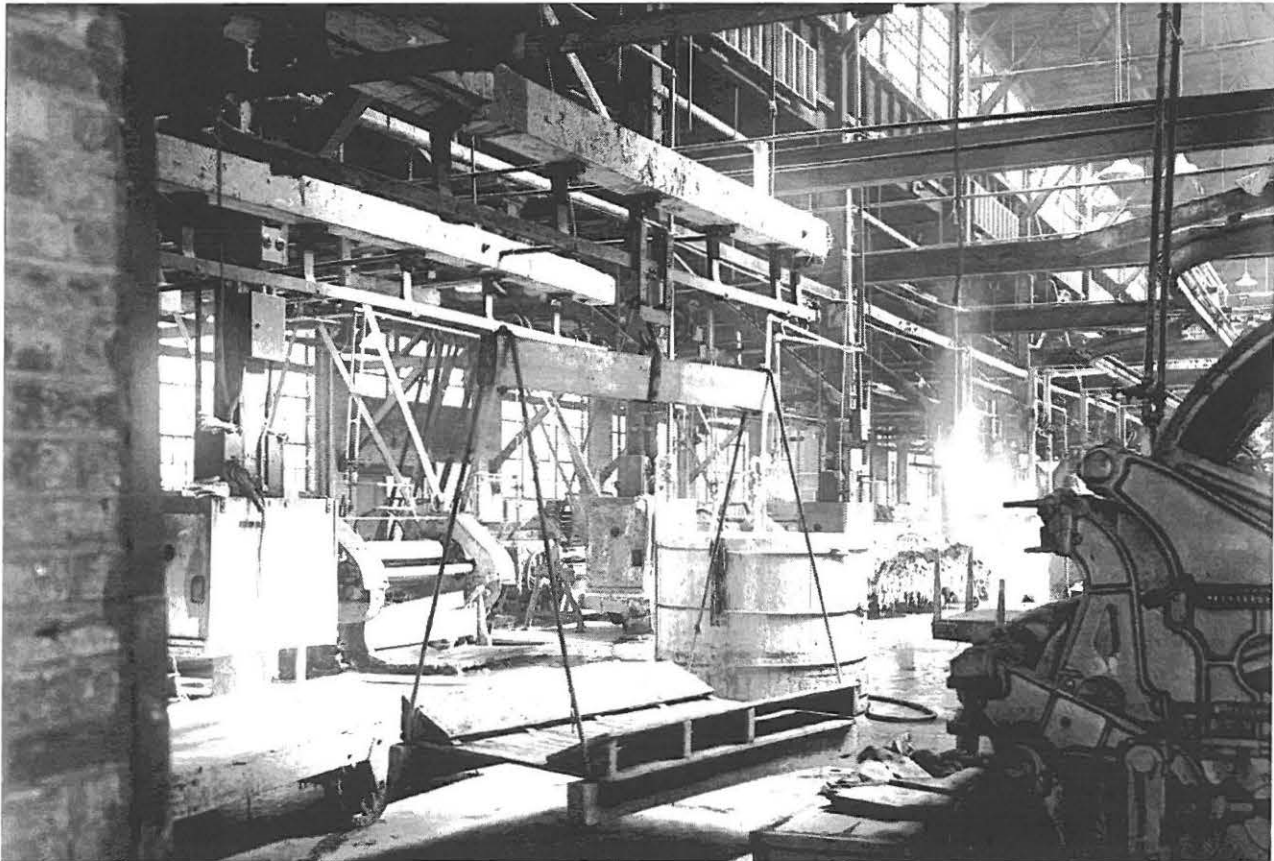
Figure 5: Interior of Beam and Wash House (Section 4), 1932

Completed in July 1920, the Beam and Wash House (Section 4) was one of the first buildings in the tannery to be built. The building runs along Maryland Avenue, with a two-story western half and single-story eastern half. Exterior walls are brick with concrete foundations and are regularly fenestrated primarily with large window openings with brick lintels and concrete sills, all of which have been infilled with glass block. Both roofs are flat, but the eastern roof features a raised central clerestory section clad in non-historic fiberglass panels, with original multi-paned wood windows intact and visible from the interior.

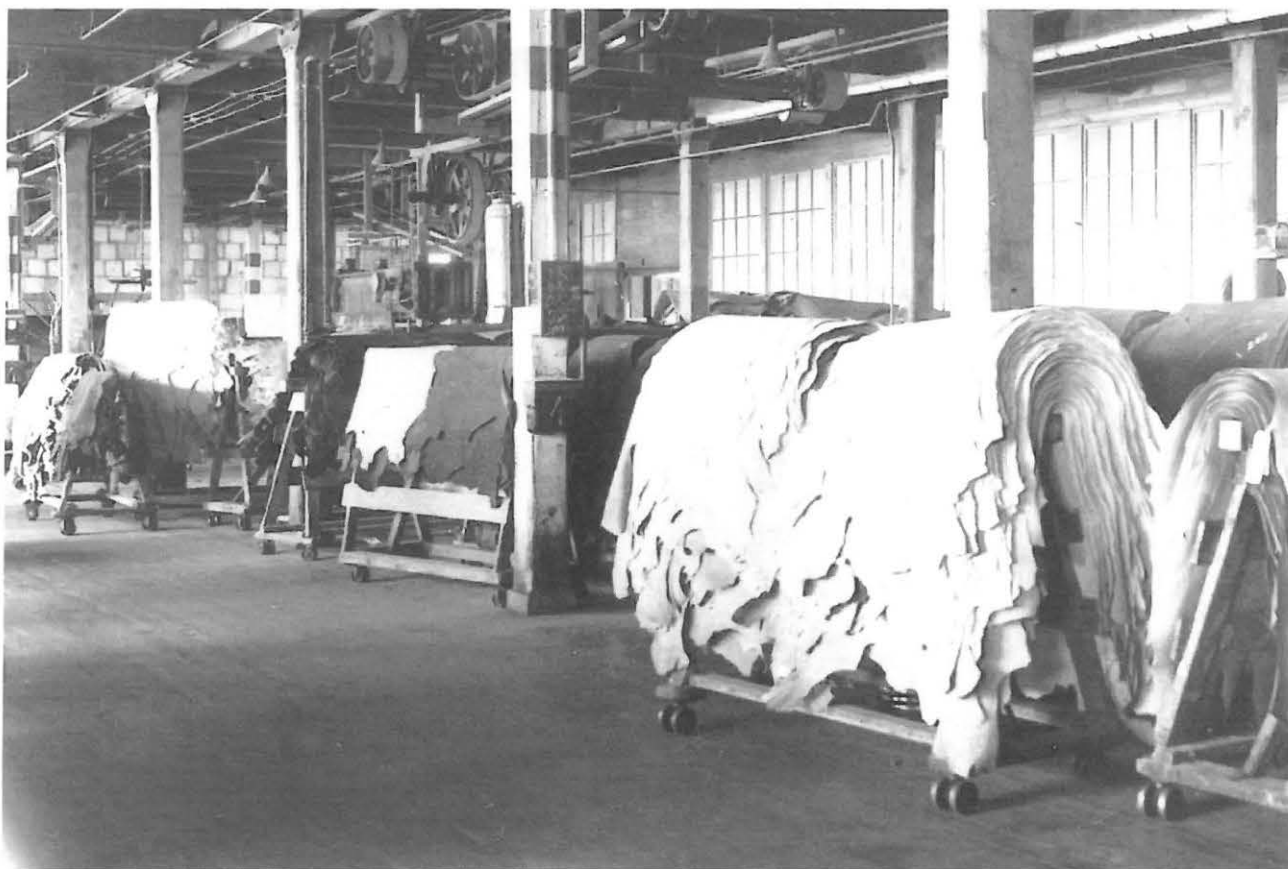
Figure 7: Interior of main tanning sections (Sections 7 and 8), 1932

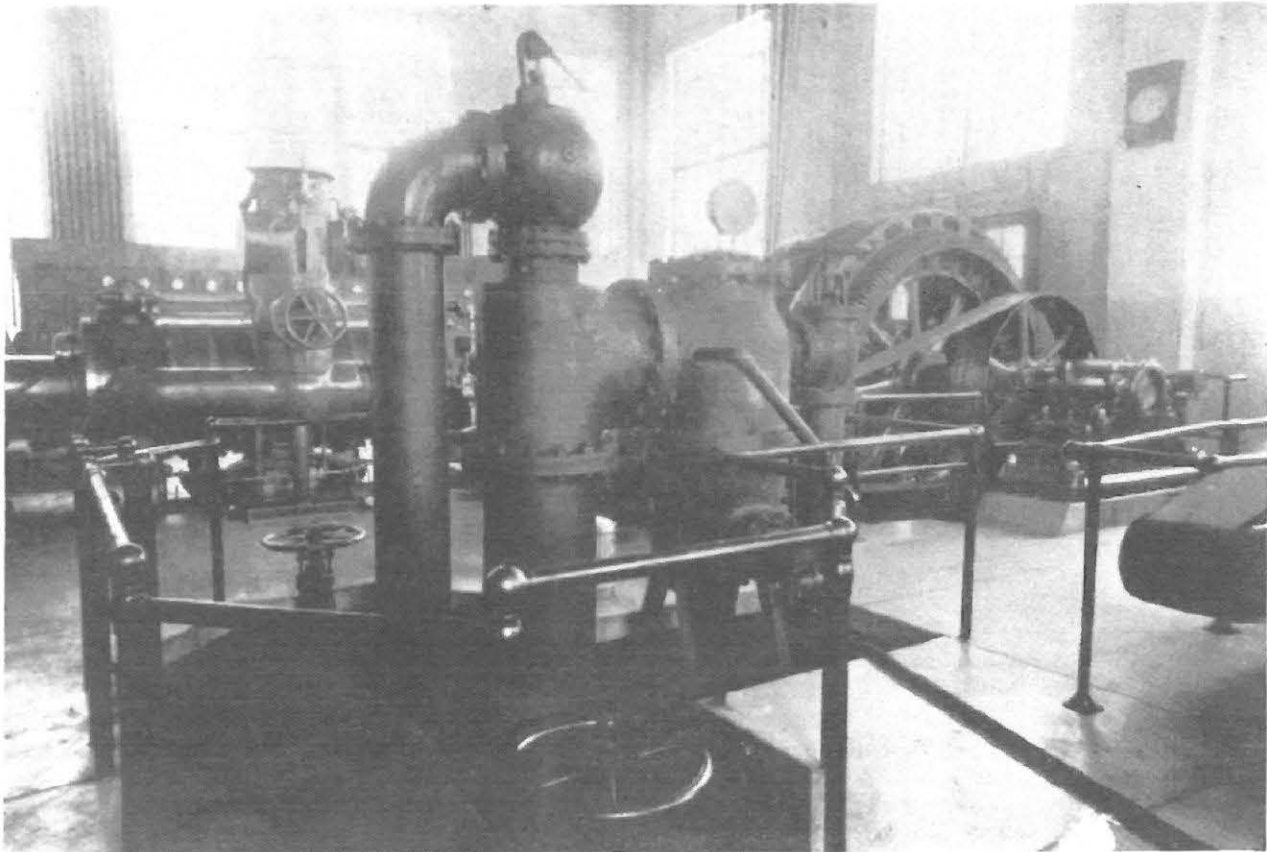
Figure 8: Interior of Engine Room (Section 1), 1922 (*Power Plant Engineering*, June 1, 1922)

FIG. 1. VIEW OF THE ENGINE ROOM SHOWING THE JET CONDENSER IN THE FOREGROUND, WHICH MAY BE USED WITH EITHER ONE OF THE TWO ENGINES

rectangular footprint and is divided into three main sections: the west two-thirds held three large coal-feed boilers and a coal bunker, which supplied steam to the factory and drove a pair of large generators in the adjacent engine house.

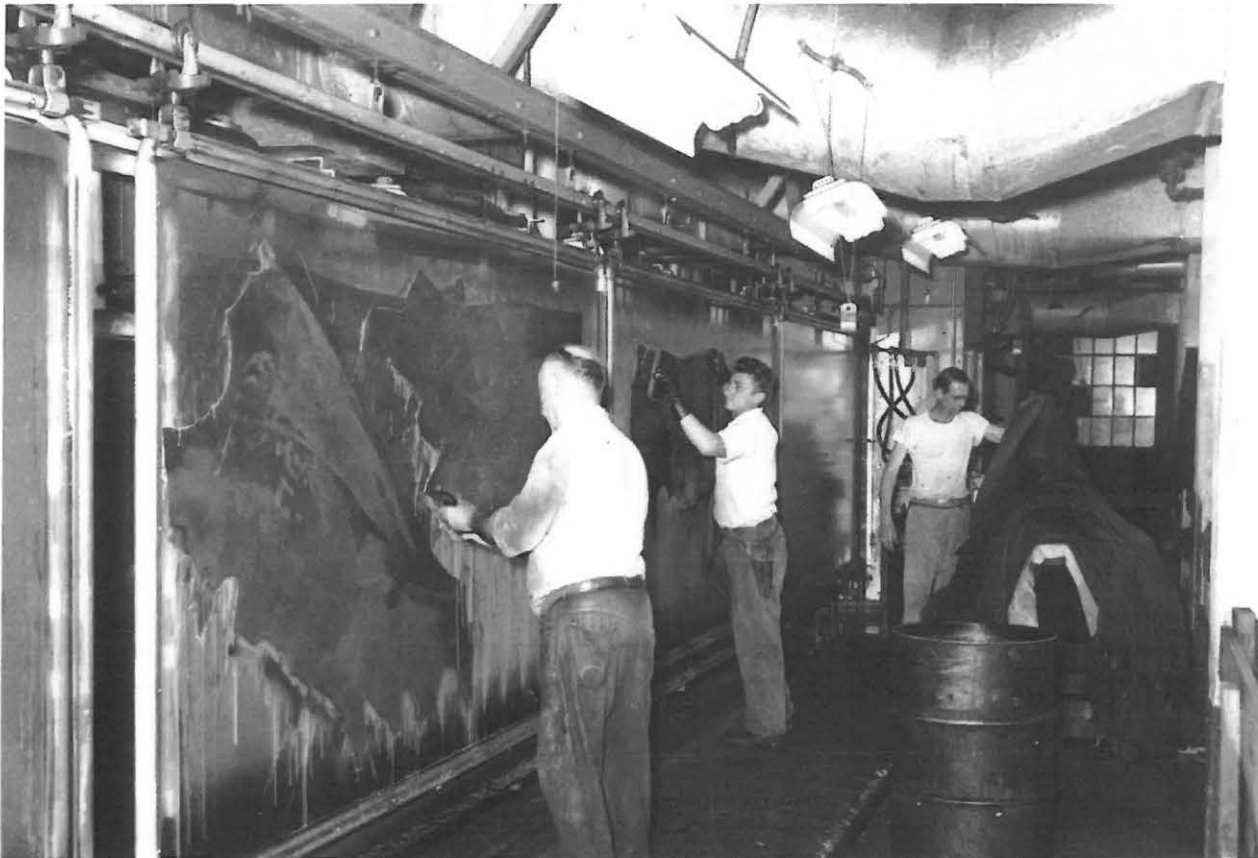
Figure 9: Interior of main tanning sections (Sections 7 and 8), scraping hides, 1957

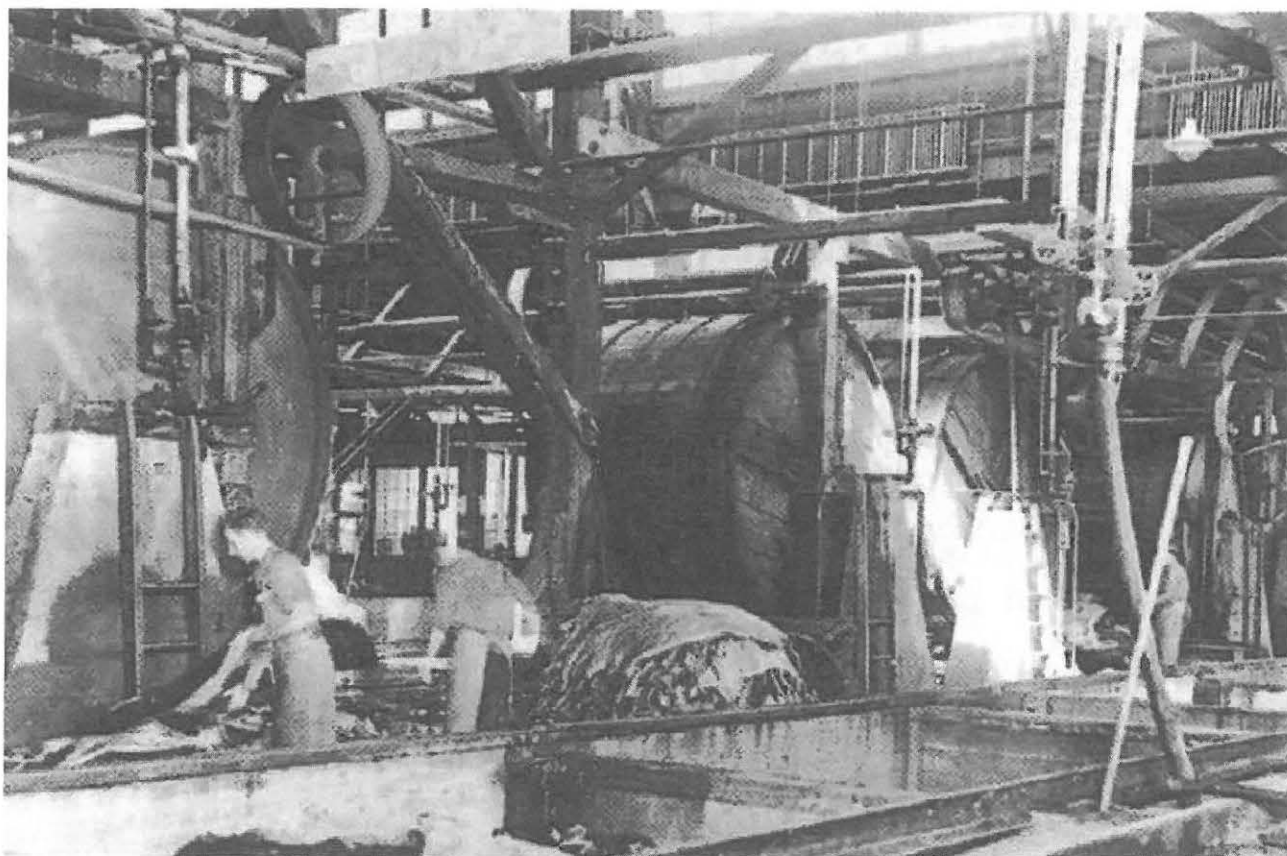
Figure 10: Interior of Beam and Wash House (Section 4), c. 1960s
