ITEM DESCRIPTION: 2018 Fire Department Capital Budget Station Repairs

May 29, 2015
ZS Project No. 7402

Subject: **Fire Station 1 Condition Assessment FINAL Report
833 New York Avenue, Sheboygan, Wisconsin**

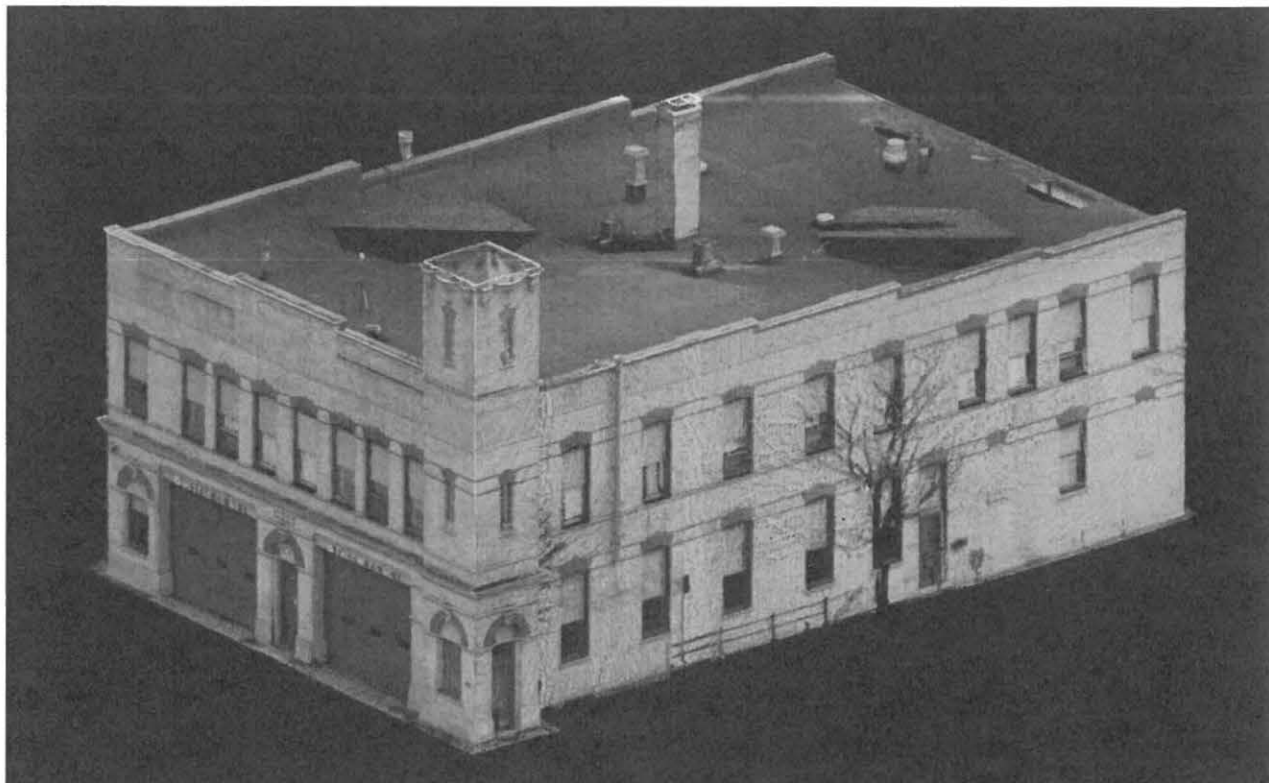
Figure 3: Sheboygan Fire Station No. 1 colorized 3D laser scan image.

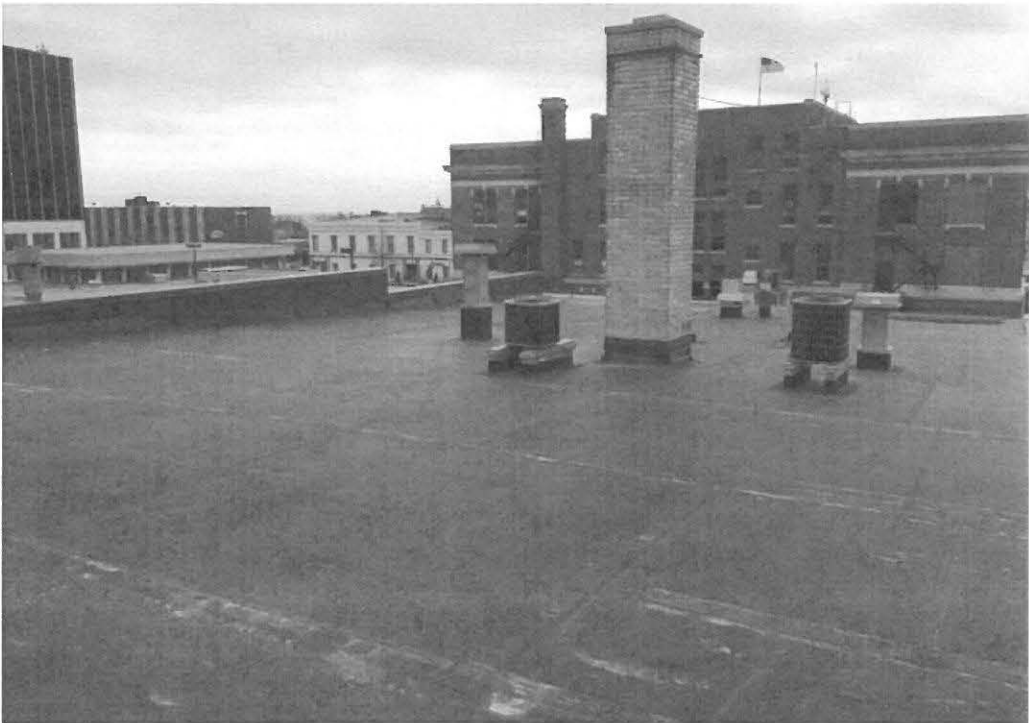
Description: Fully adhered EPDM roof system (Figure 8).

Figure 8: Full adhered EPDM roof system.

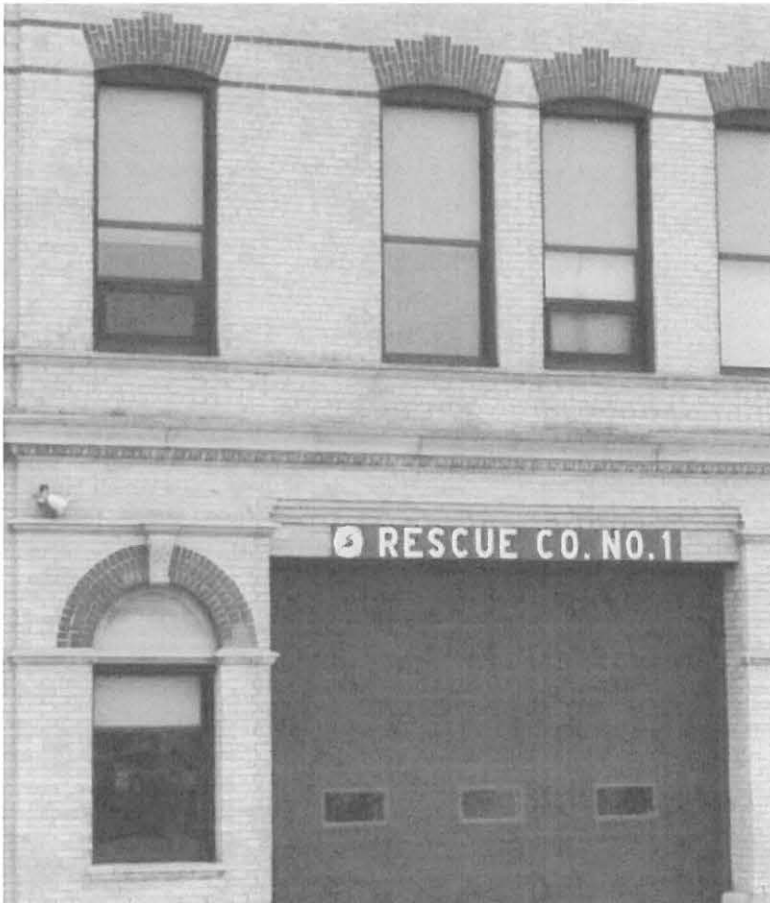
Description: The windows throughout the building are mill finish aluminum frame systems, consisting of synthetic material panels at the upper sashes and clear insulated glass at the lower sashes (Figure 20). The interior wood frames are original construction, and were refinished in the 1990's. There is a hose tower on the northwest corner of the building that includes non-original glass block units within window openings.

Figure 20: Typical window systems.

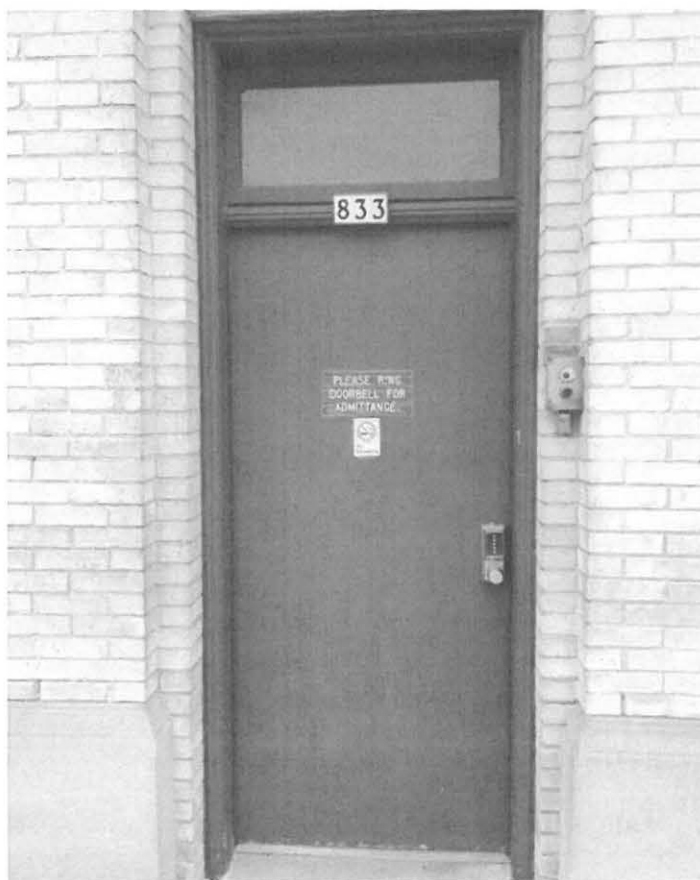
Description: The storefront entrance assemblies are mill finish aluminum frame systems with clear single pane glazing (Figure 22). Two original wood doors are located on the west facade. Two sets of metal clad wood framed french doors with transom windows are present on the south facade.

Figure 22: Typical entrance door system.

Repair/Timeframe: Replace doors on west facade (0-1 years).
