Sheboygan City Hall - Sheboygan, WI
 Part I Space List Summary
 March 27, 2006 - updated June 2015

Condition Assessment Report-DRAFT

Subject: **City Hall Property Condition Assessment DRAFT Report
828 Center Avenue, Sheboygan, Wisconsin**

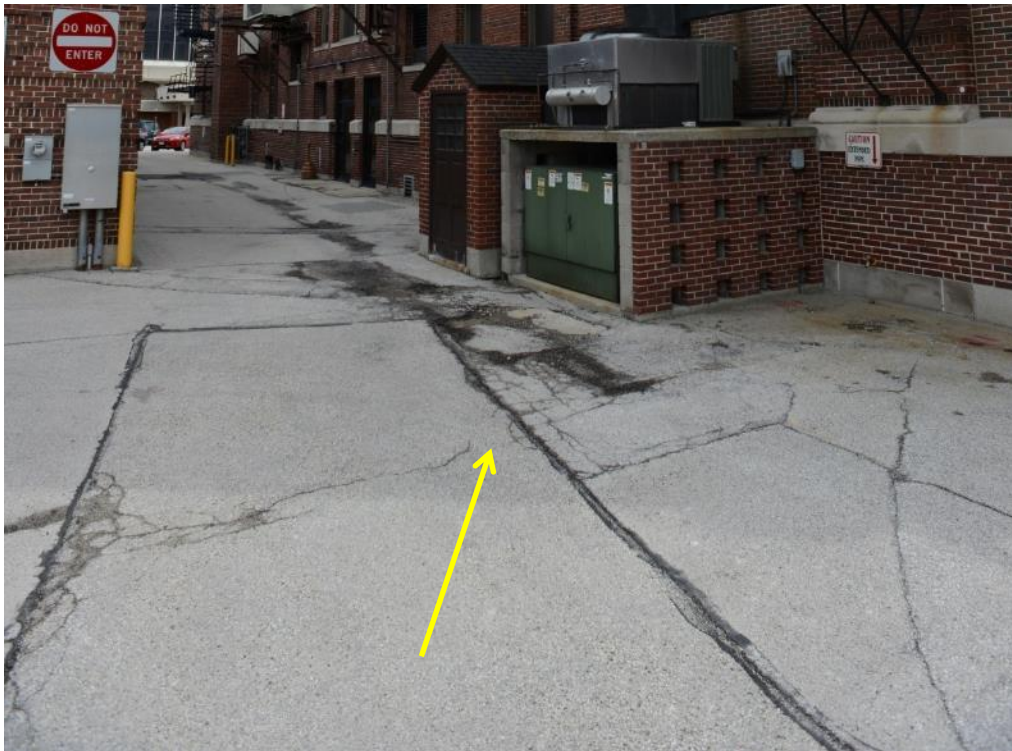
- b. Deteriorating asphalt alley driveway (Figure 13).

Figure 13: Deteriorating asphalt pavement at alley, north elevation

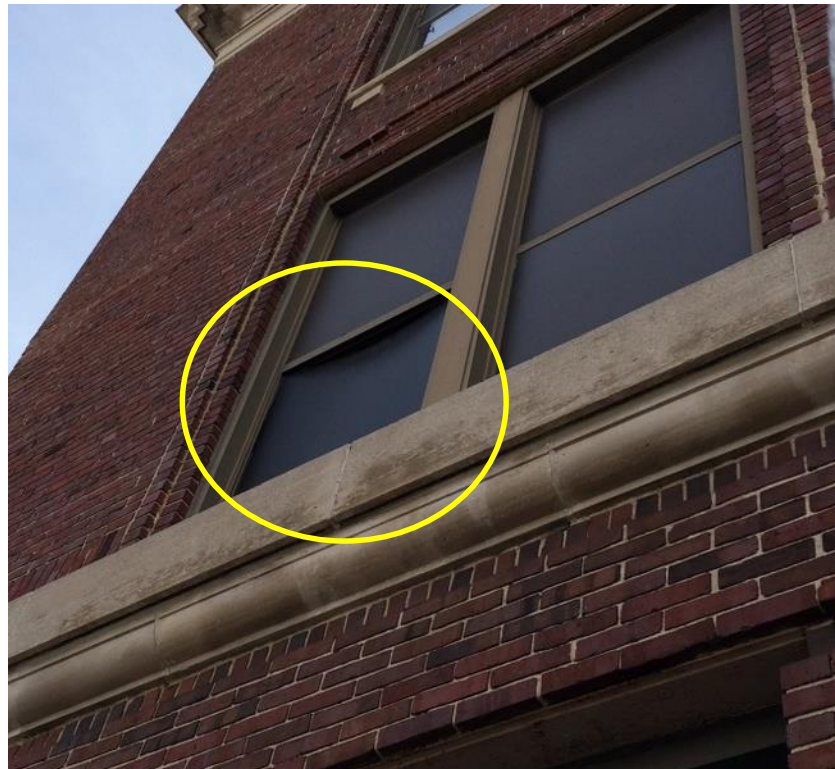
- c. Detached opaque window panel on the west facade (Figure 32).

Figure 32: Detached window panel on west facade.

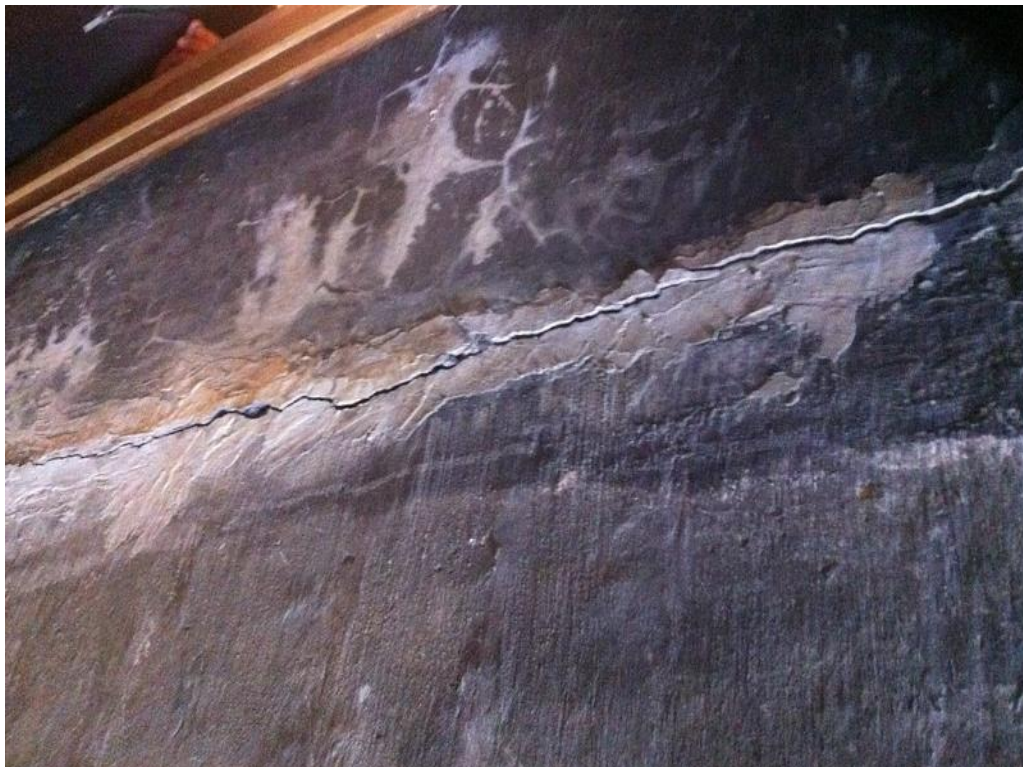
Figure 62: Foundation cracking in north basement exit stairwell

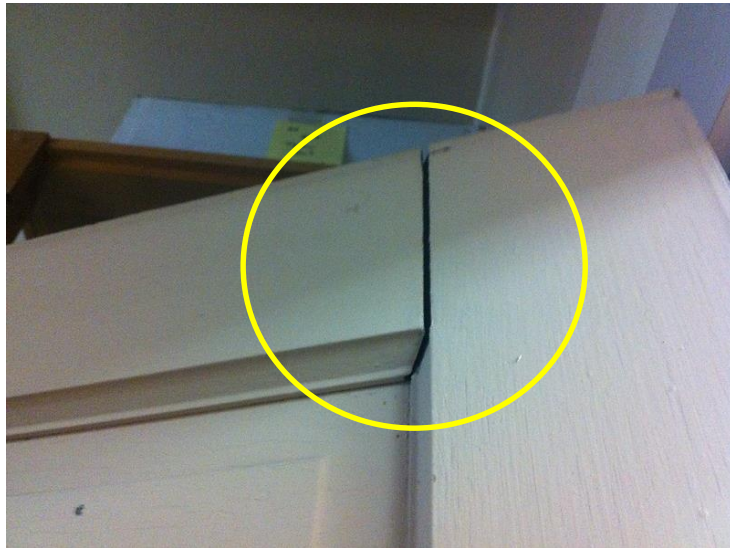
Figure 67: Door separating at joint

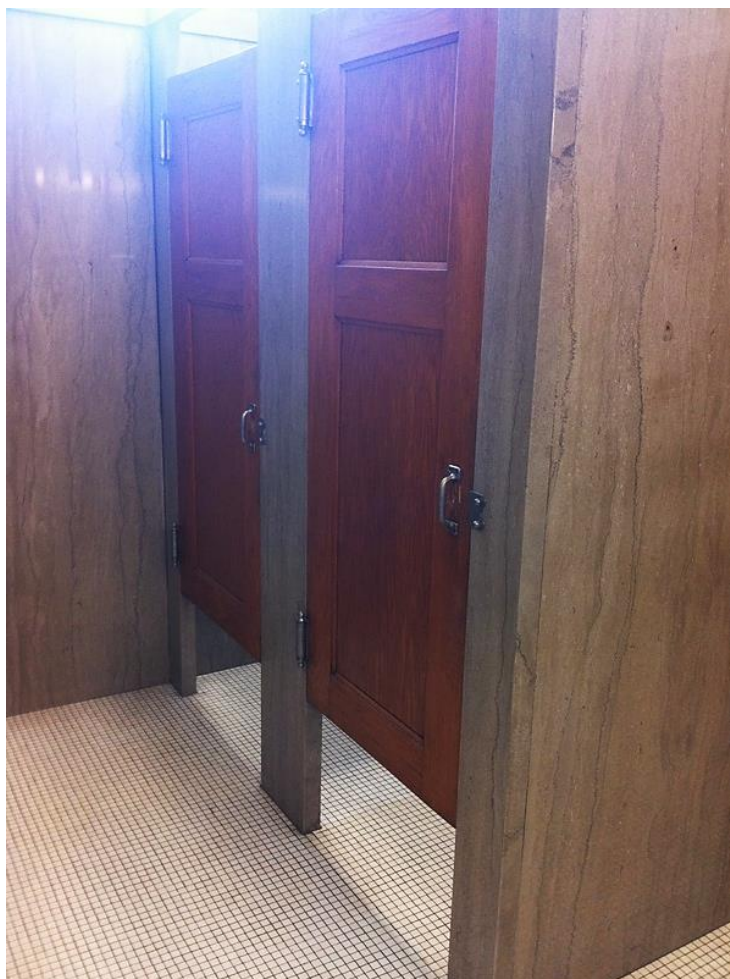
Figure 68: Second floor women's restroom, not ADA accessible

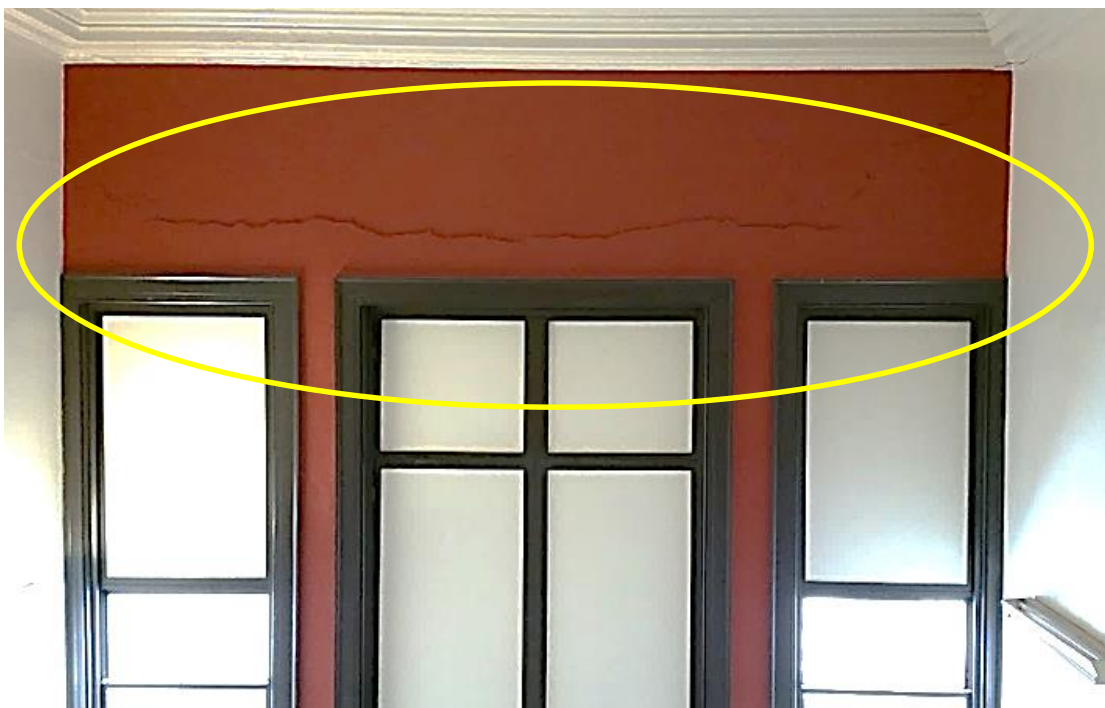
Figure 70: Significant wall cracking in stairwell at fourth floor on north facade

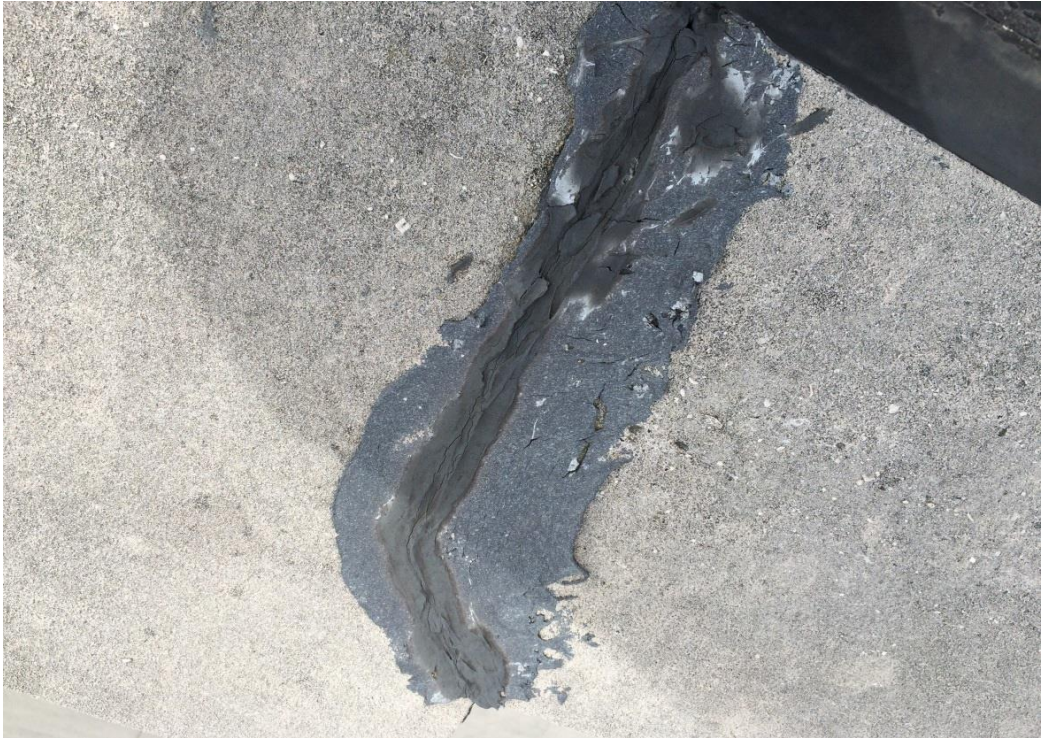
- a. Deteriorated stone coping sealant at all locations (Figure 9).
Repair/Timeframe: Remove all existing stone coping sealant and replace with new sealant (1-3 years).

Figure 9: Deteriorated stone coping sealant.

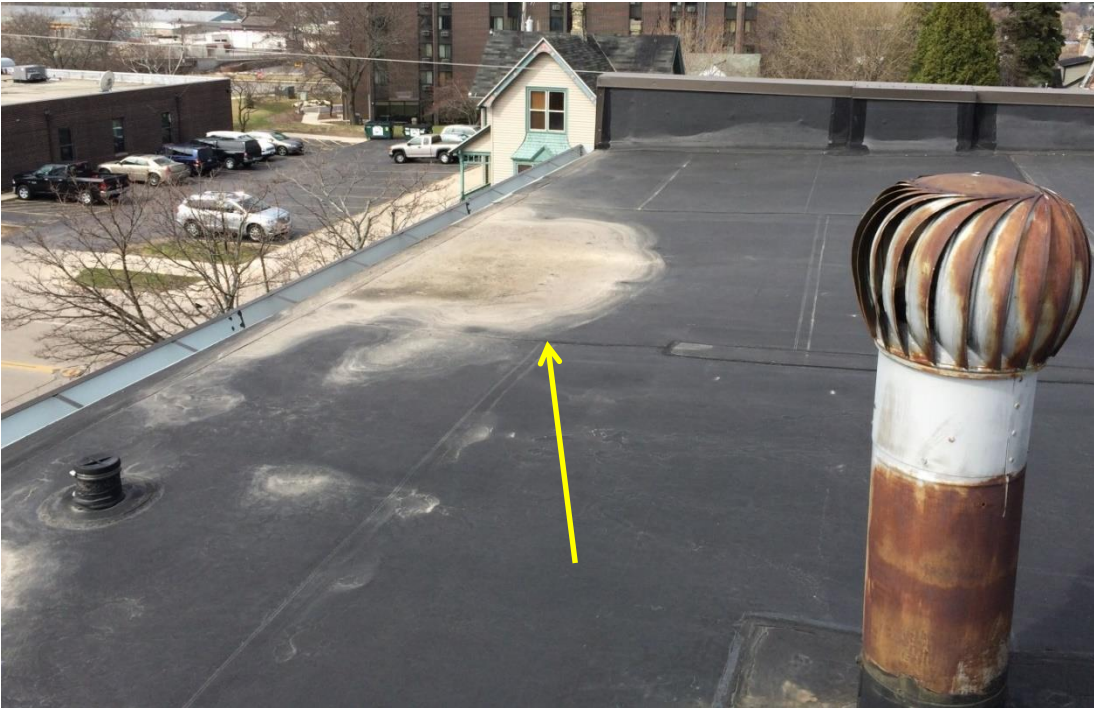
- i. Dirt buildup observed indicating water ponding at south roof edge (Figure 18).
Repair/Timeframe: Adjust roof slope to achieve positive slope to drain during roof replacement (1-3 years).

Figure 18: Ponding at south roof edge.

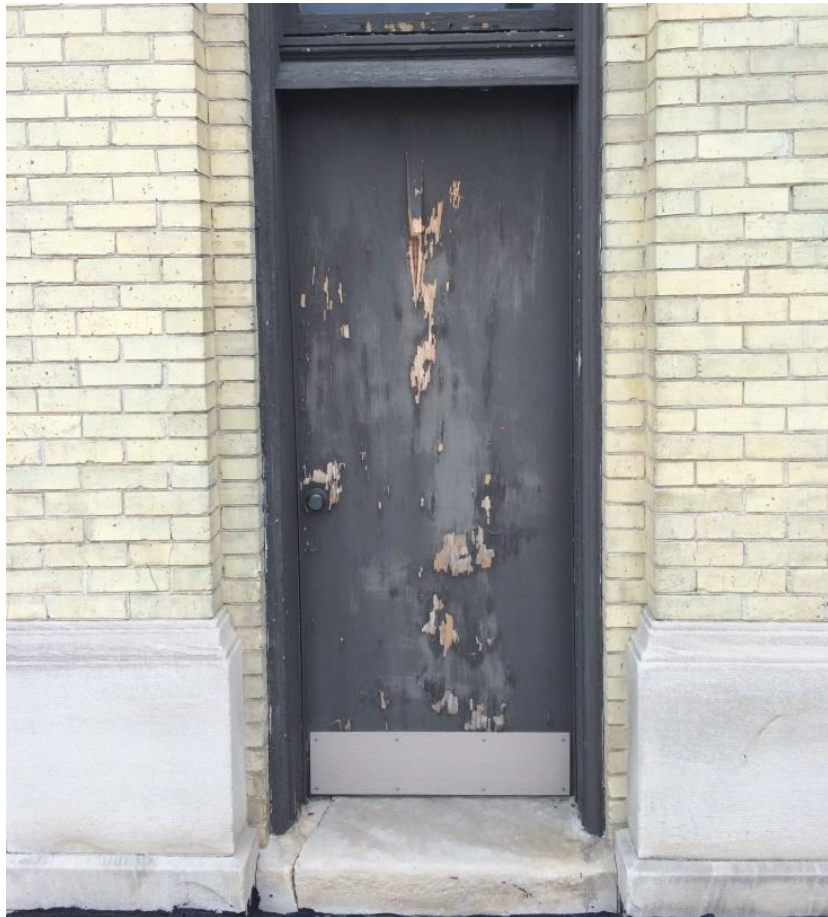
- a. West facade wood doors in extremely poor condition (Figure 23).

Figure 23: Deteriorating wood door.

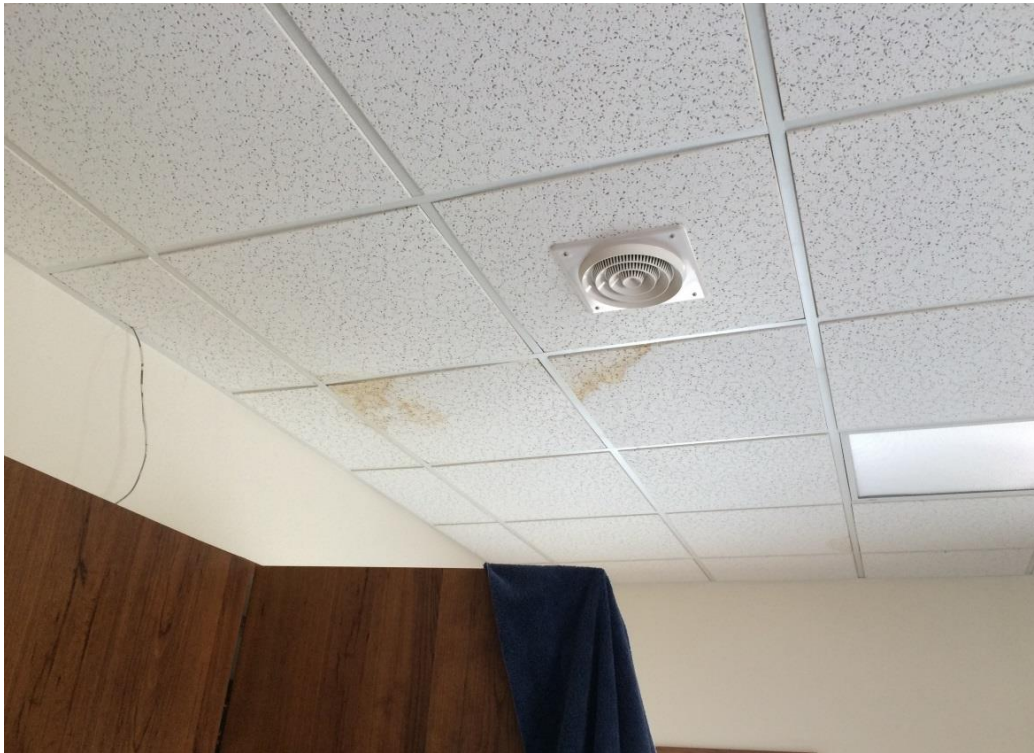
Figure 47: Stained ceiling tiles.

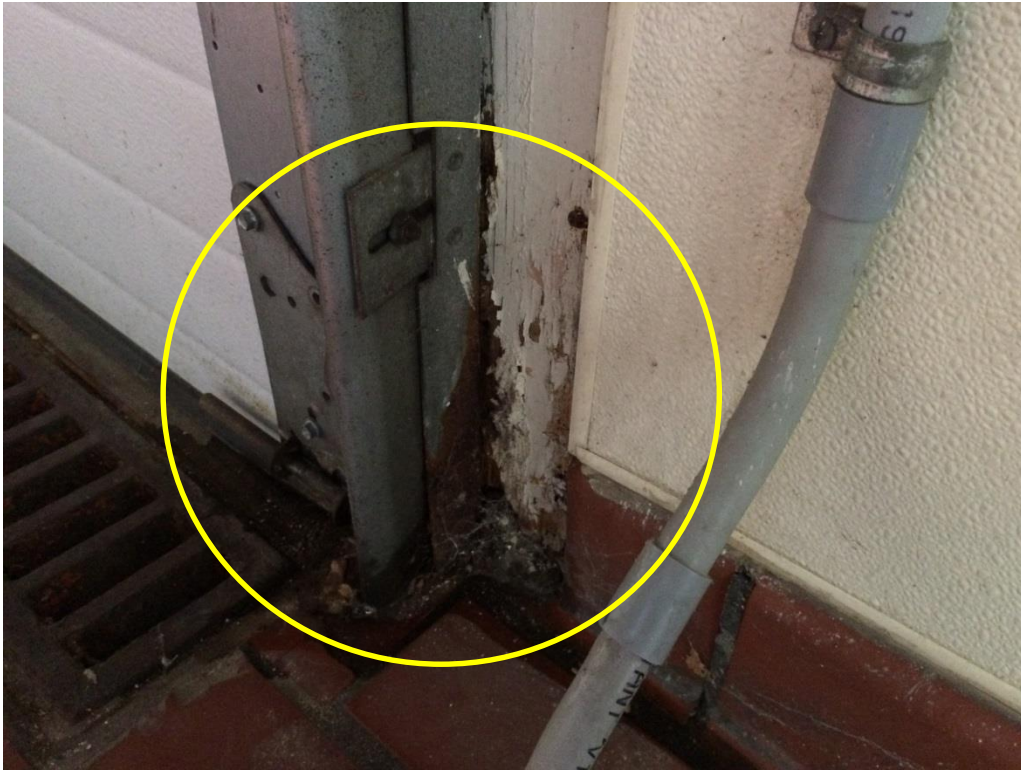
Figure 49: Deterioration of wood trim at garage door.

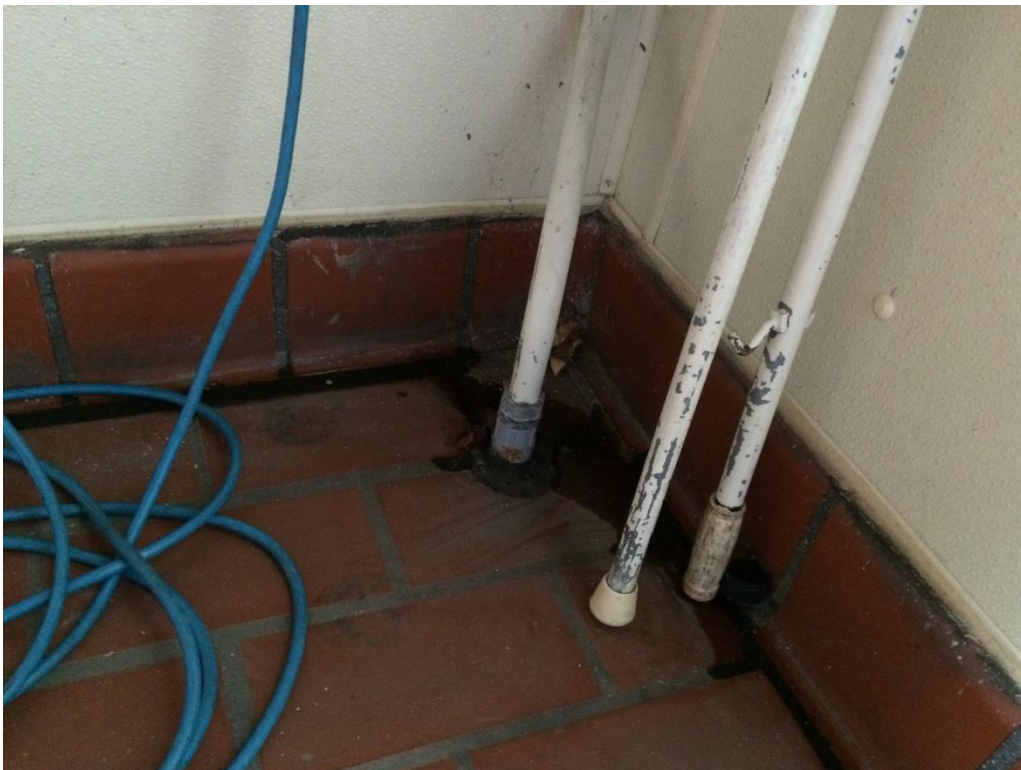
Figure 50: Unsealed penetrations allowing leaking into basement.

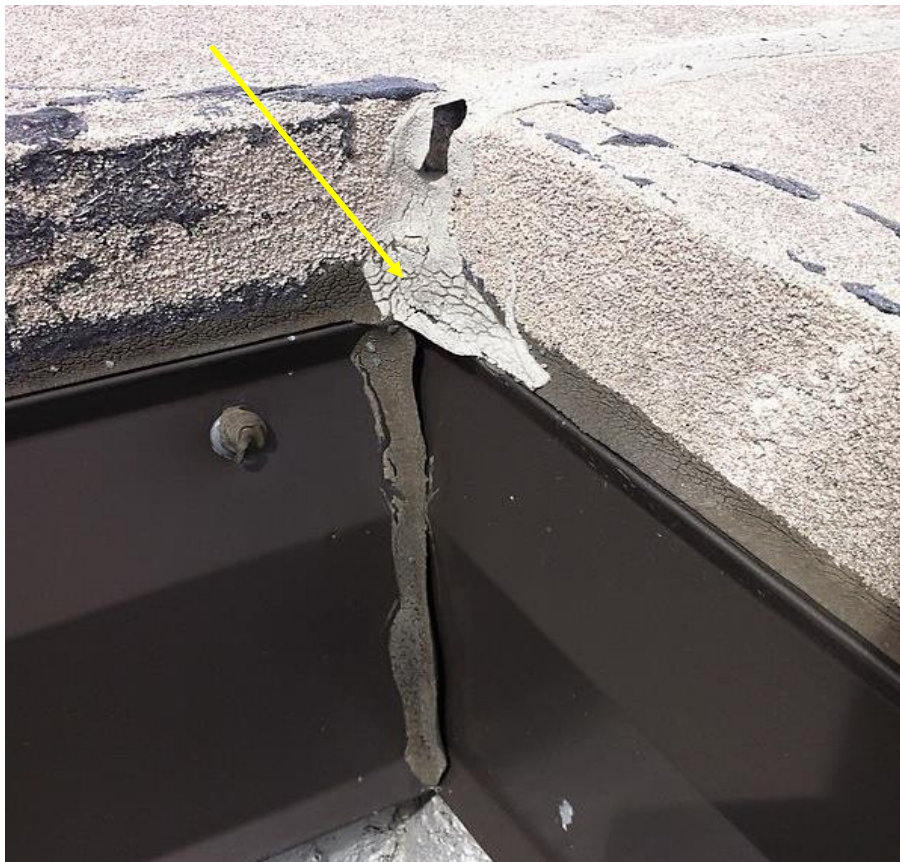
Figure 12: Open sealant joint at top of counter flashing.

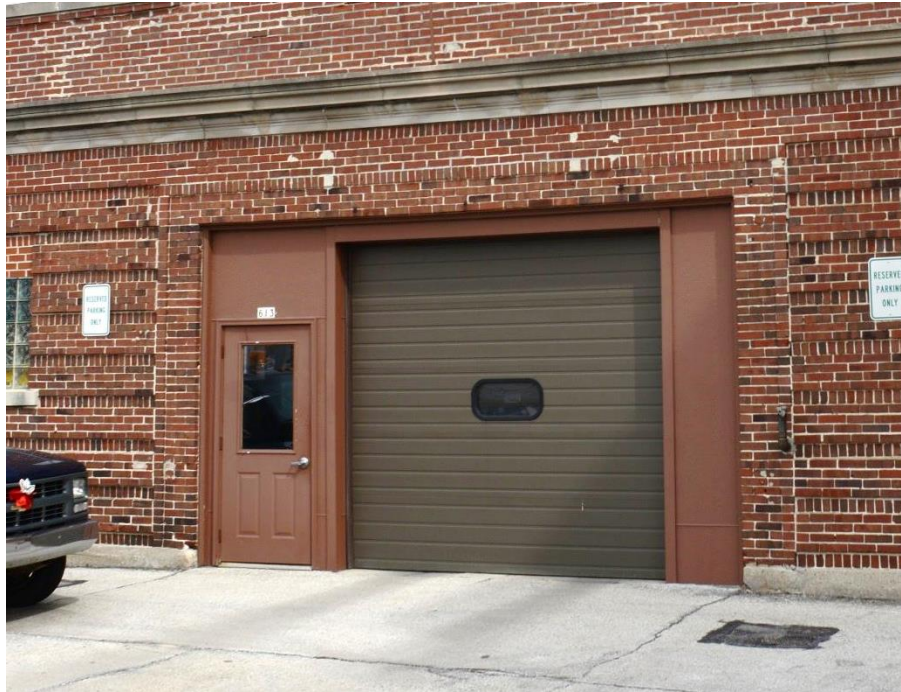
Description: The entrance assemblies are aluminum frame systems with clear single pane glazing, as well as automatic overhead garage door systems. The individual entrance doors and overhead garage doors are all in overall good condition (Figures 19 - 21).

Figure 19: West facade doors.

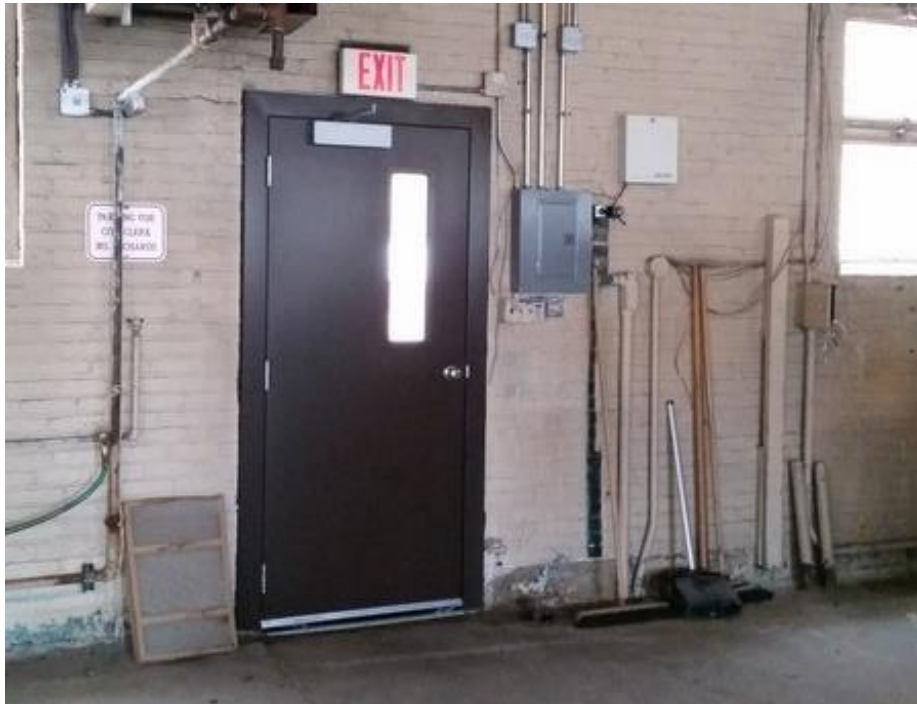
Figure 21: Interior view of south facade access door.

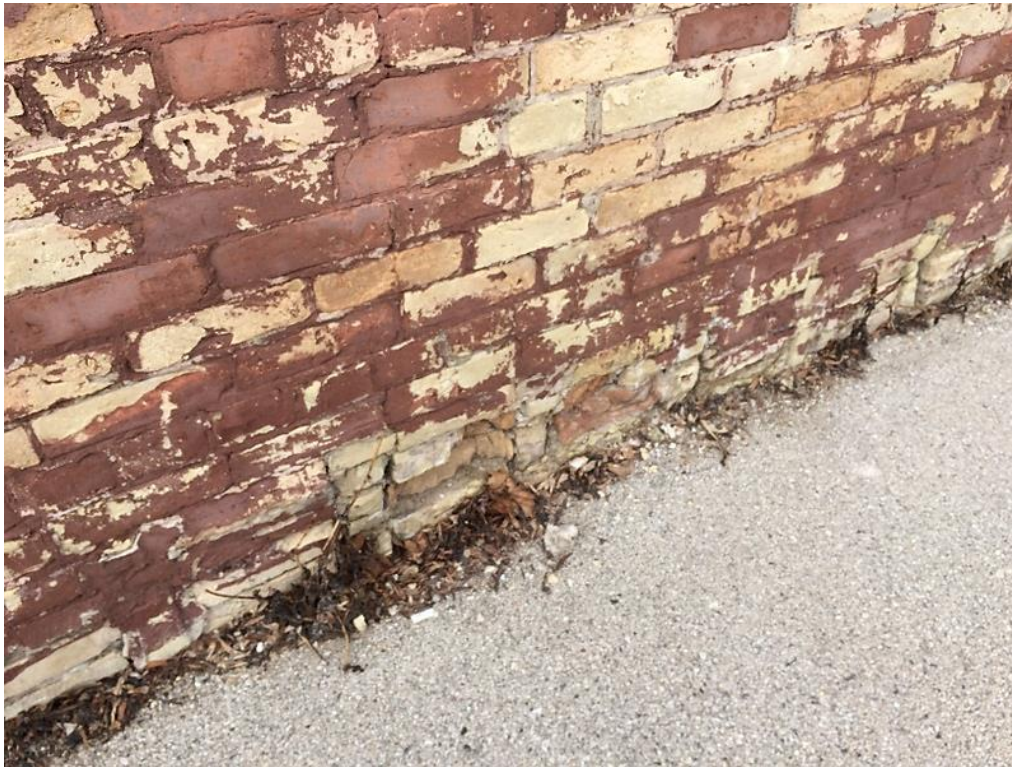
- a. Significant brick and mortar deterioration (Figures 22 - 24).

Figure 23: Deteriorated mortar joints.

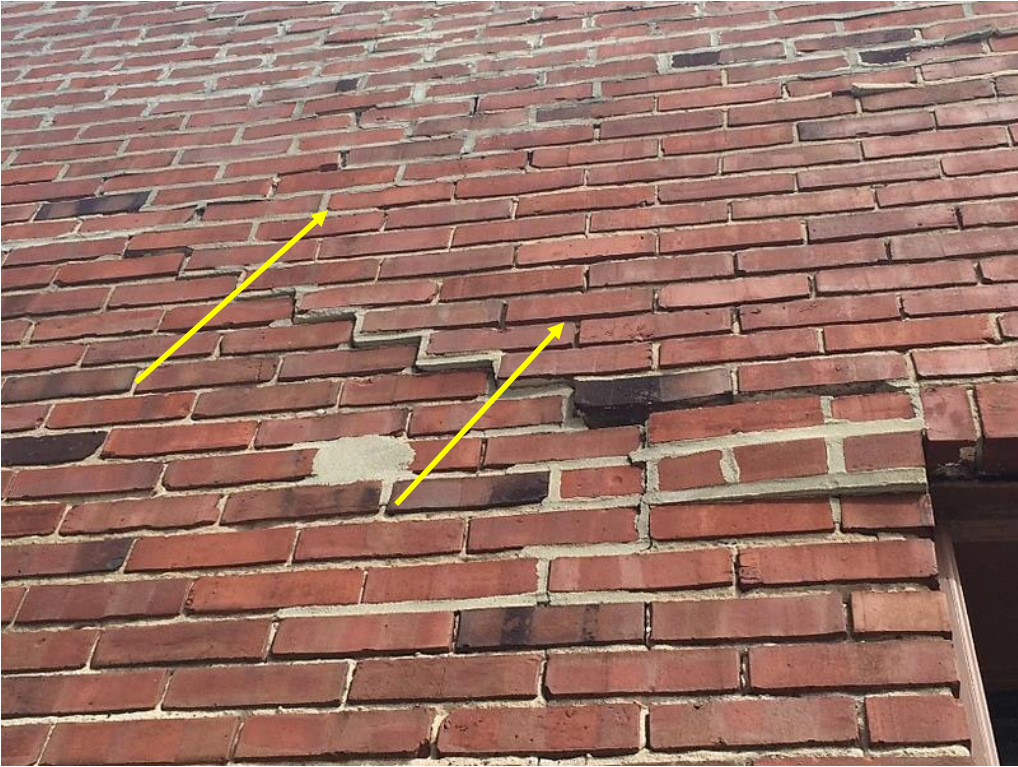
- b. Out of plane movement (Figure 25).

Figure 25: Out of plane brick movement.

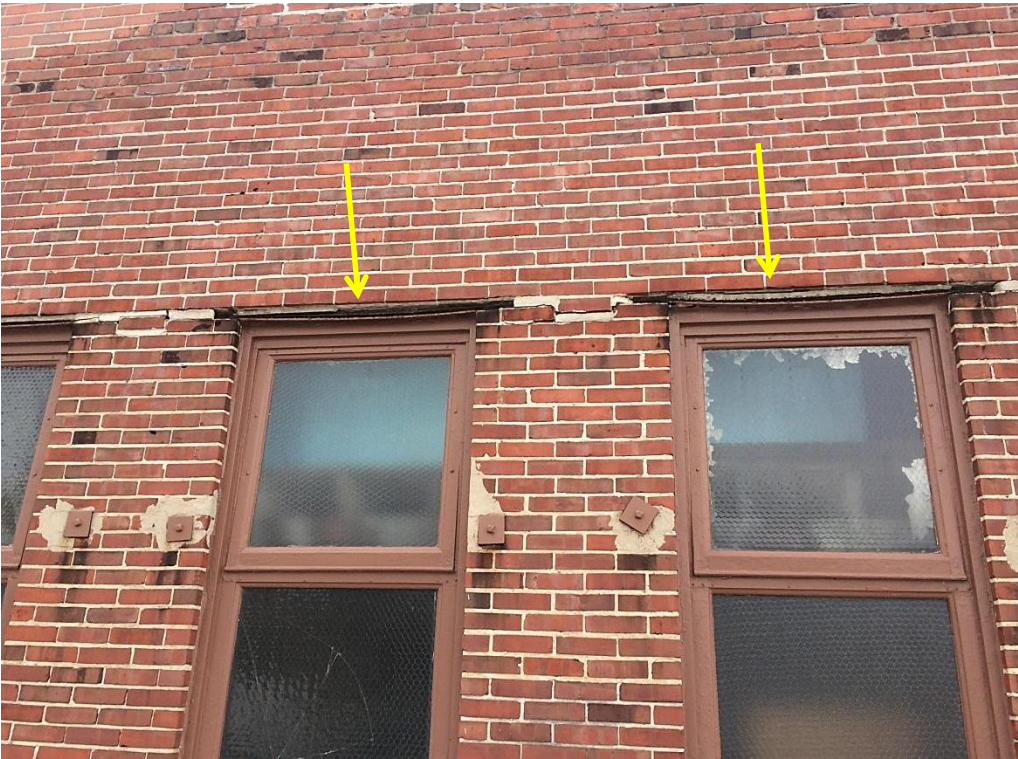
- c. Corroded window and door steel lintels with rust jacking causing brick masonry out of plane movement (Figures 26 - 29).

Figure 26: Corroded steel window lintels.

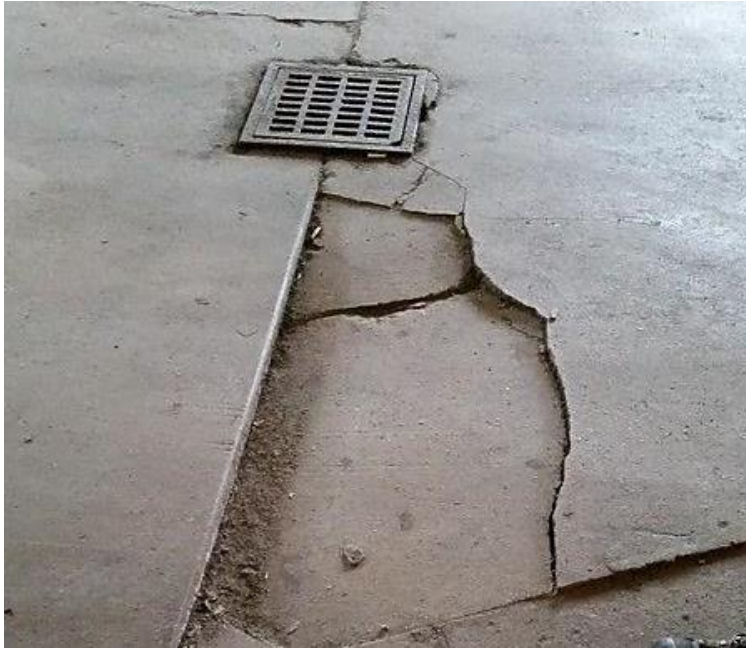
- e. Concrete floor cracking and deterioration (Figure 35 & 36).

Figure 35: Concrete floor cracking.

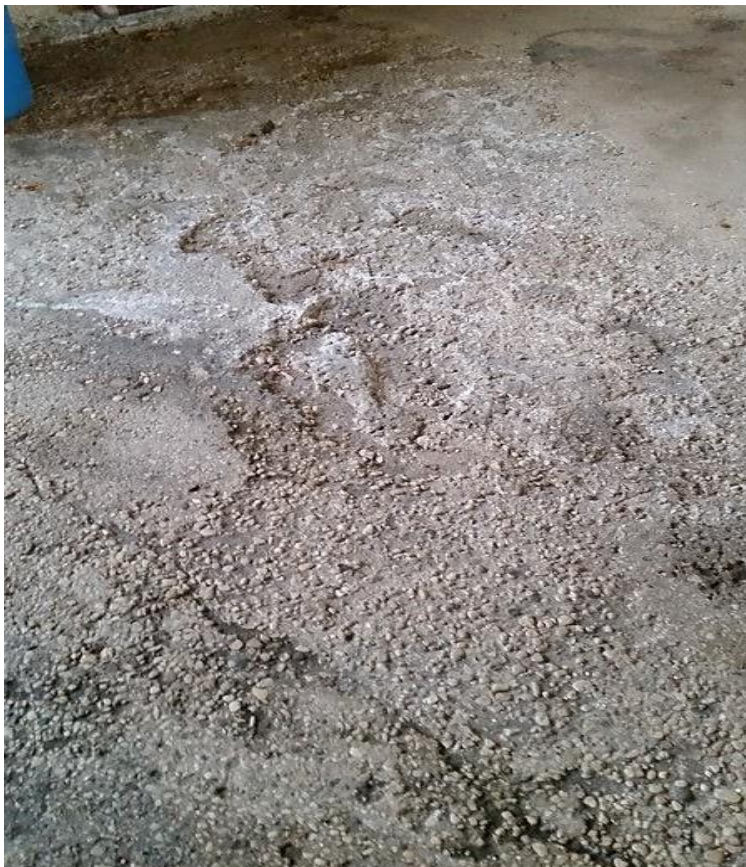
Figure 36: Deteriorating concrete floor.
