Sheboygan City Hall - Sheboygan, WI
 Part I Space List Summary
 March 27, 2006 - updated June 2015

Condition Assessment Report-DRAFT

Subject: **City Hall Property Condition Assessment DRAFT Report
828 Center Avenue, Sheboygan, Wisconsin**

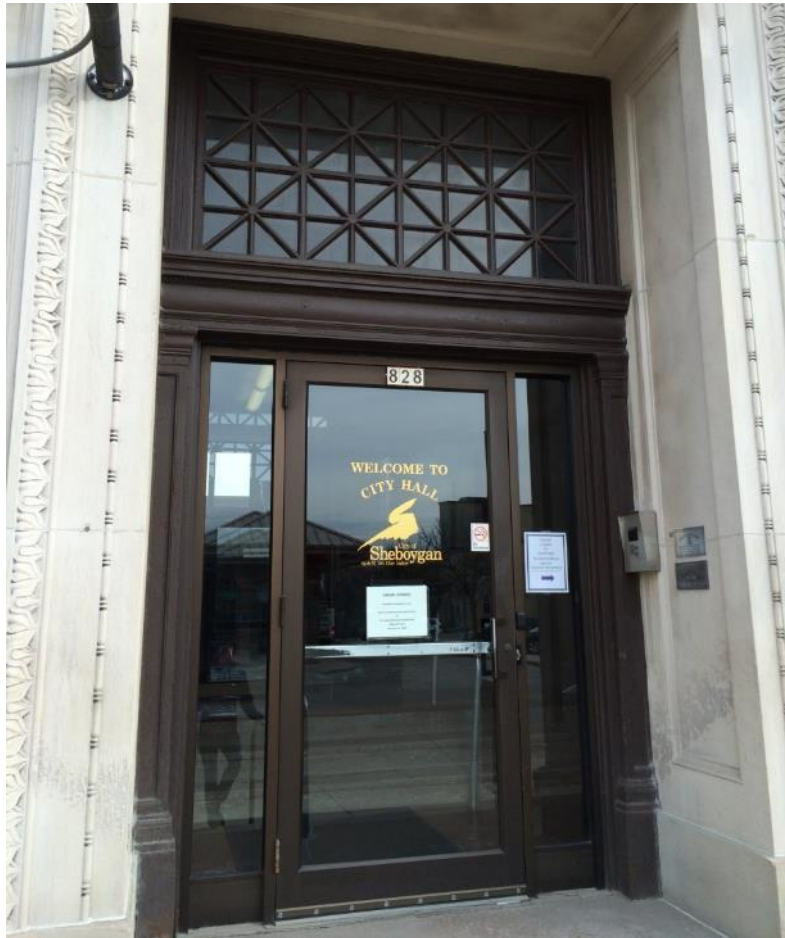
Figure 32: Main entrance door, south facade

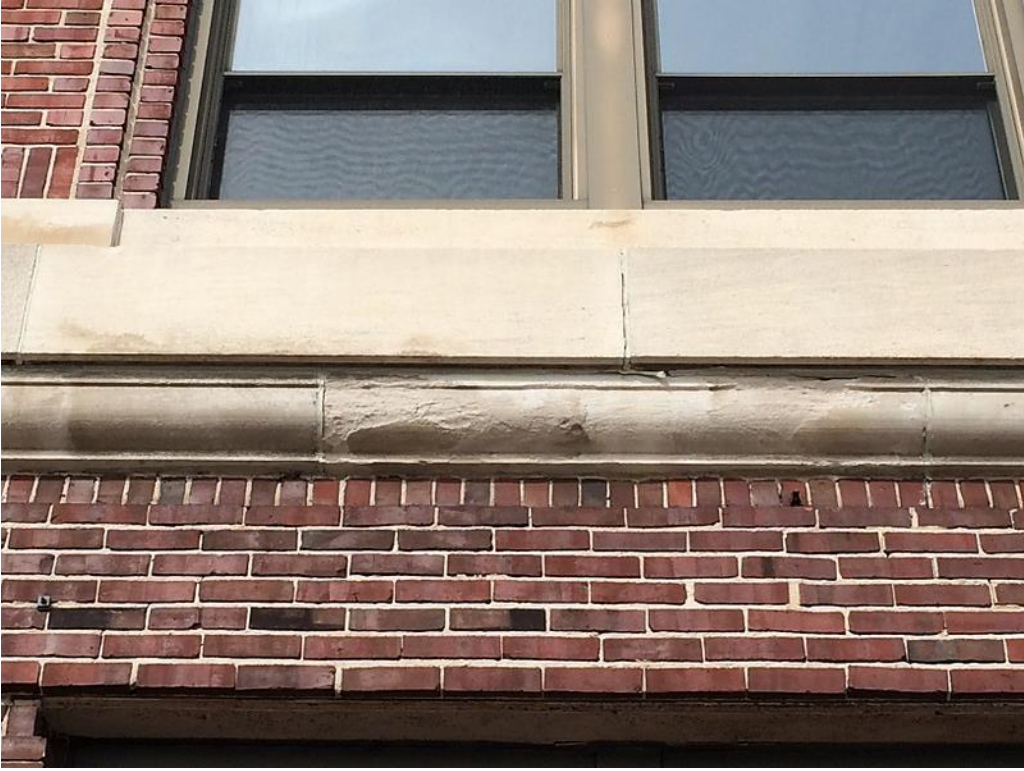
Figure 43: Stone erosion.

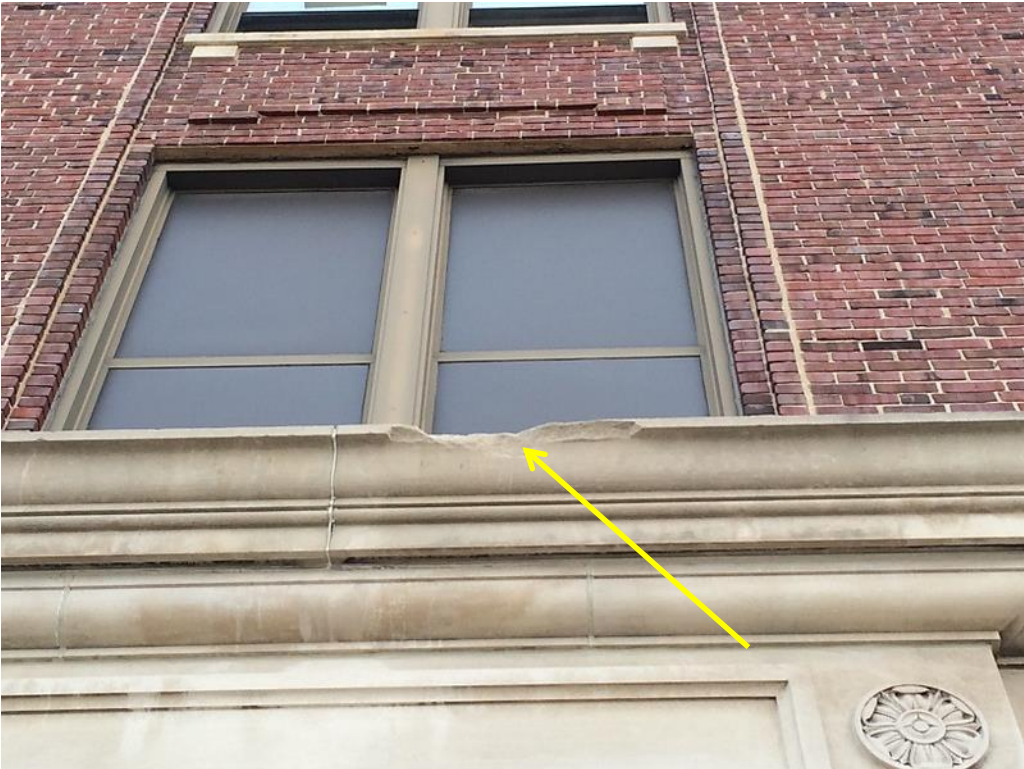
Figure 44: Spalled Stone

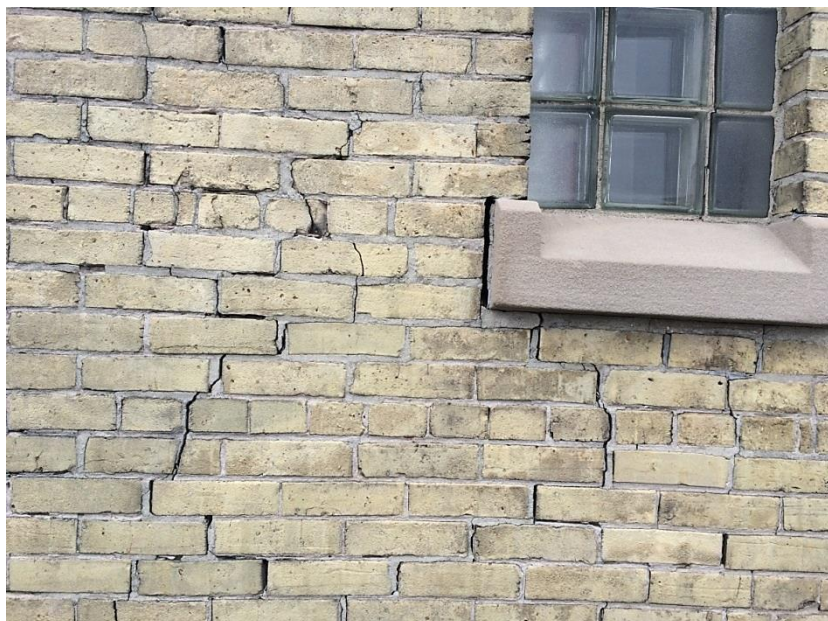
- a. Brick cracking at random locations (Figure 24).

Figure 24: Brick/mortar cracking.

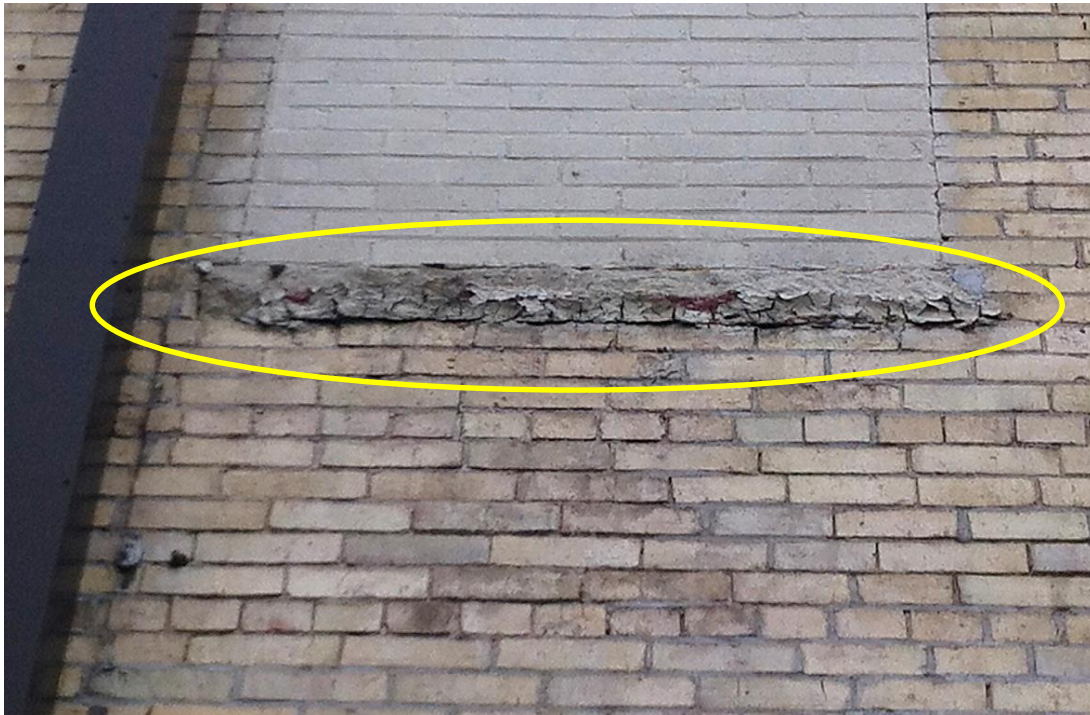
d. Deteriorated and cracked stone sills (Figures 35 & 36).

Figure 35: Deteriorated sill.

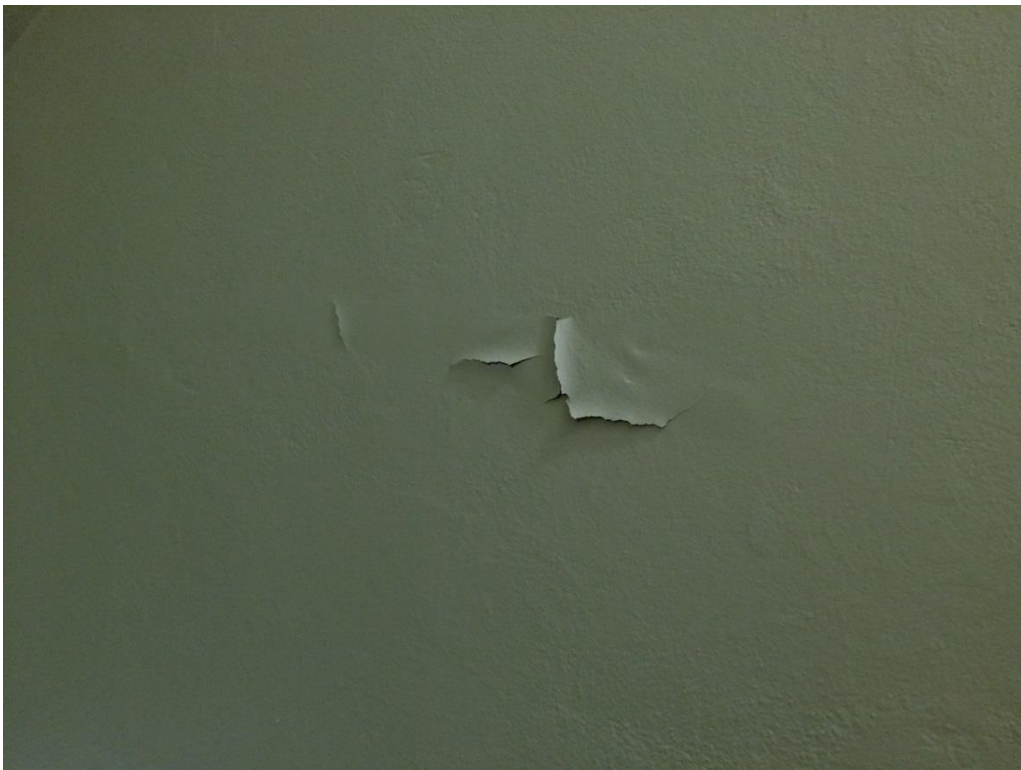
Figure 44: Paint failure.

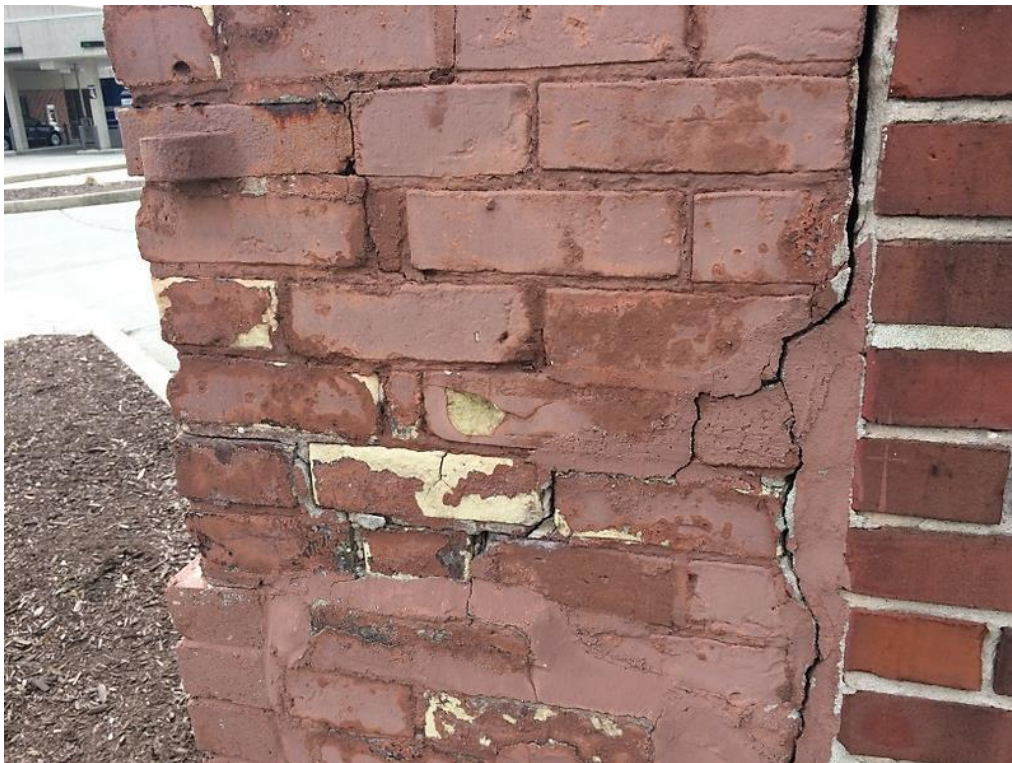
Figure 24: Deteriorated brick.
